SUMMIT INSPECTIONS

Property Location: 6501 MATILIJA AVENUE
VALLEY GLEN, CA

Structure Type: Single Family Home

Inspection Date: March 14, 2024

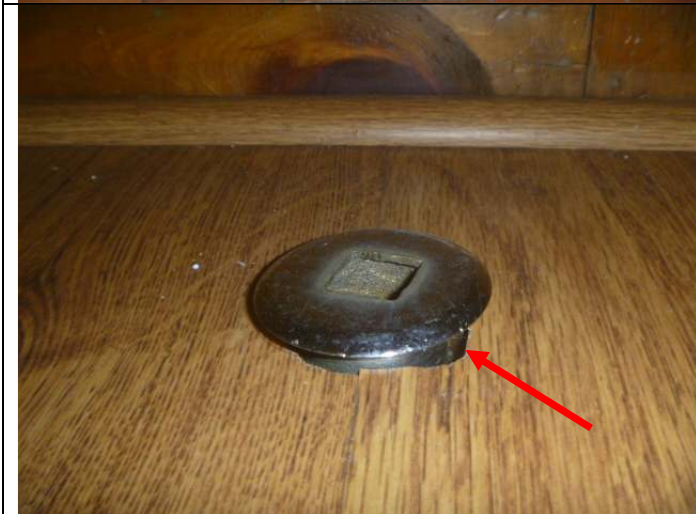
Fireplace gas valve not flush with the floor.

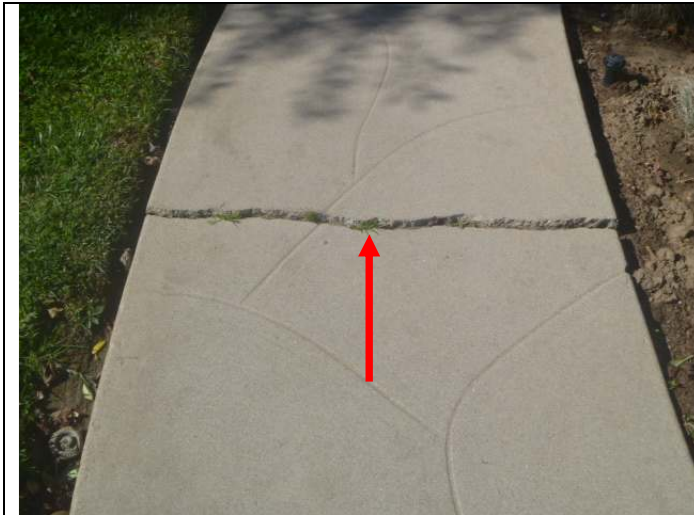
- A PORCHES:** Functional.
- B PATIOS, DECKS AND WALKS:** See POOL section regarding the deck. There is a cracked and uneven area in the front walkway. The front walkway is roughly repaired at the driveway. There are minor cracks in the north side walkway. The left rear walkway is noticeably cracked and lifted.

Front walkway crack and unevenness.

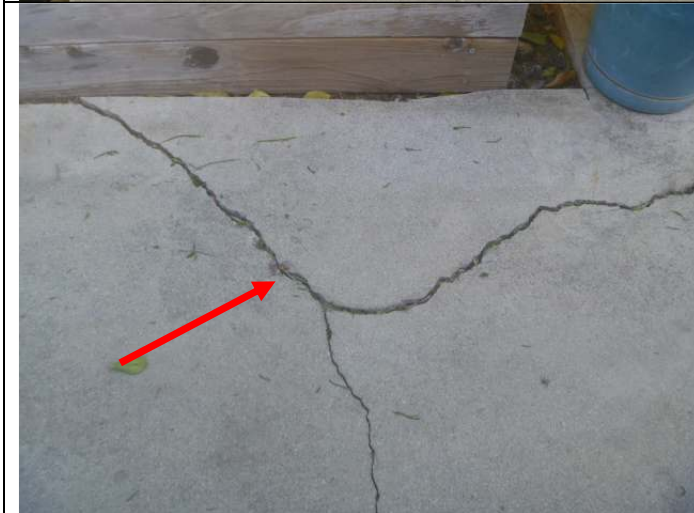
Cracks in the north side walkway.

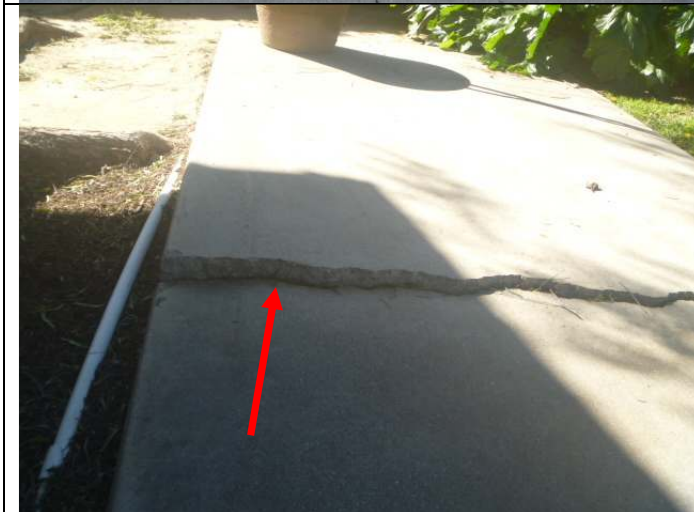
Cracked and lifted left rear walkway.

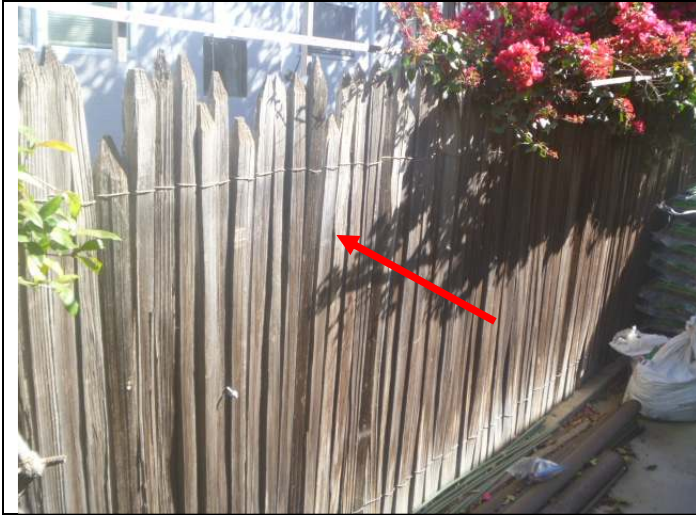
- **SPRINKLERS:** The sprinkler system is automatic and was not operated.
- B FENCES AND WALLS:** The north side and rear wood fences are old and noticeably weathered. The right front gate with pool area access is not properly self-closing.

Old north side wood fencing.

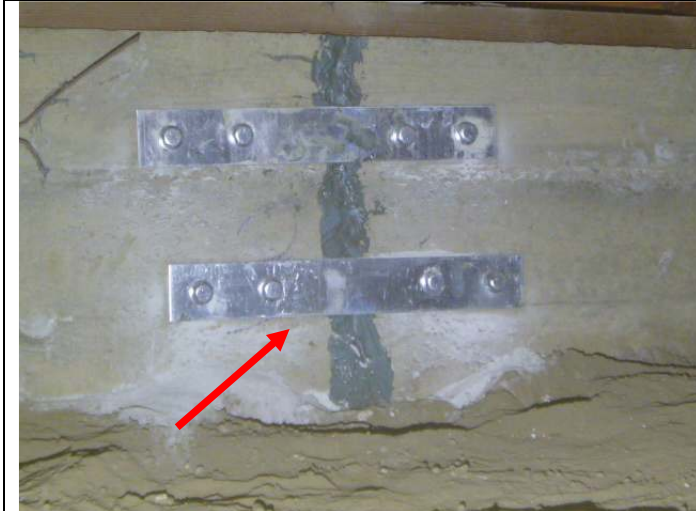
Foundation crack repair (toward the right front).

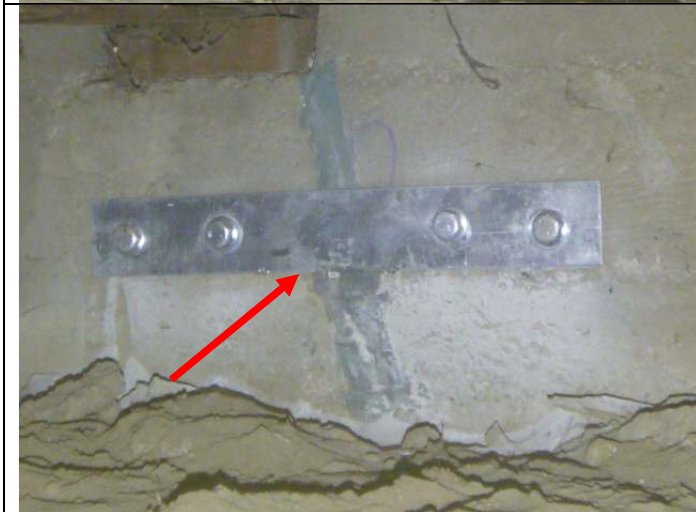
Foundation crack repair (south wall toward the left front).

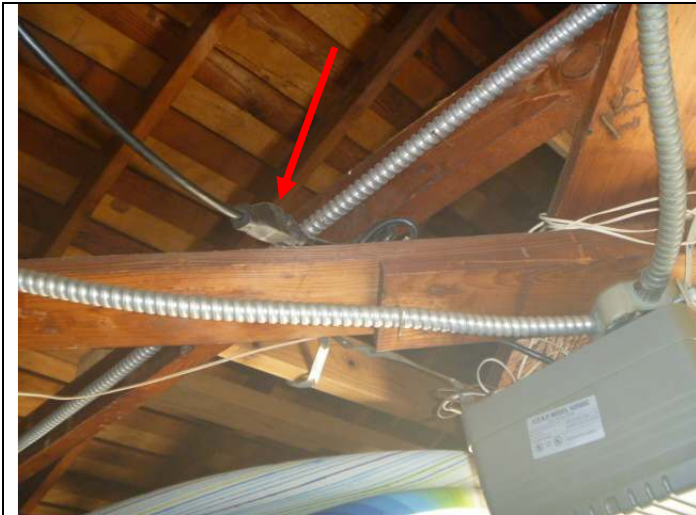
Extension cord wiring to the garage door opener.

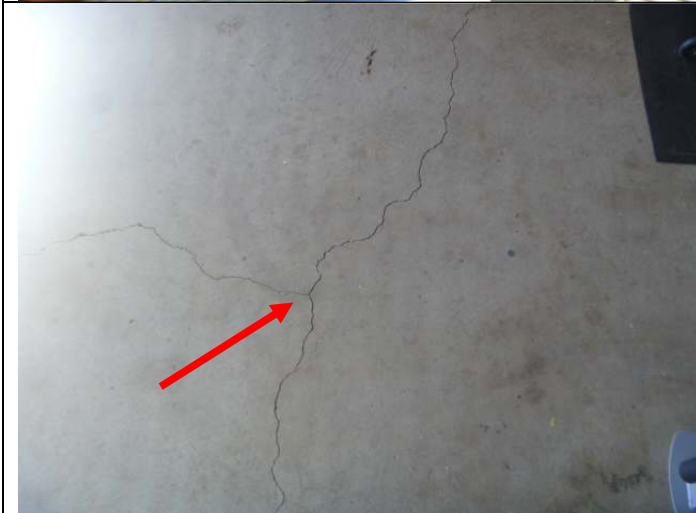
Minor cracks in the garage slab floor.

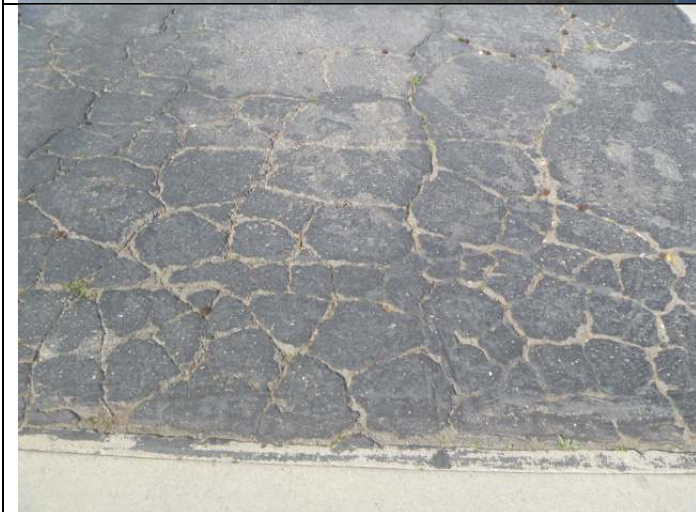
Old and cracked asphalt driveway.

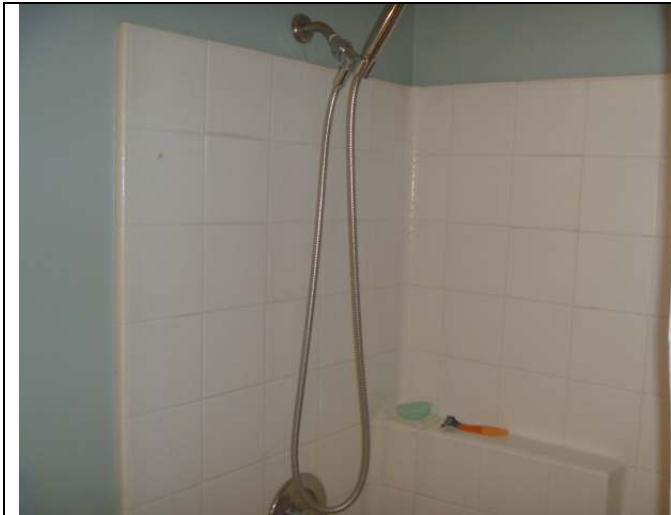
North bathroom shower/tub.
Note: There is evidence of a removed enclosure door set.

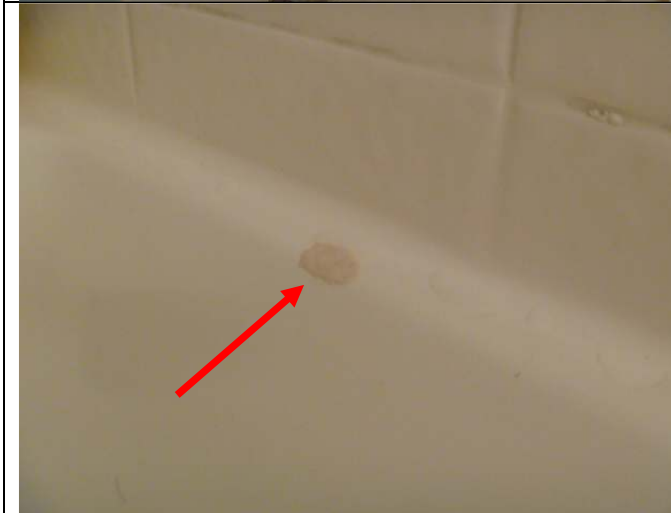
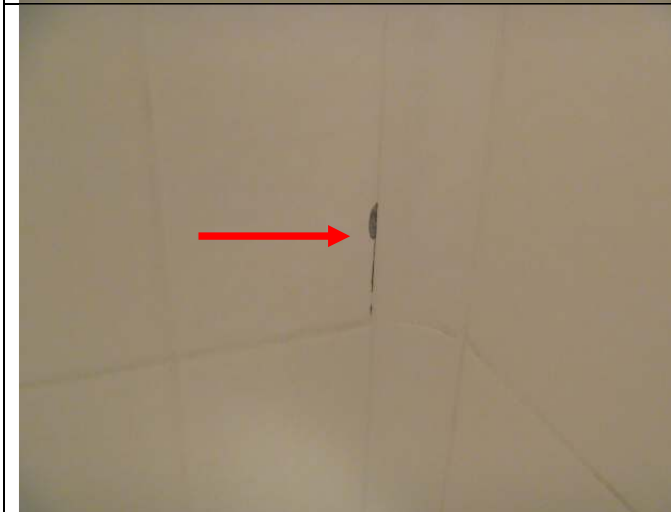
North bathroom shower/tub
surface damage.

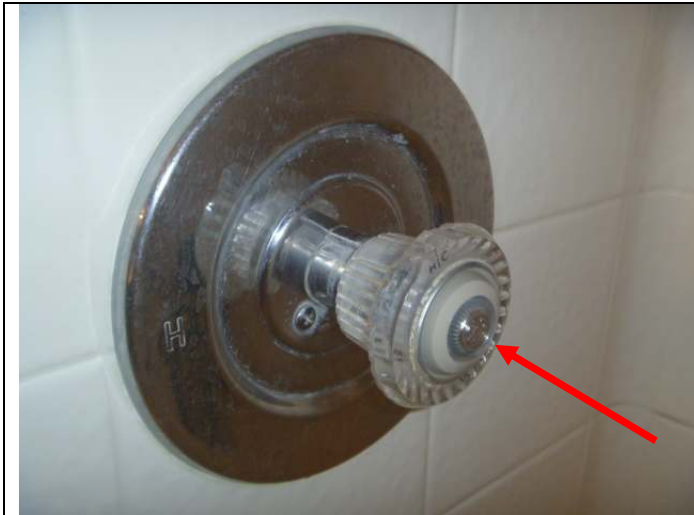
North bathroom shower/tub fixture. Note: The valve (pull type) is somewhat stiff.

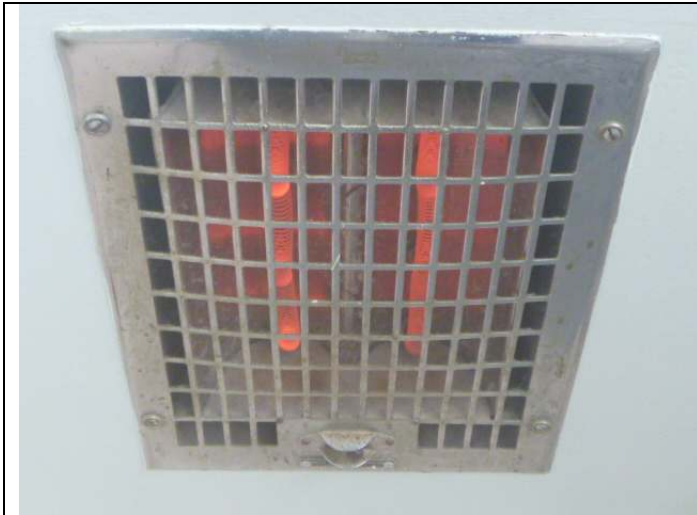
South bathroom old wall heater coil.

- A ELECTRICAL:** Note: The receptacles are a ground fault circuit interrupter (GFCI) type.
- VENT FANS:** None.
- B HEATING:** Wall Registers – Ceiling Lamp (south) – Wall Coil (south). South: Recommend considering disconnecting the wall heater coil (electric) – for enhanced safety.

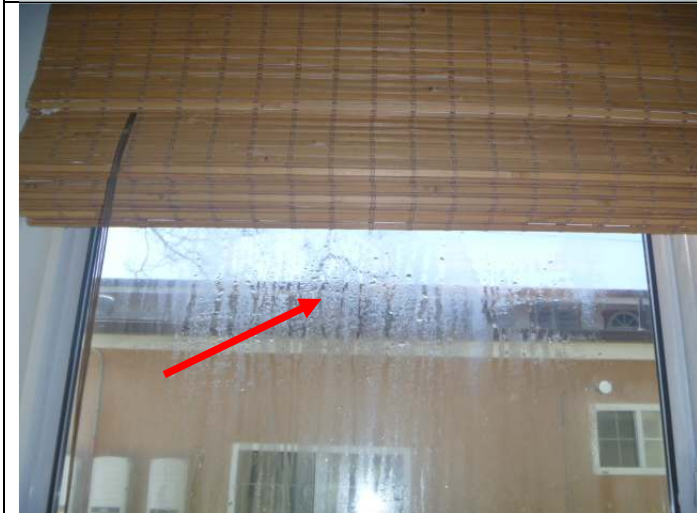
Fogged window pane (dual pane type) in the south front bedroom.

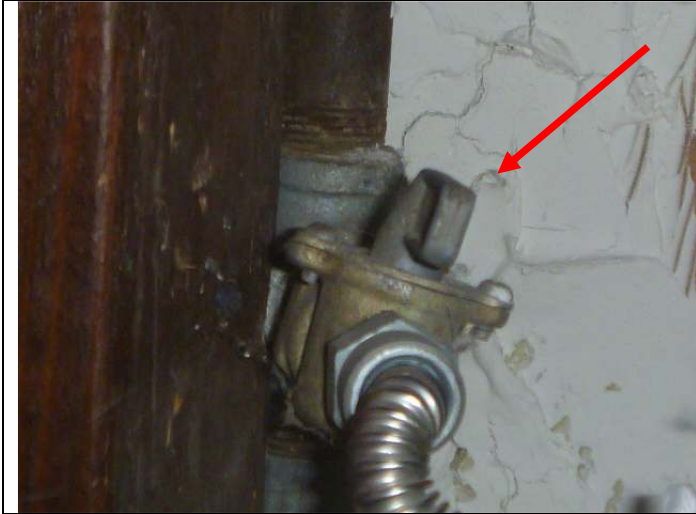
Old dryer gas valve below the water heater.

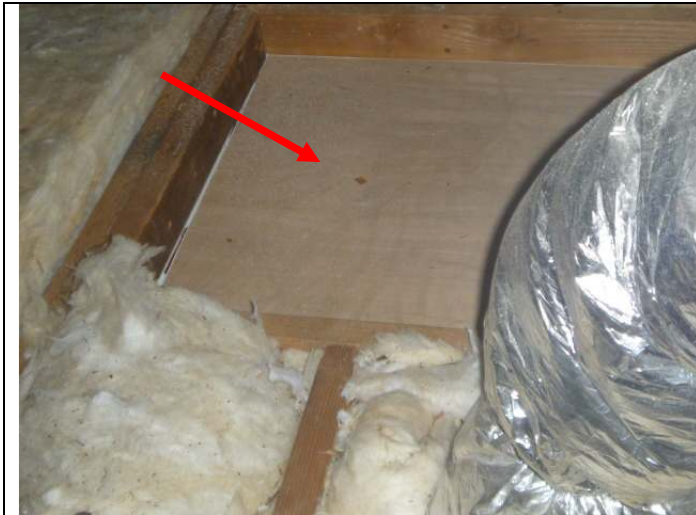
Small area with missing attic insulation.

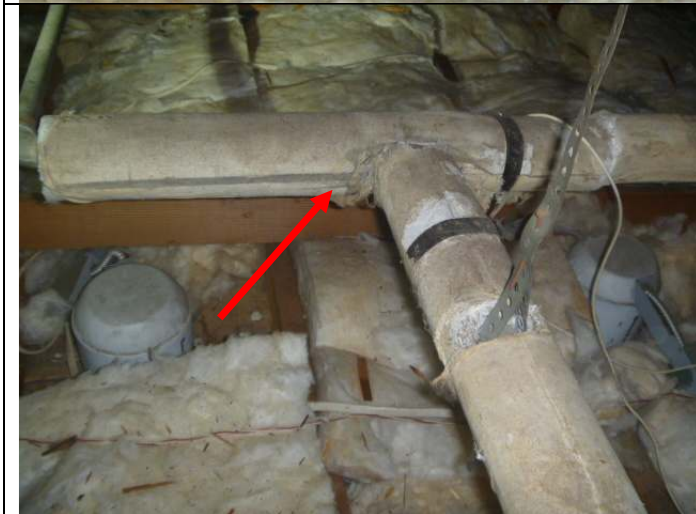
Asbestos pipe insulation in the attic.

- A INSULATION:** Functional (batts type).
- **ADDITIONAL COMMENTS:** There is a considerable amount of asbestos insulated piping (not in use). Recommend consulting an asbestos specialist for further review and abatement. There is an open electrical box in the north end of the attic. Note: The left front and left rear sections of the attic have especially limited access.

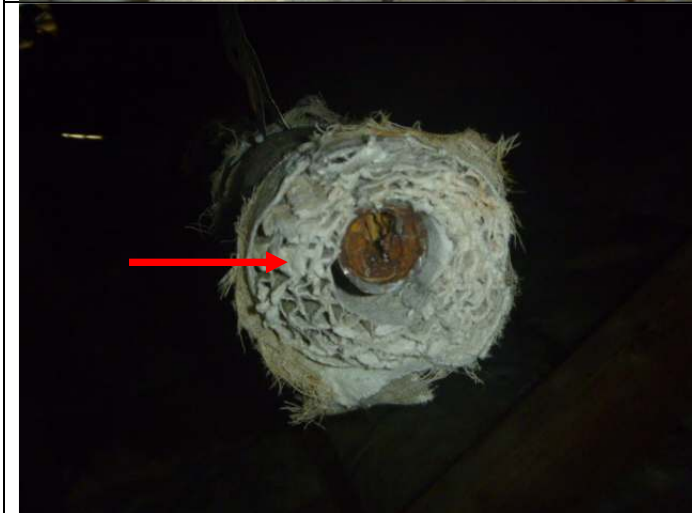
Cross section of the above noted asbestos pipe insulation.

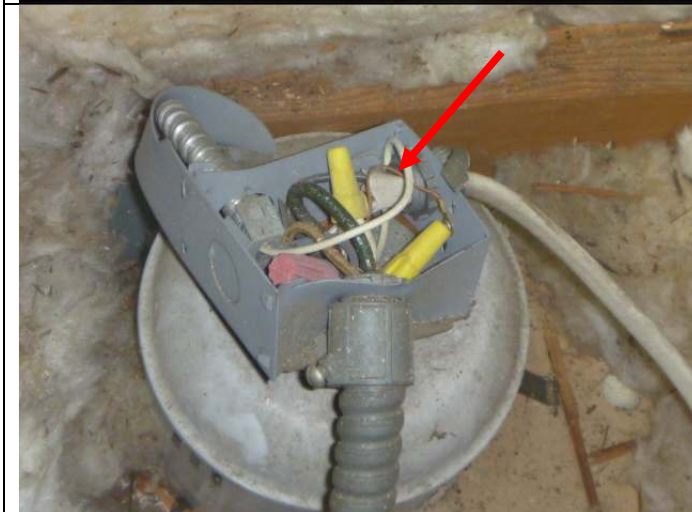
Open electrical box at the north end of the attic.

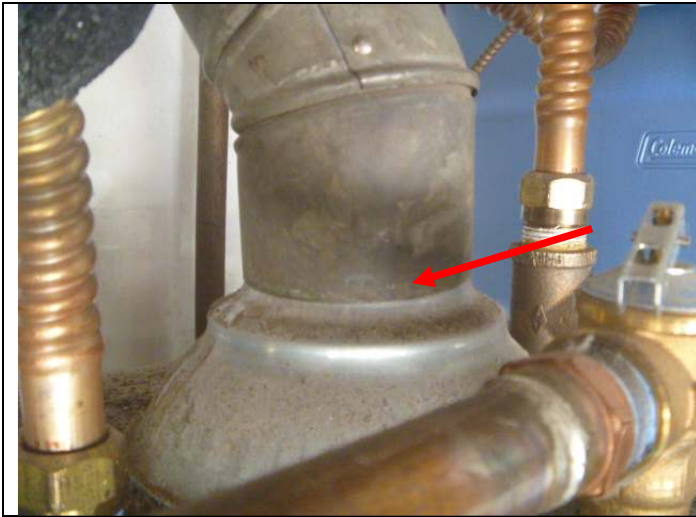
No securing screws for the water heater vent pipe at the downdraft diverter.

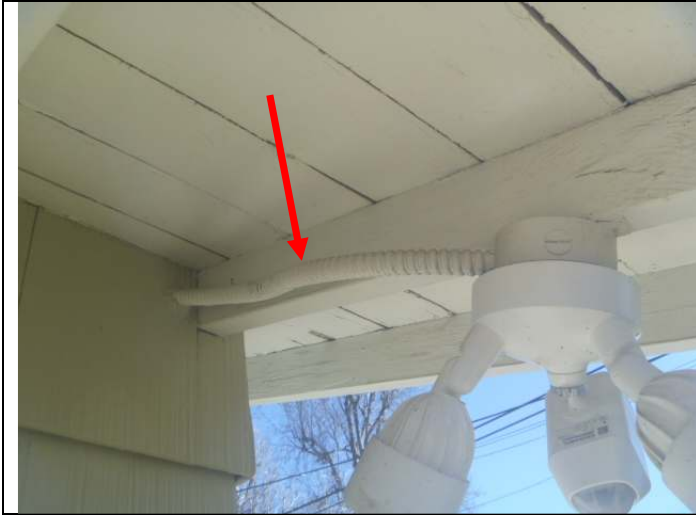
Flexible conduit wiring under the garage left front eave. Note: The wiring is not rated for exterior use, however, this is possibly the original installation.

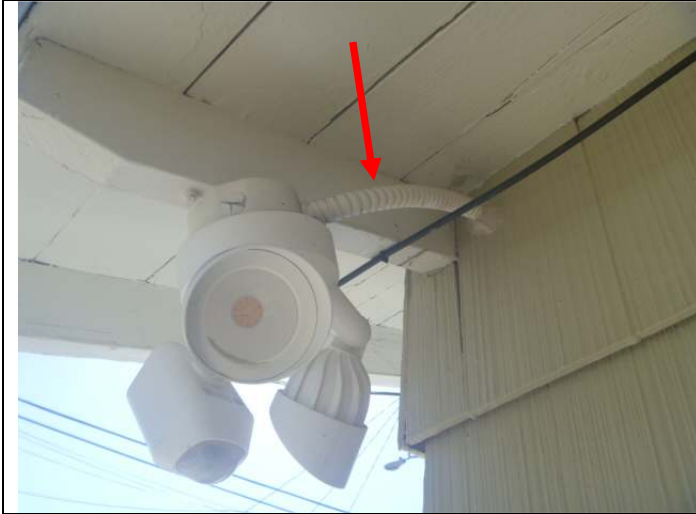
Flexible conduit wiring under the garage right front eave. Note: The wiring is not rated for exterior use, however, this is possibly the original installation.

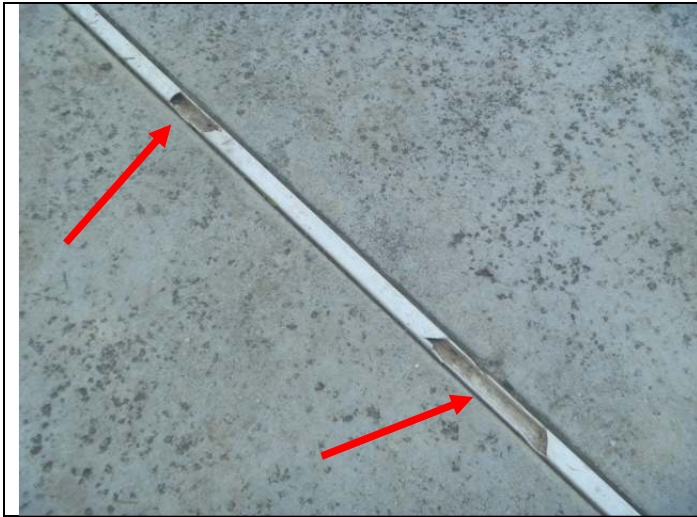
Damaged vinyl along the pool deck expansion joints.

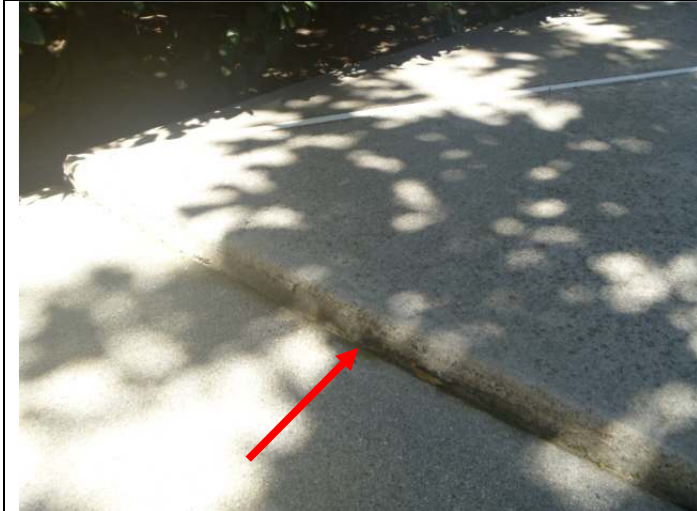
Uneven joint at the left rear of the pool deck.

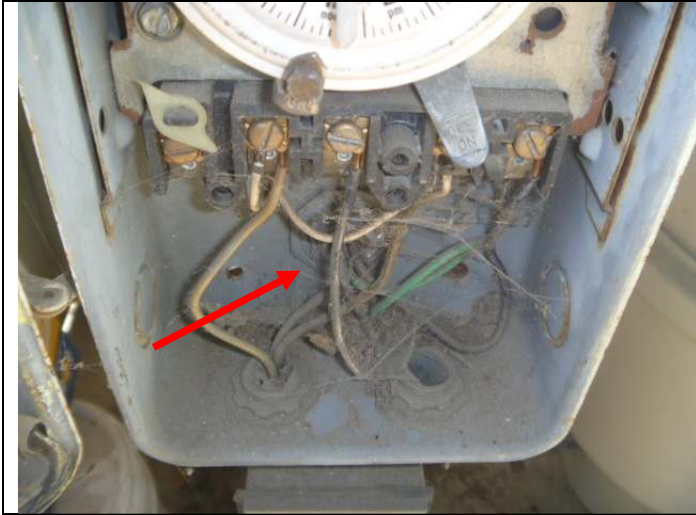
Pool timer with missing insulating cover.

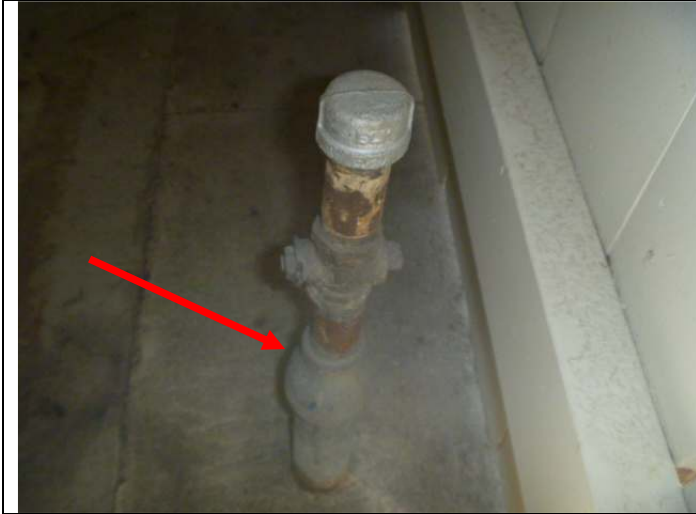
Old gas piping for a previous pool heater.
