SUMMIT INSPECTIONS

Property Location: 9976 TUJUNGA CANYON BOULEVARD
TUJUNGA, CA

Structure Type: Single Family Home

Inspection Date: March 7, 2024

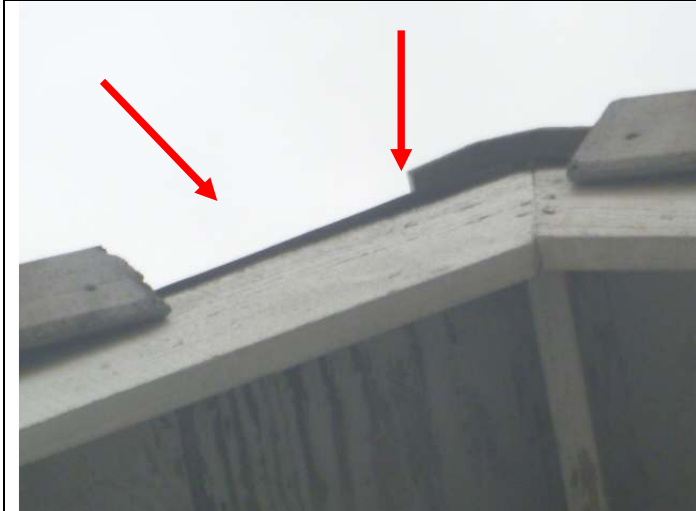
- B ROOF:** The main roof is a concrete tile type. The roofing overall appeared to be intact and in generally satisfactory condition. However, there are a few missing tiles at the east gable end of the roof (adjacent to the ridge). Note: No direct entry was made onto the roof as not to potentially damage the tiles. The two small flat sections of the roof at the front bedroom windows are rolled composition or similar type. There are irregular sealant repairs along the perimeter of the roof. The sunroom roof is a composition shingle (20-year rated) type. The roofing overall appeared to be intact but older (some general deterioration is visible). The roof slope is insufficient for shingles. Also, there is lifted flashing and sealant along the stucco wall connection.

Missing tiles at the east gable end of the upper roof.

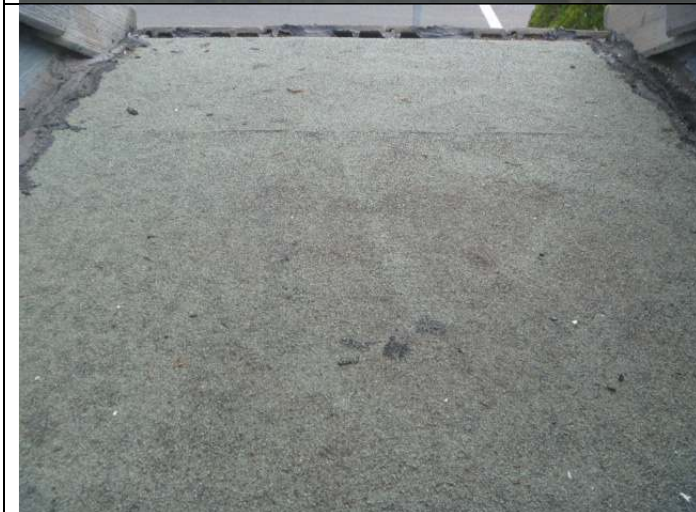
Left front dormer roof (off the west front bedroom). Note: There is a similar area off the east front (primary) bedroom.

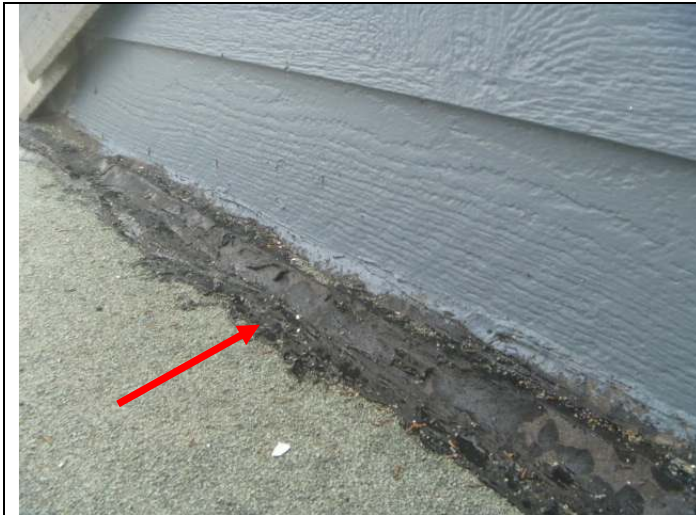
Sealant along the perimeter of the above roof.

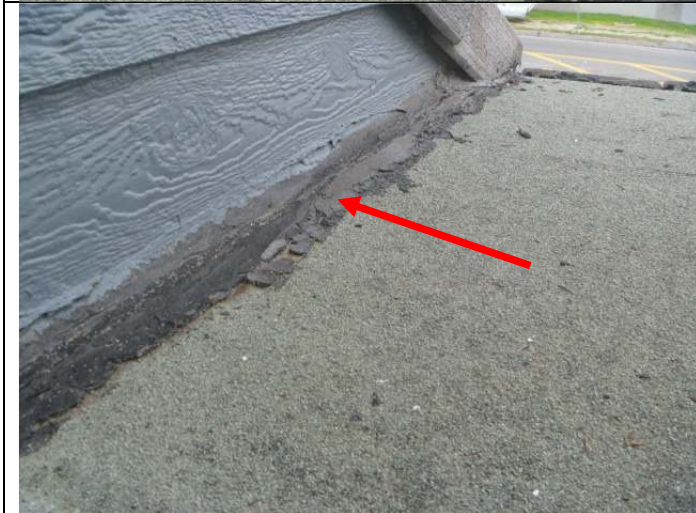
Sealant along the perimeter of the above roof.

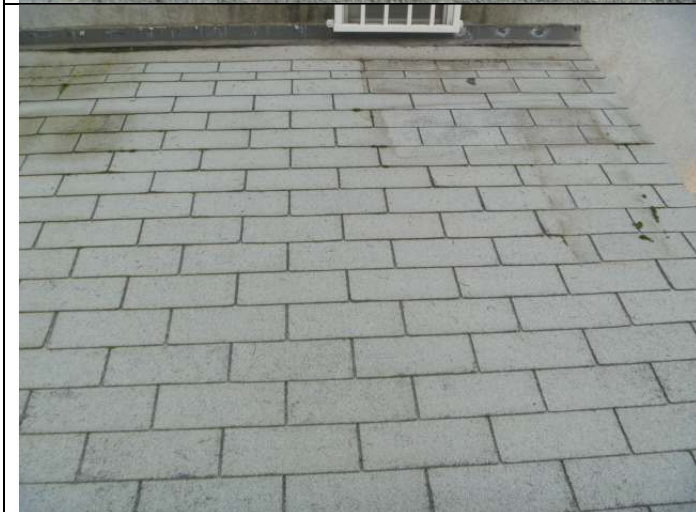
Sunroom roof. Note: The roof slope is insufficient for shingles.

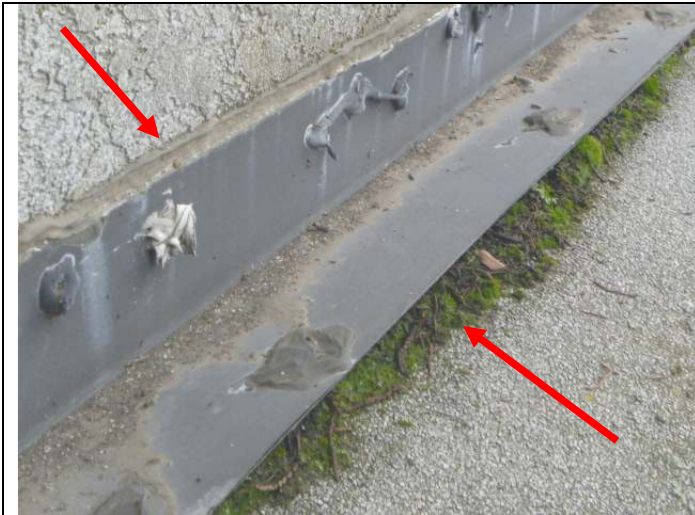
Lifted flashing and sealant along the stucco wall connection.

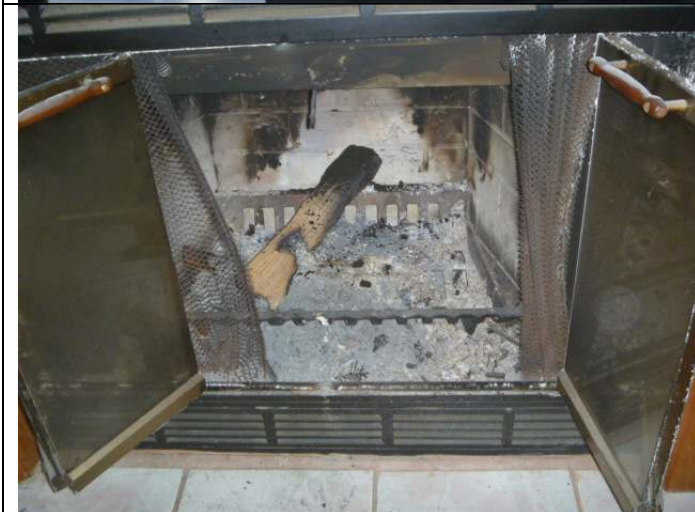
- B CHIMNEY:** The chimney (prefabricated type, with spark arrestor/rain cap) inspection is limited. Recommend consulting a chimney specialist. Note: The gas pipe in the fireplace is capped. There is no hearth extension (matching floor tiles only) at the front of the fireplace. The wooden mantel does not have the proper clearances around the fireplace opening.

Fireplace. Note: There is no hearth extension (matching floor tiles only) along the front of the fireplace.

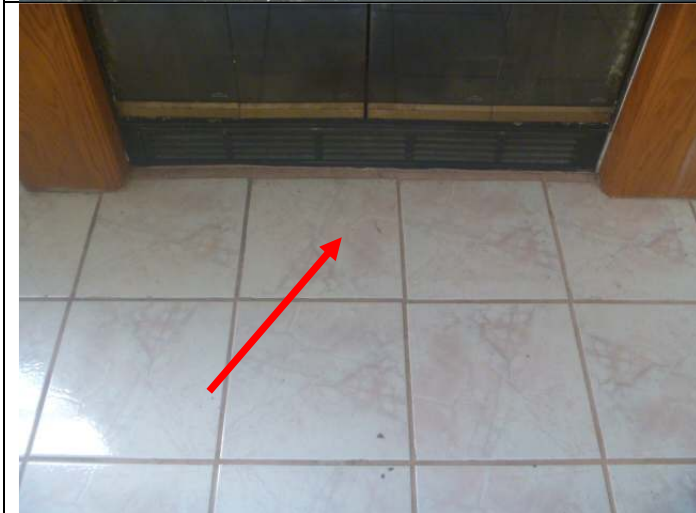
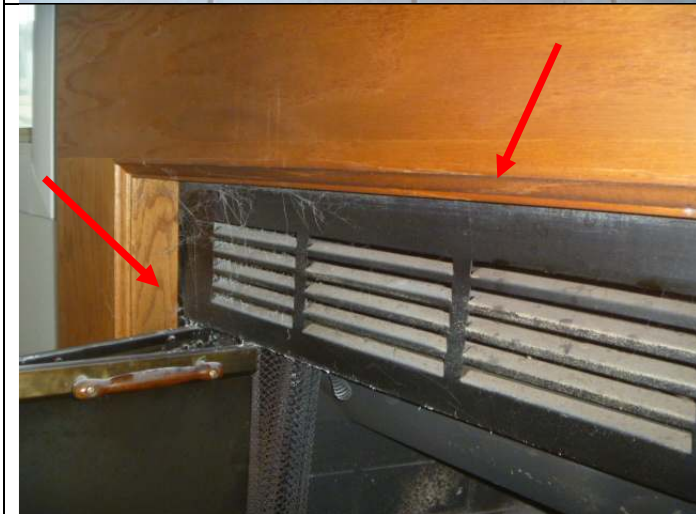
Fireplace mantel without the proper clearance around the fireplace opening.

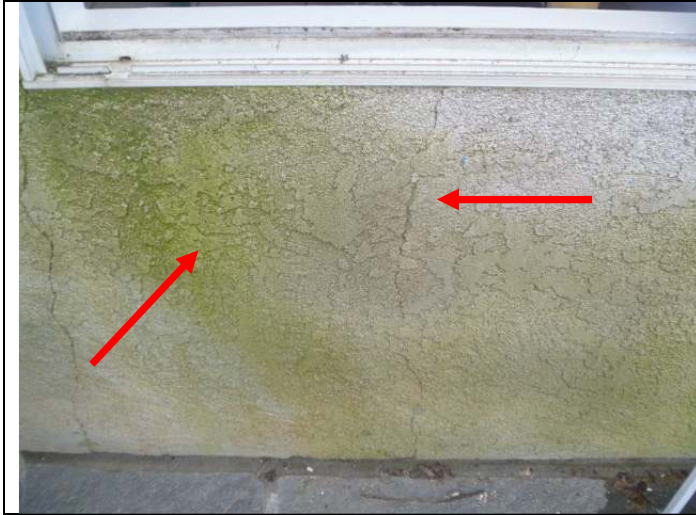
Stucco cracking and discoloration.

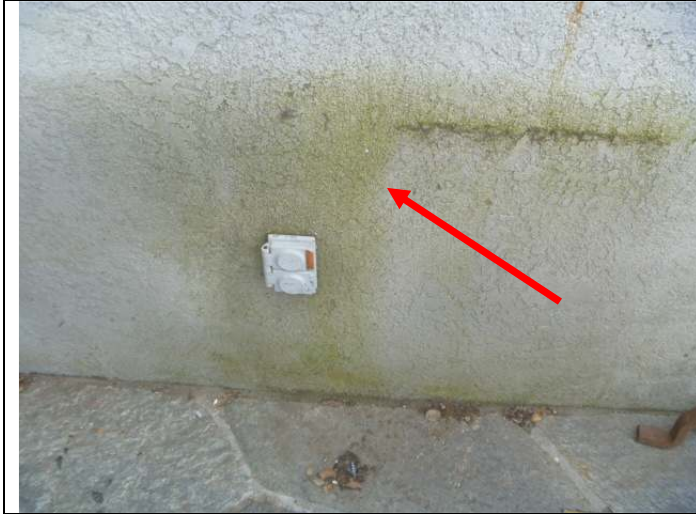
Stucco discoloration.

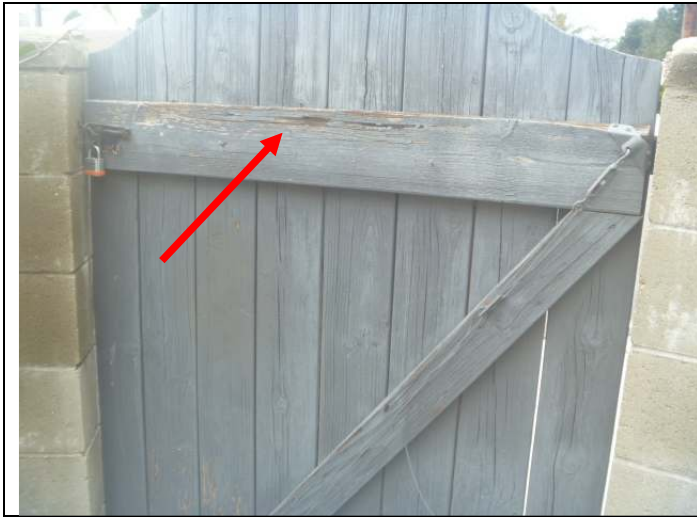
Weathered wood gate at the left rear.

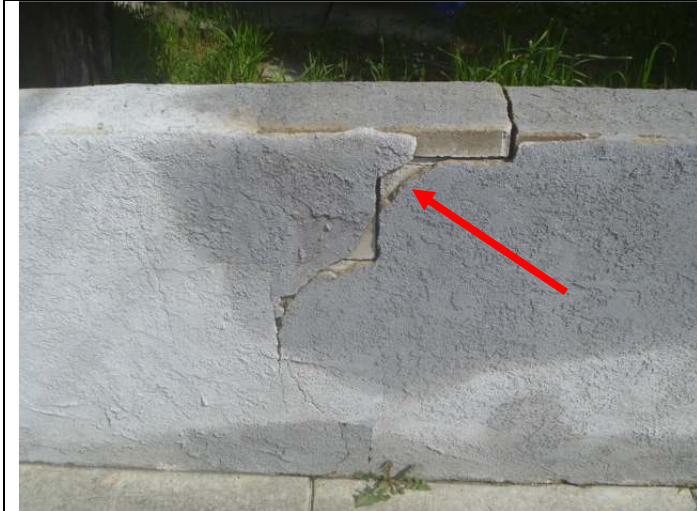
Cracks in the left front block/stucco wall.

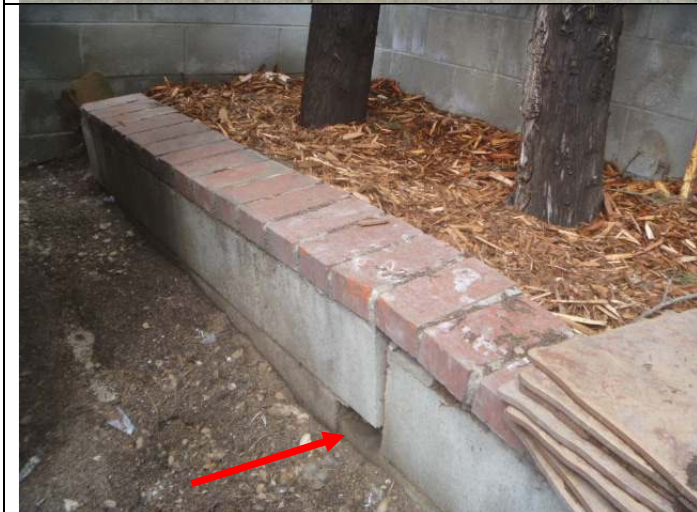
Displacement in the right rear planter wall.

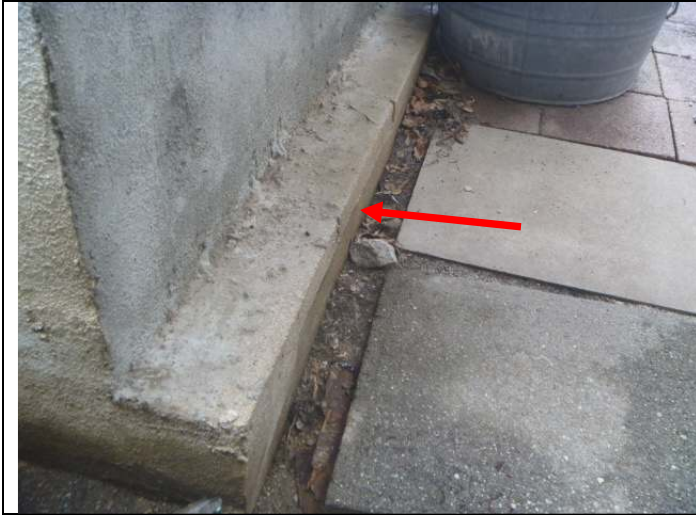
Added concrete, likely for water diversion, along the sunroom lower rear exterior wall.

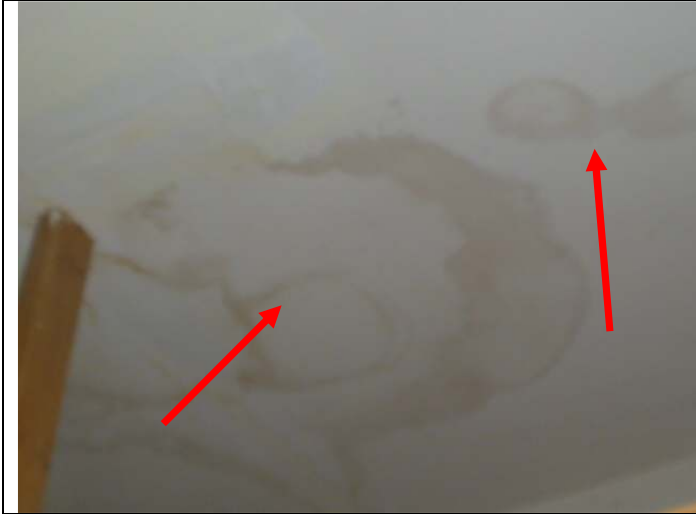
- B ROOF:** See EXTERIOR section. Note: There is some discoloration in the ceiling – at least partially roof related and appeared to be old.
- A FIRE SEPARATION:** Functional.
- A/ GARAGE DOOR:** Manual. The garage door is older.
B
- WINDOWS:** None.
- B ELECTRICAL:** The left receptacle on the west wall is a ground fault circuit interrupter (GFCI) type. Recommend installing GFCI protection for the right receptacle on the west wall and for

Discoloration in the garage ceiling.

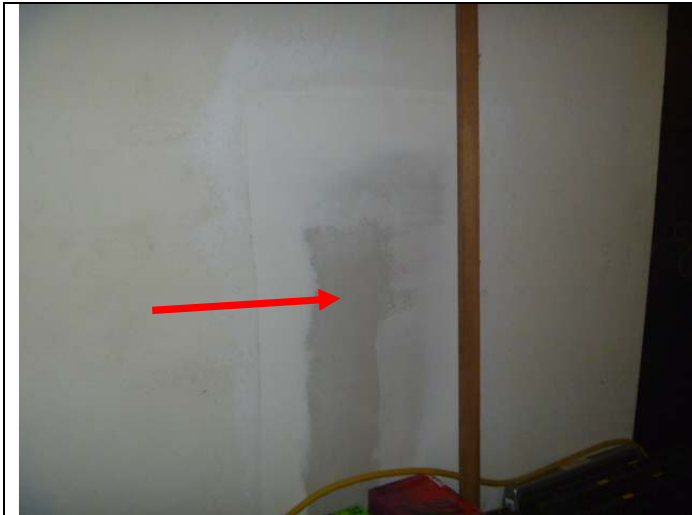
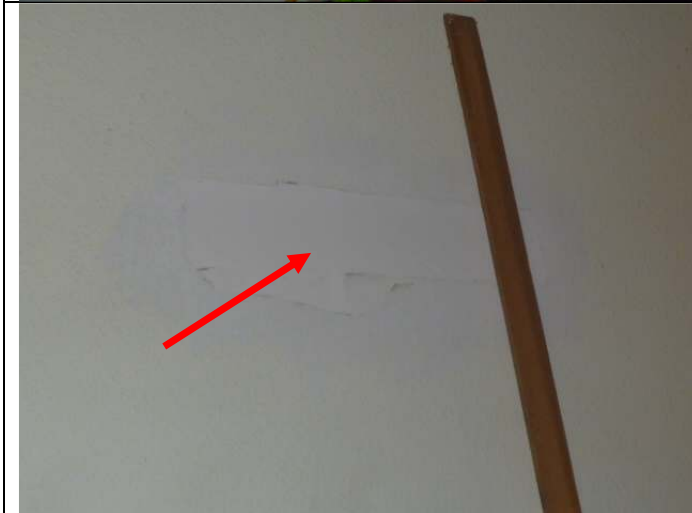
- A DRIVEWAY:** There are minor cracks in the concrete driveway.
- **ADDITIONAL COMMENTS:** The garage access was limited due to personal items. There are minor cracks in the slab floor. There are repair related irregularities in the rear wall (on the backside of the downstairs bathroom shower) – likely plumbing leakage and repair related.

Garage rear wall repair (on the backside of the downstairs 3/4 bathroom shower).

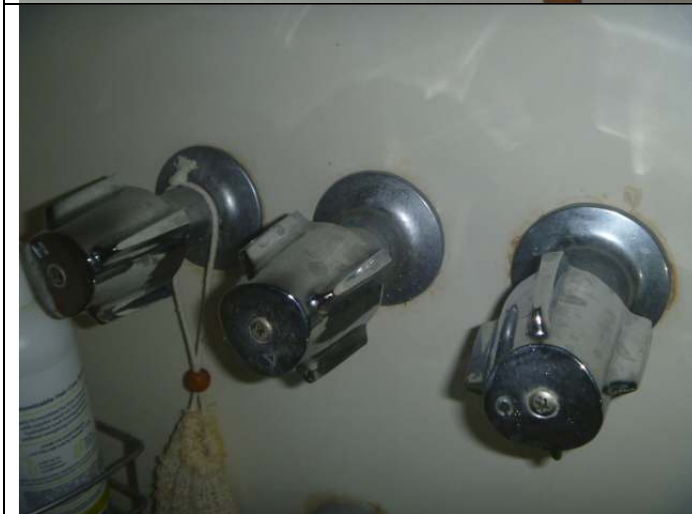
- C FIXTURES:** The majority of the plumbing fixtures are older. Note: The toilets are to be replaced. Full: The shower/tub hot and cold water valves squeak during operation. The shower/tub diverter valve leaks. The sink stopper is missing. Downstairs 3/4: The sink stopper top piece is missing.

Full bathroom shower/tub fixtures. Note: The hot and cold water valves squeak during operation. The shower/tub diverter valve leaks.

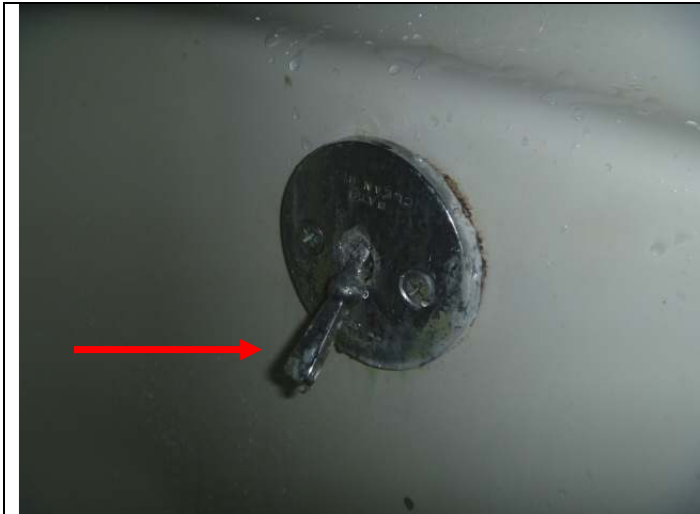
<p>Tub stopper control. Note: The stopper is inoperative.</p>

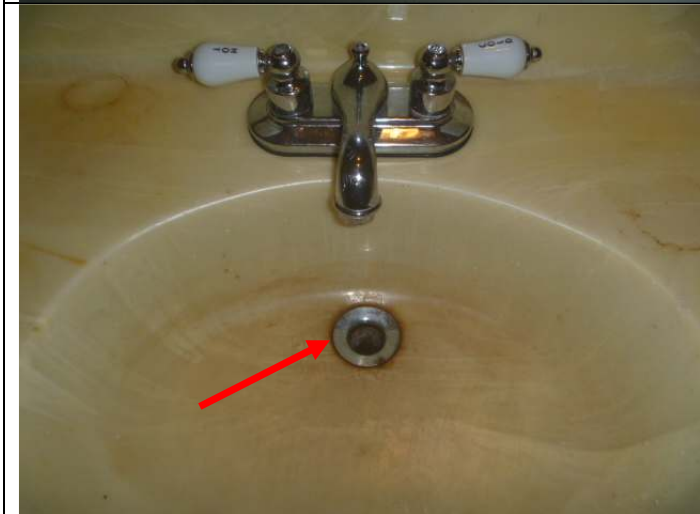
<p>Discoloration in the full bathroom sink. Note: The missing sink stopper.</p>

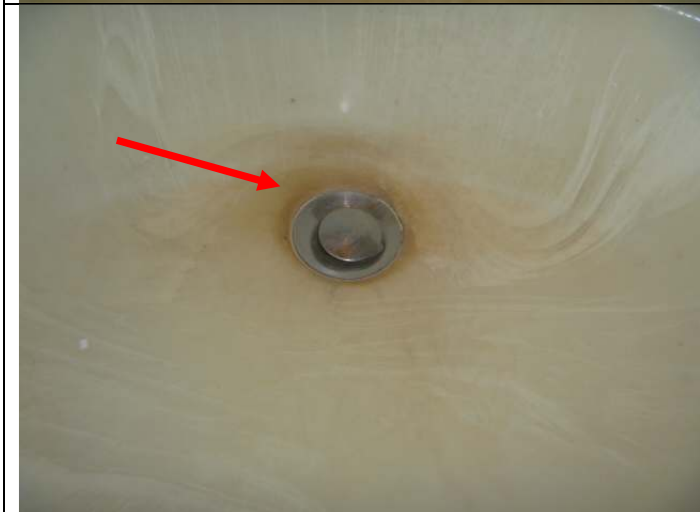
<p>Discoloration in the upstairs 3/4 (primary) bathroom sink.</p>

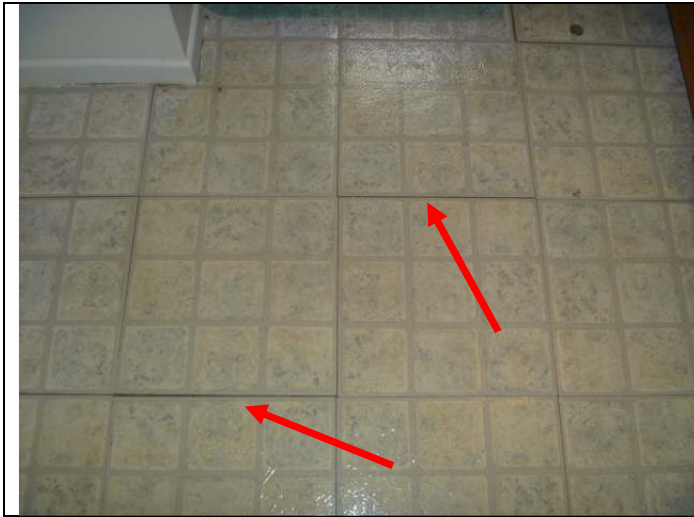
Gaps in the upstairs 3/4 (primary) bedroom vinyl flooring tiles.

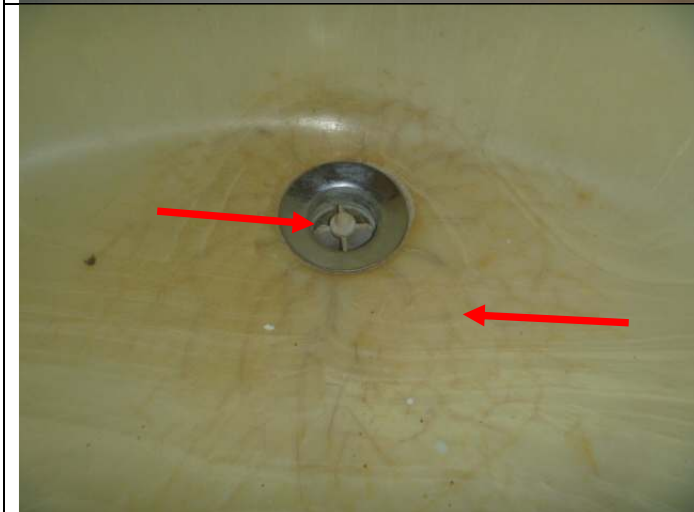
Discoloration and cracking in the downstairs 3/4 bathroom sink. Note: The missing sink stopper top piece.

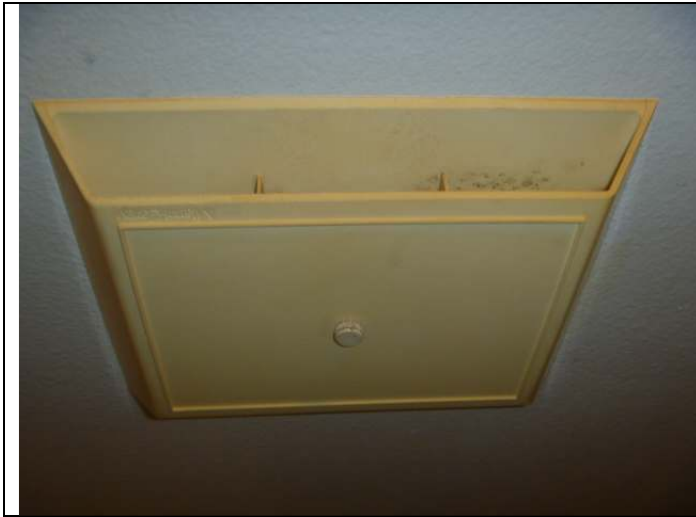
Downstairs 3/4 bathroom vent fan. Note: The fan is relatively noisy.

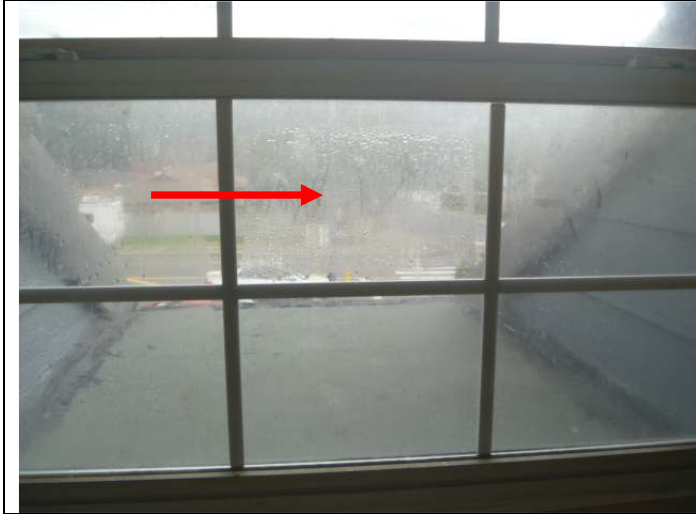
- A WALLS AND CEILINGS:** Functional.
- A DOORS:** Functional.
- B WINDOWS:** West Front: There is a fogged window pane (dual pane type) at the front. East Front (primary): There is a fogged window pane (dual pane type) at the front.
- A FLOORS:** Functional.
- A ELECTRICAL:** Functional.

Fogged window pane (dual pane type) at the front of the west front bedroom.

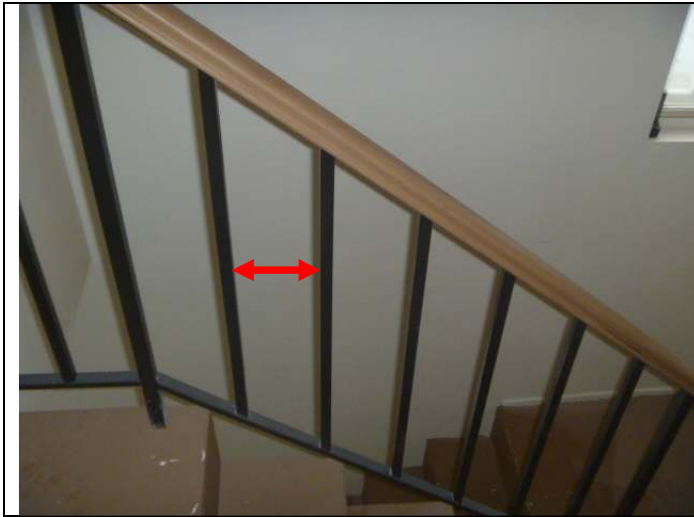
- ADDITIONAL COMMENTS:** Living Room: See EXTERIOR section regarding the chimney and the fireplace. Hallway & Stairway: The railing spacing is relatively wide (approx. 5 ½” and 5” vs. no more than 4”) – older style installation. Note: The stairway lower section handrail is to be installed. Sunroom: Note: There is a main drain cleanout at the lower left front wall.

Stairway railing with relatively wide spacing – older style installation.

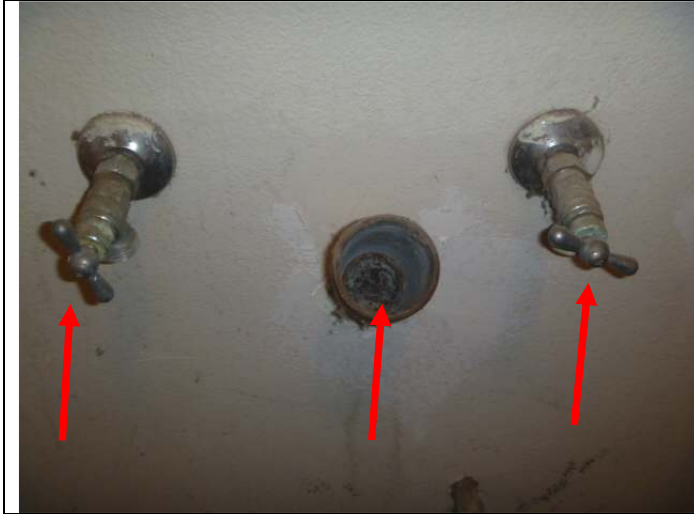
- A LOCATION:** Garage
- C PLUMBING:** The washer valves are older and leak. Note: The washer drain was not tested.

Washer valves and drain. Note: The valves are older and leak.

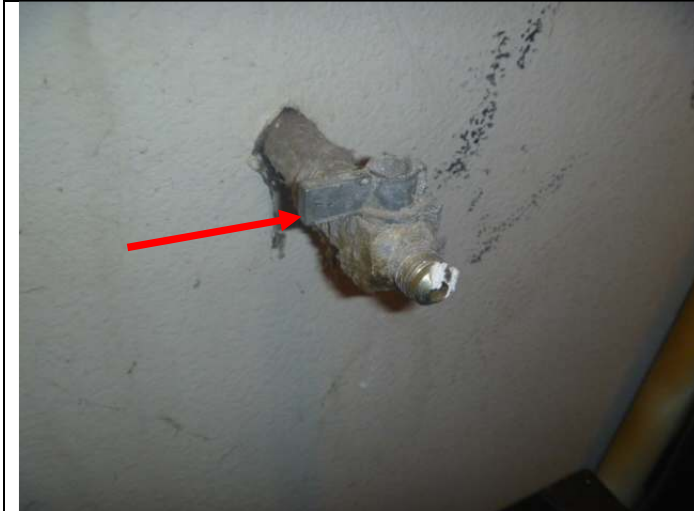
Older gas valve for the dryer.

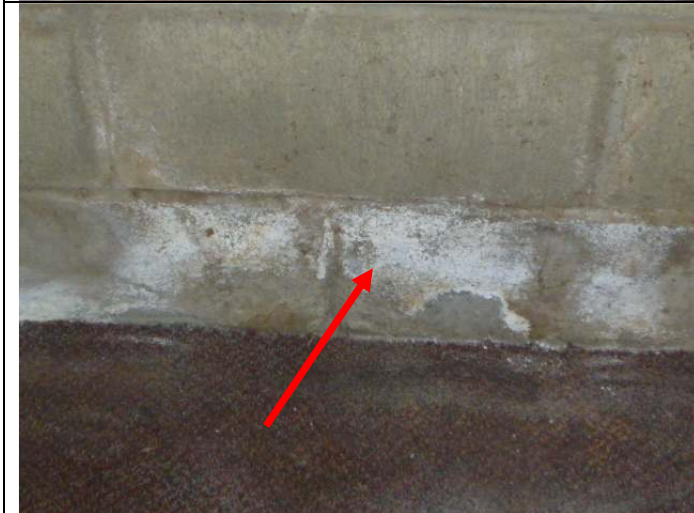
- B WALLS AND CEILINGS:** Sunroom: The sunroom is not finished. There is evidence of moisture entry, in the form of efflorescence, along the lower rear wall – possibly old. See EXTERIOR section for exterior drainage related comments. There is exposed fiberglass insulation at the ceiling. Note: The room access was especially limited due to personal items.

Efflorescence along the sunroom lower rear interior wall.

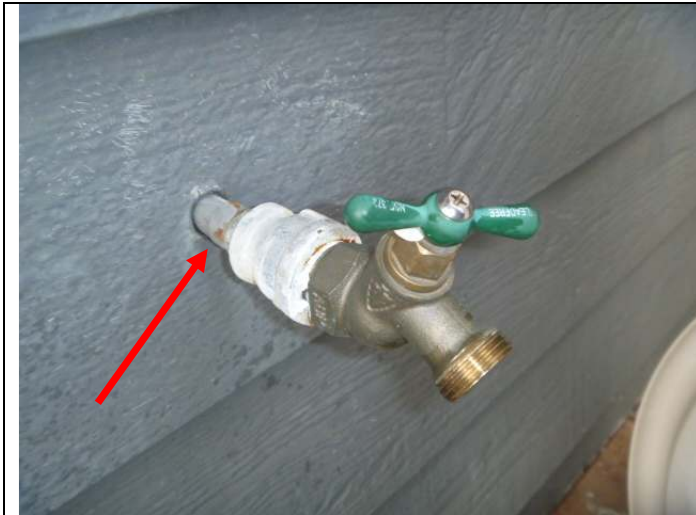
Left front exterior hose bib.
Note: The pipe is somewhat loose at the wall.

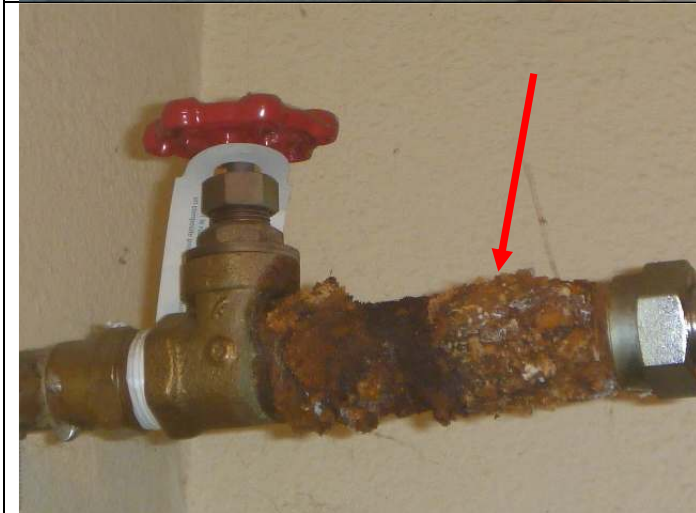
Noticeably rusted water piping at the water shut off valve above the water heater.

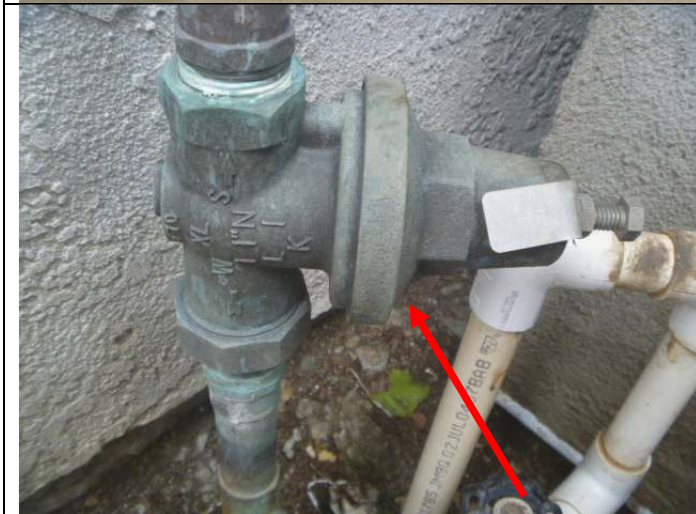
- C **FIXTURES:** The plumbing fixtures appeared to be in functional condition with the exceptions noted. See BATHROOMS and LAUNDRY sections. The main water valve (at the east exterior) and the water shut off valve above the water heater are an older gate valve type. The hose bibb at the left front exterior (off the kitchen) is somewhat loose at the wall (minor).
- B **WATER PIPES:** Copper. The water piping overall appeared to be functional. However, there is a noticeably rust on the water piping at the water shut off valve above the water heater. Recommend repair. Note: The majority of the water piping is concealed.
- **WATER PRESSURE:** Incoming: 90 psi
Regulated: 90 psi (see below)
- C **PRESSURE REGULATOR:** The water pressure regulator at the east exterior is inoperative. Note: Code requires pressure to be regulated to a

maximum of 80 psi and newer systems are commonly regulated somewhat lower (e.g., to 65 psi).

Inoperative water pressure regulator.

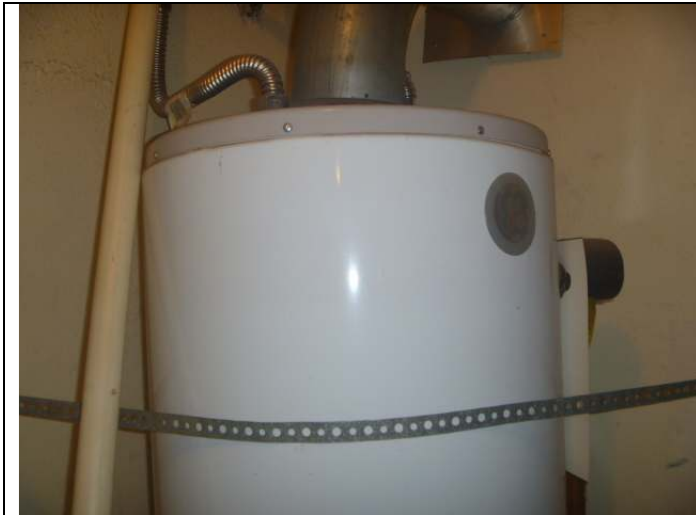
Water heater upper section.
Note: The required seismic bracing is to be installed.

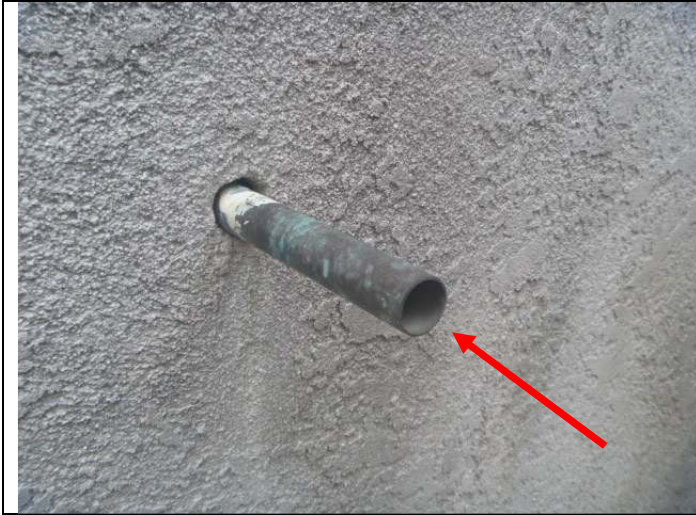
Water heater pressure relief valve outlet pipe pointing outward (vs. downward) at the exterior wall.

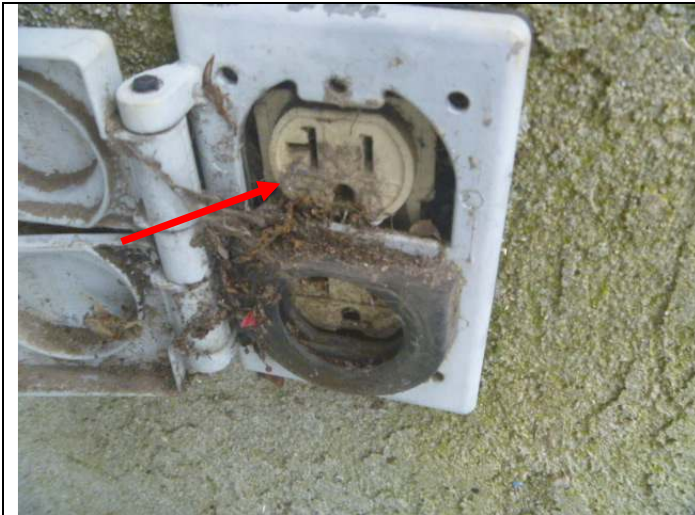
Left rear patio receptacle without ground fault circuit interrupter (GFCI) protection.

- B LIGHTS AND RECEPTACLES:** The accessible lights and receptacles appeared to be in functional condition with the exceptions noted. See GARAGE, BATHROOMS, KITCHEN and LIVING ROOM/ETC sections. Recommend installing ground fault circuit interrupter (GFCI) protection for the exterior receptacle at the left rear – for enhanced safety. Note: GFCI protection was required at the time of original construction. Some of the receptacles are older. Recommend individual unit replacement as needed.

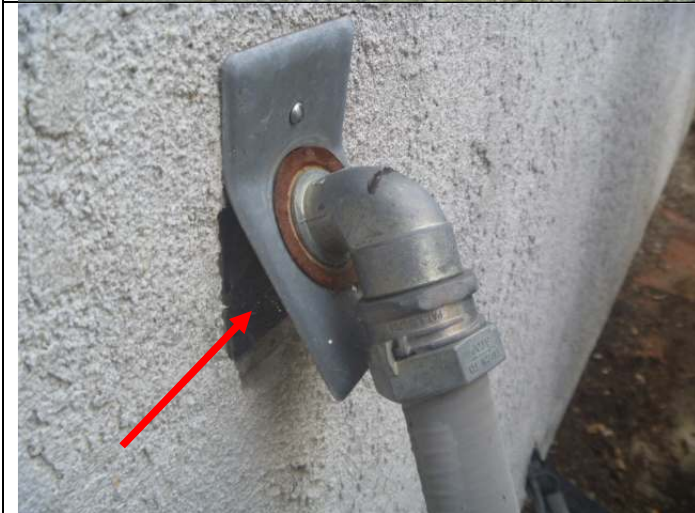
- B WIRING:** Nonmetallic cable (Romex). The majority of the wiring is a nonmetallic cable (Romex) type and the wiring overall appeared to be functional. The electrical conduit for the air conditioner condensing unit is loose at the exterior wall. Note: There is no terminated larger gauge wiring, disconnected and not in use, to the right of the main service panel.

Air conditioning electrical conduit loose at the wall.

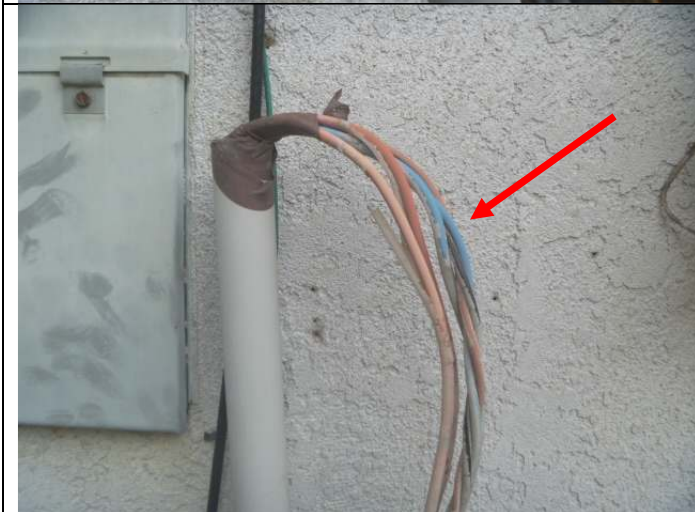
Disconnected larger gauge wiring to the right of the main service panel.

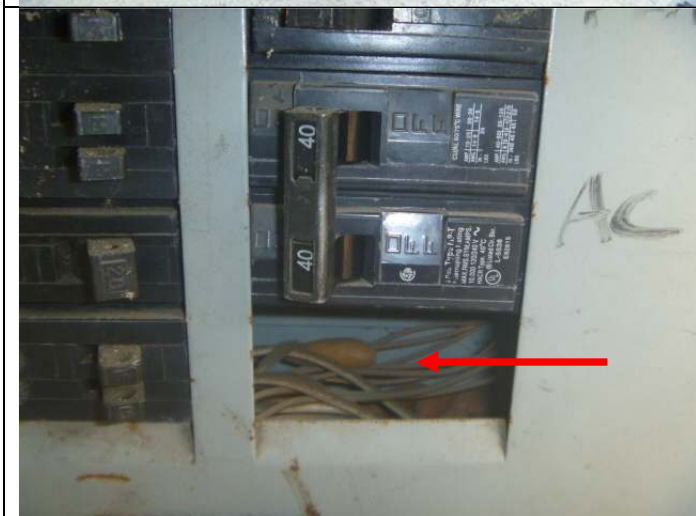
An open knockout in the panel interior cover.

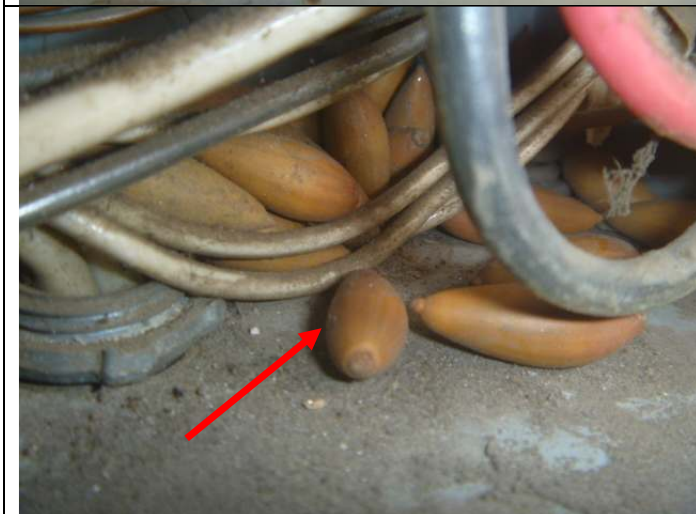
panel overall appeared to be functional, however, the capacity and the number of circuits are limited. Note: There is an open knockout in the panel interior cover. There is some loose tree debris (seed cones) within the panel. Recommend removal.

Loose tree debris within the main electrical service panel.

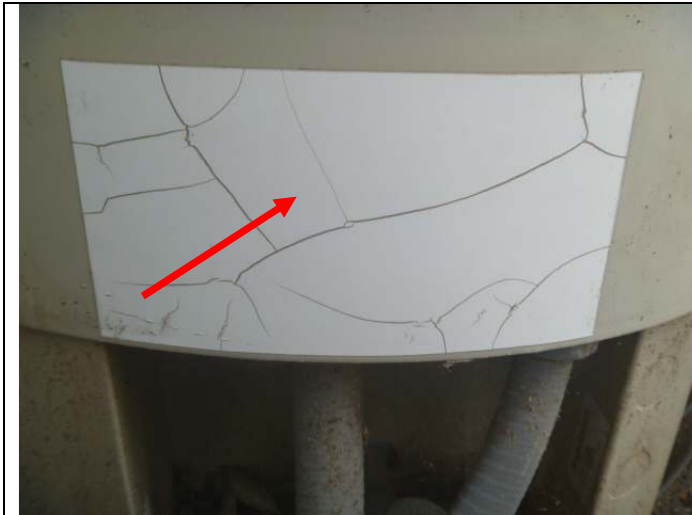
Air conditioner faded and illegible label.

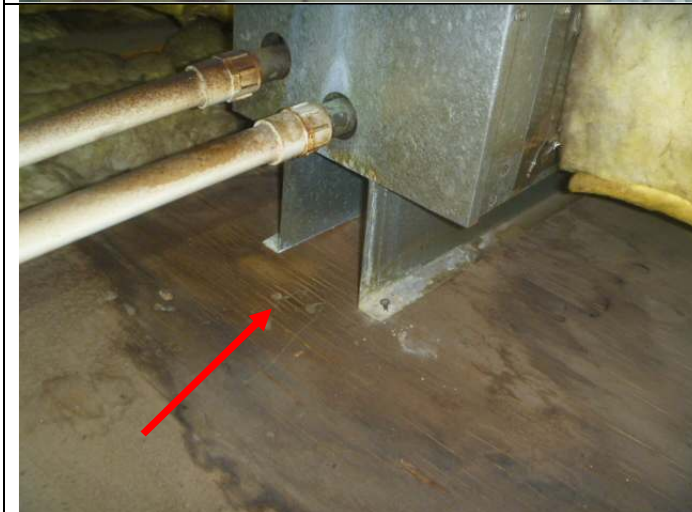
- A **LOCATION:** Heater/Fan Unit: Attic
AC Condensing Unit: East Exterior
- **ADDITIONAL COMMENTS:** The heating/air conditioning system is the original (approx. '89) and well beyond its expected service life. Also, there is no catch pan below the air conditioner coil unit in the attic and the plywood platform below the coil is discolored (moisture related). Recommend considering consulting a heating/air conditioning contractor. Note: The air conditioning refrigerant is the obsolete R-22 type. The air conditioner condensing unit is not securely mounted. The heater gas line is without a sediment trap – common older installation.

No catch pan below the air conditioner coil. Note: The moisture related discoloration in the plywood

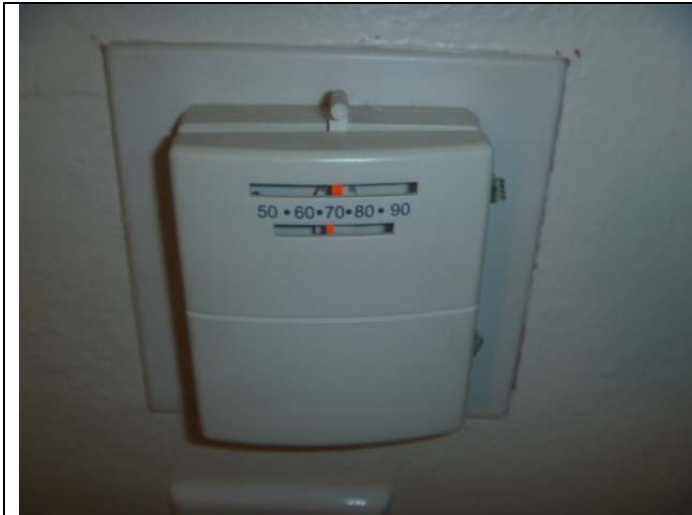
- B **TYPE:** Central Forced Air (Snyder General & Comfortmaker brands)
- B **CONTROL:** The thermostat is a low voltage, analog type without setback or programmable functions.

Low voltage, analog thermostat without setback and programmable functions.

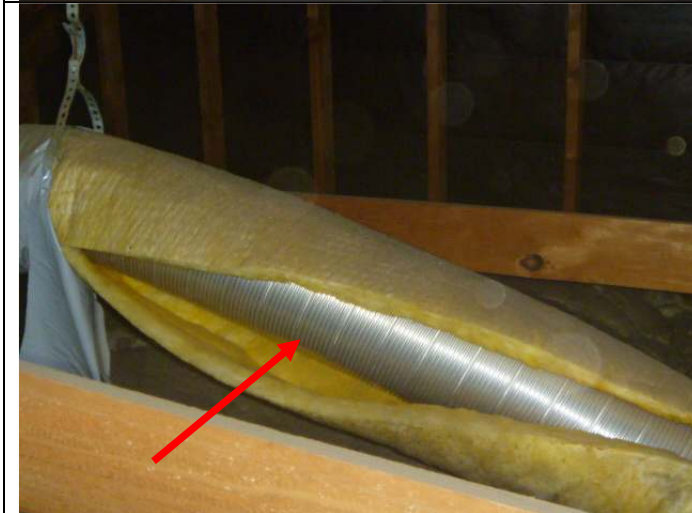
- B **DUCTS:** The ductwork is the original and there is a damaged and missing section of duct insulation toward the west end of the attic.
- A **CAPACITIES:** Heater: 80,000 BTU. Air Conditioner: Not Determined (illegible). Note: The air conditioner coil unit capacity is 4 tons.

Damaged ductwork toward the west end of the attic.
