# SUMMIT INSPECTIONS

150 S. Glenoaks Blvd. • PMB 1045  
Burbank, CA 91502  
(818) 426-9977

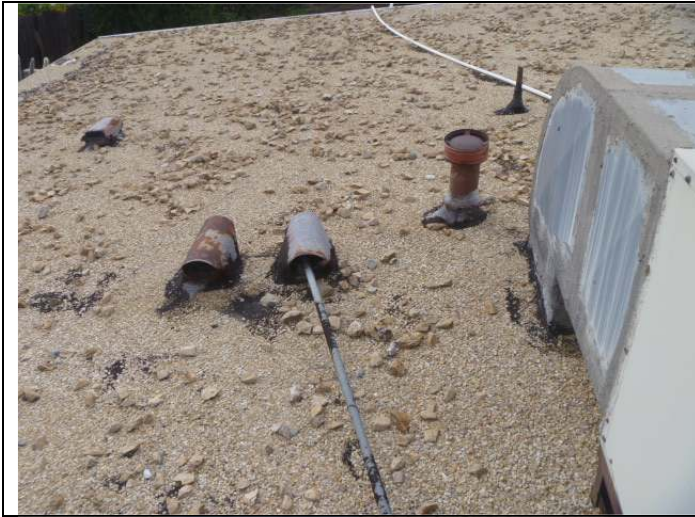
Recommend checking with the building department regarding permits.

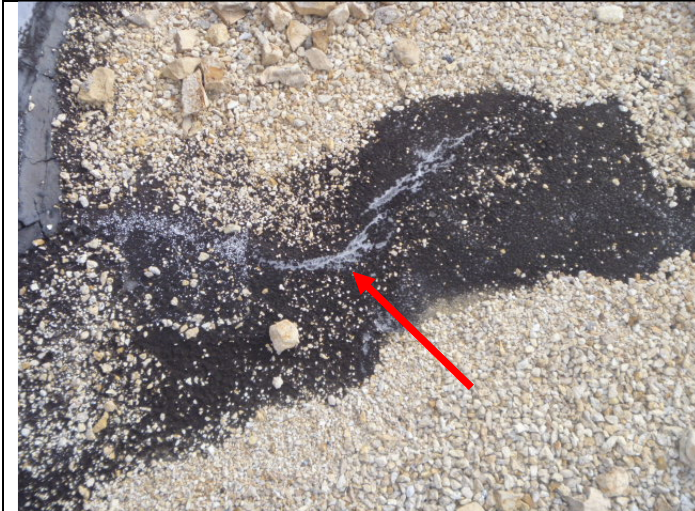
Missing gravel and deteriorated roofing material.

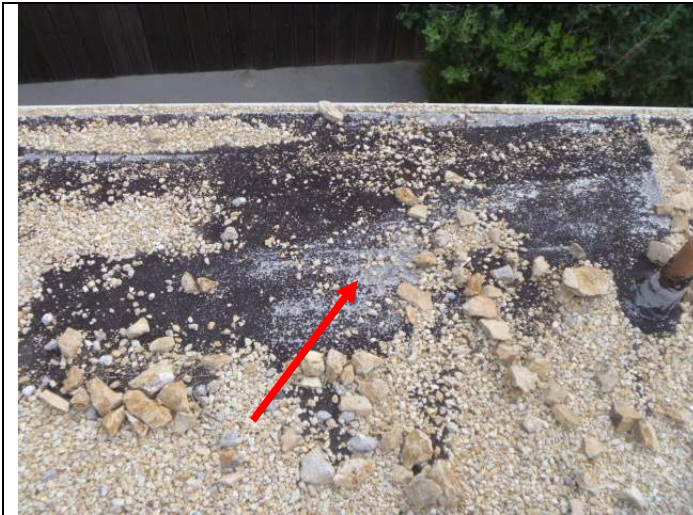
Missing gravel and deteriorated roofing material.

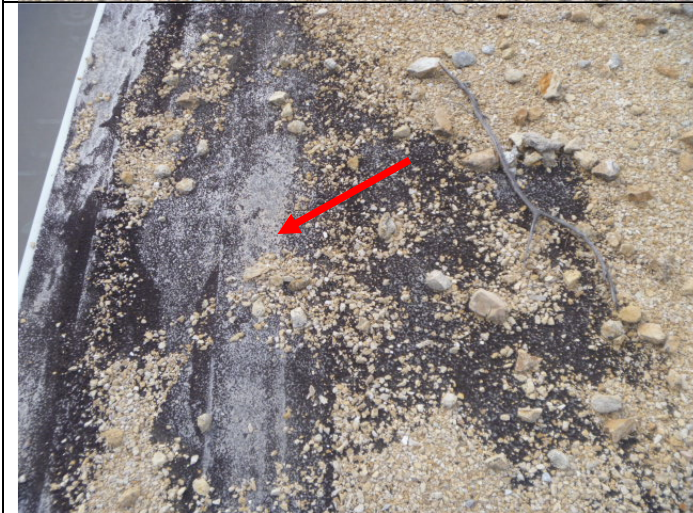
Missing gravel and deteriorated roofing material.

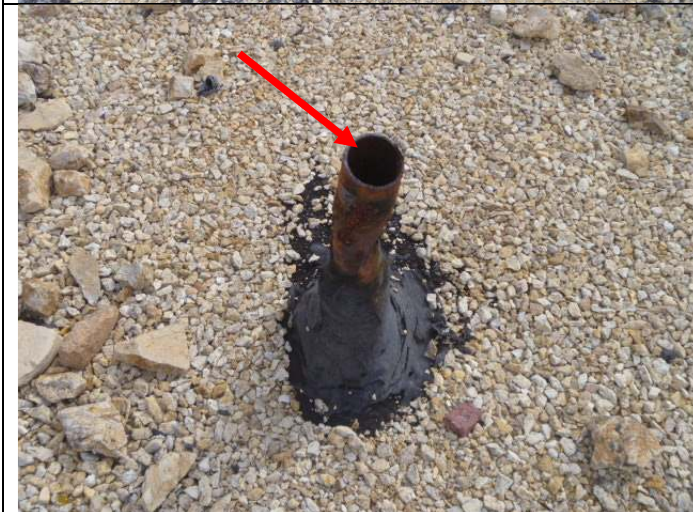
Open pipe (possibly for a previous roof mounted antenna) toward the left rear.

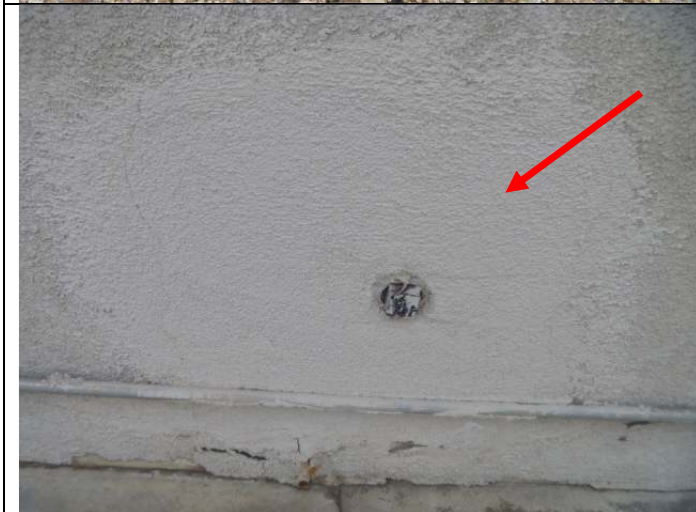
Stucco repair at the lower north  
exterior wall.

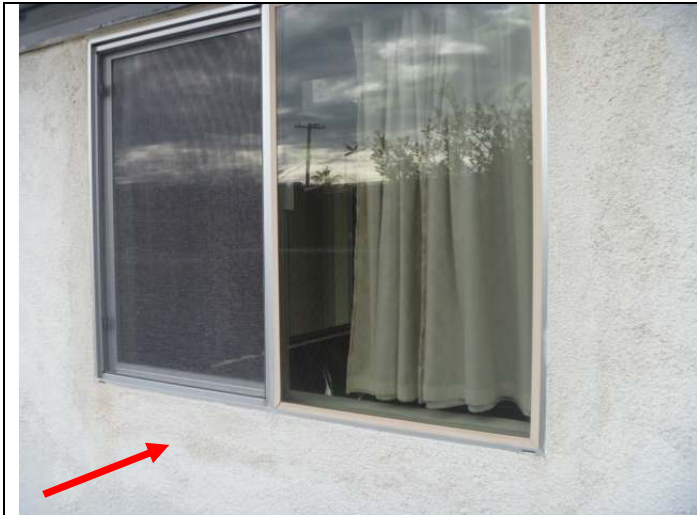
Stucco repair at the kitchen rear window.

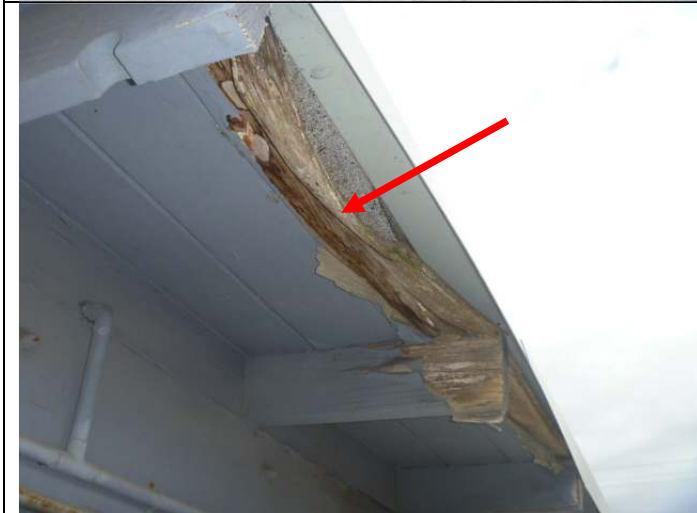
Example of damaged wood along the east eave. Note: There is additional damaged wood in multiple areas (including along the garage eaves).

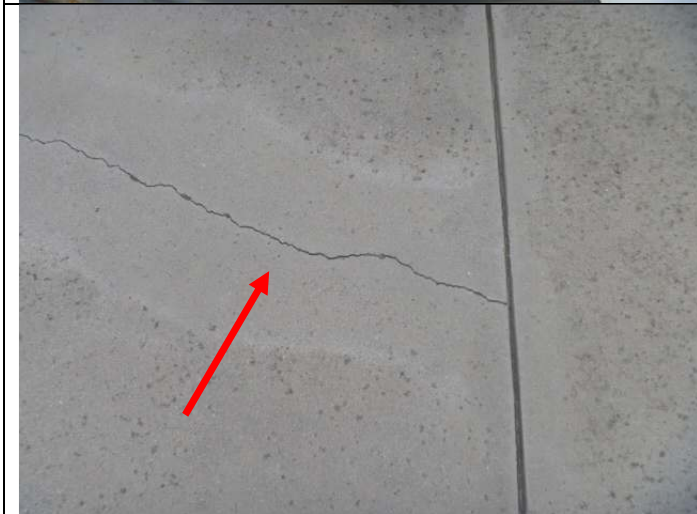
Minor crack in the right rear patio.

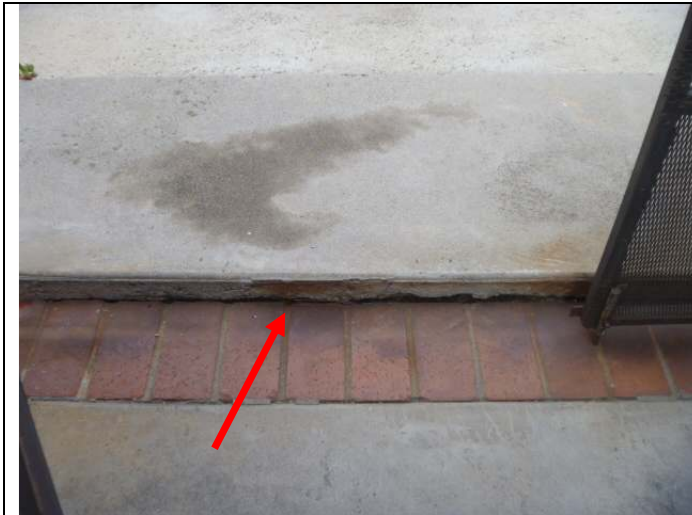
Step in the walkway at the northwest gate.

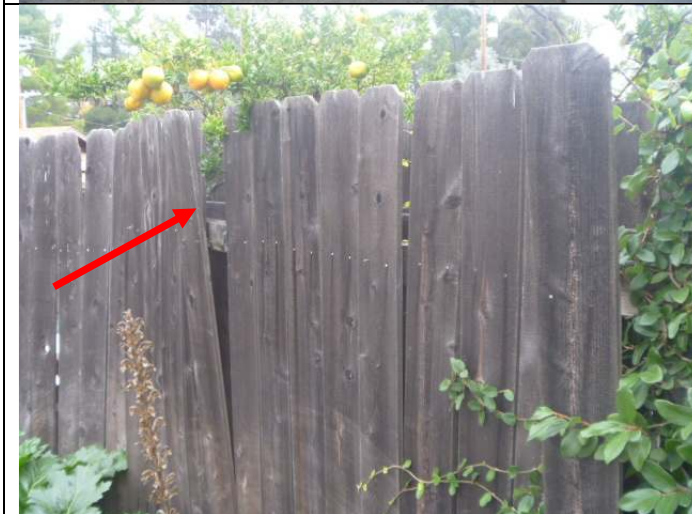
Damaged east side wood fencing.

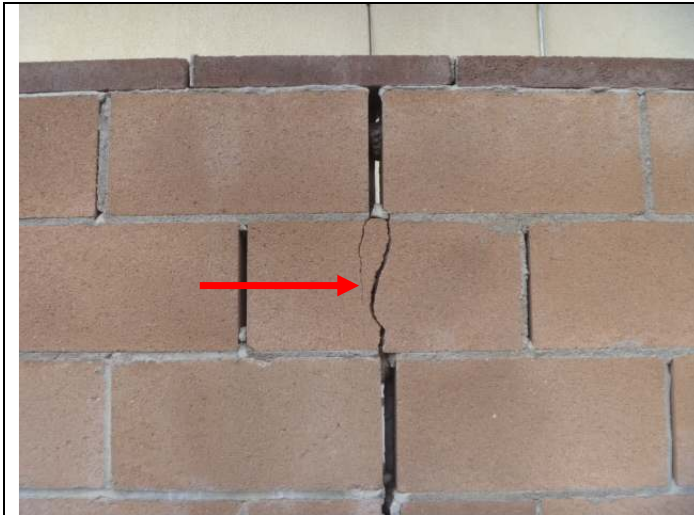
Cracking in the west block wall.

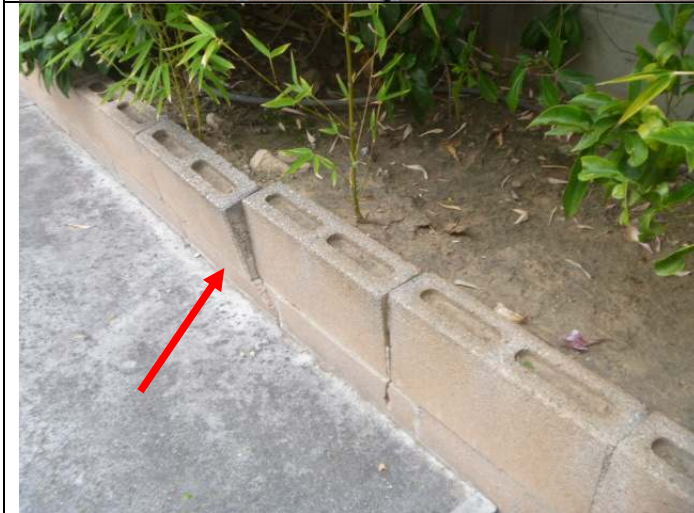
Leaning west block planter wall (toward the right rear).

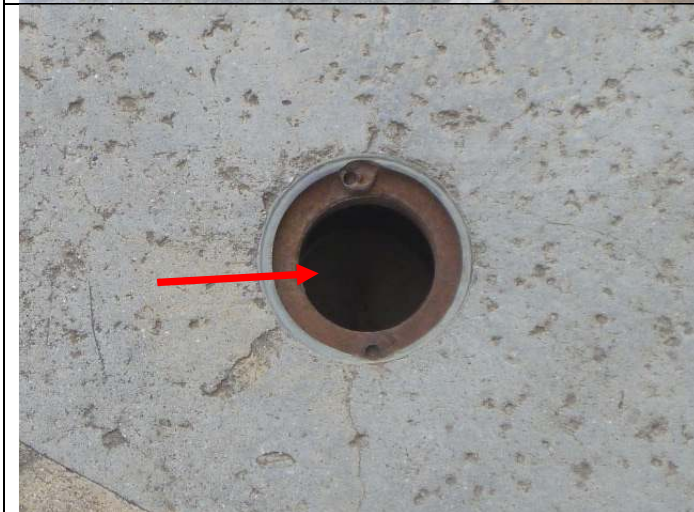
A missing exterior surface drain cover.

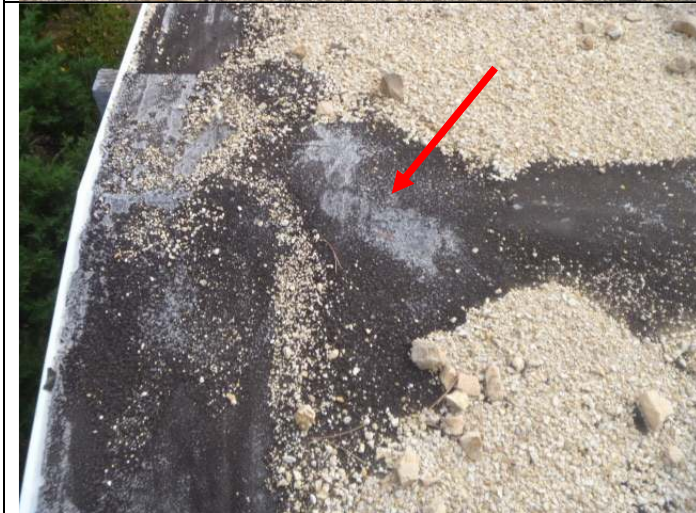
Missing gravel and deteriorated roofing material.

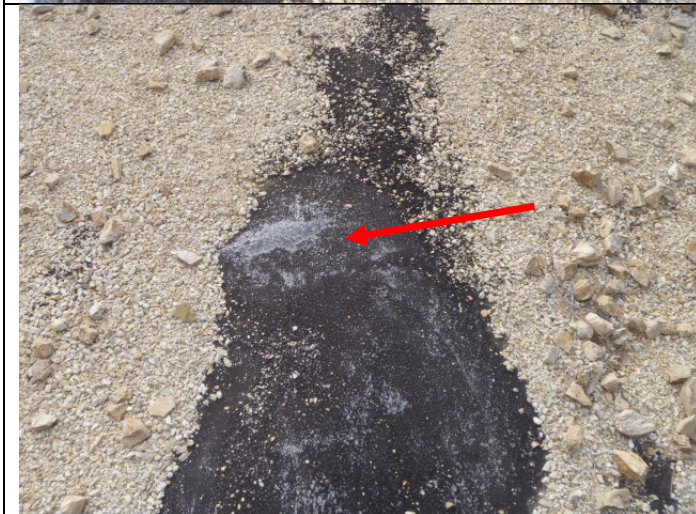
Missing gravel and deteriorated roofing material.

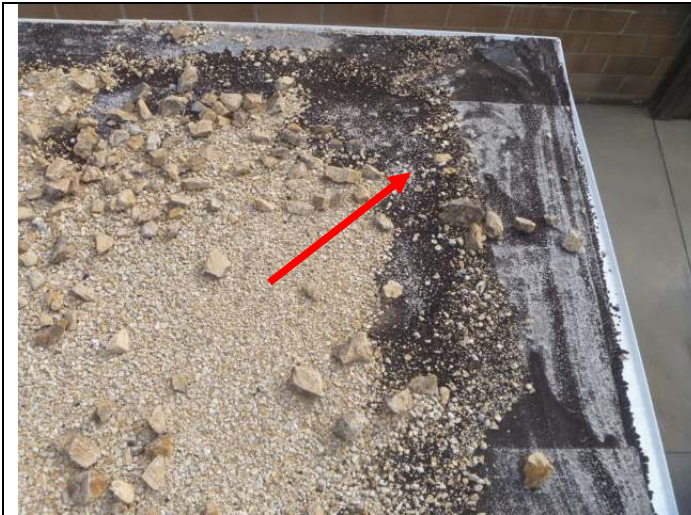
Missing gravel and deteriorated roofing material.

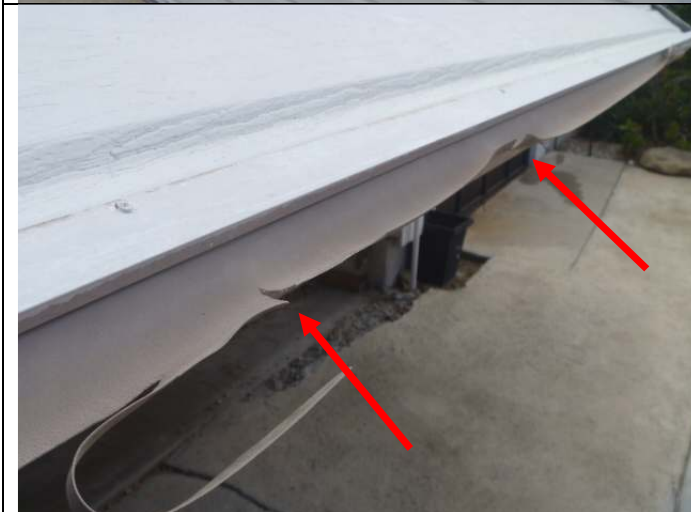
Damaged weather stripping along the bottom on the garage door.

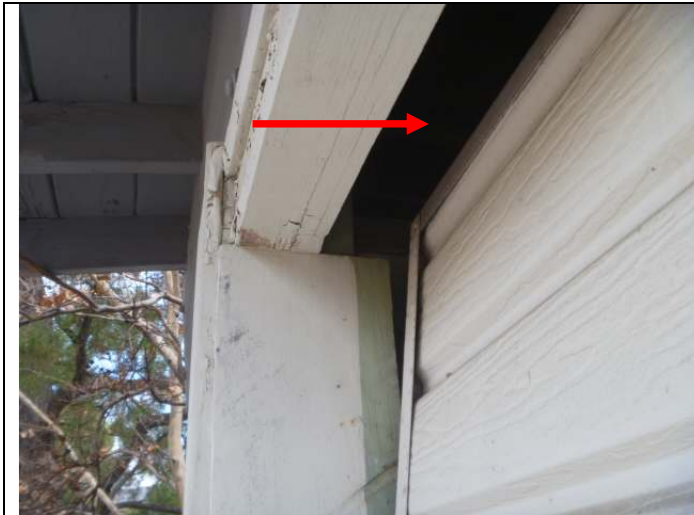
Garage door not closing completely.

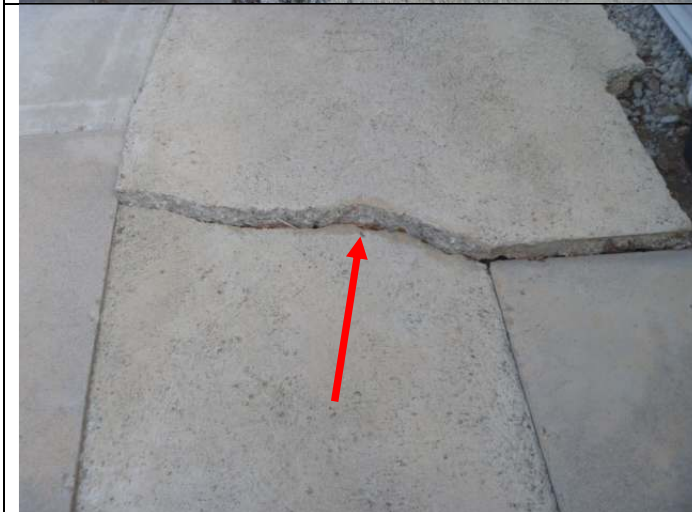
Driveway cracking and unevenness at the right front of the garage.

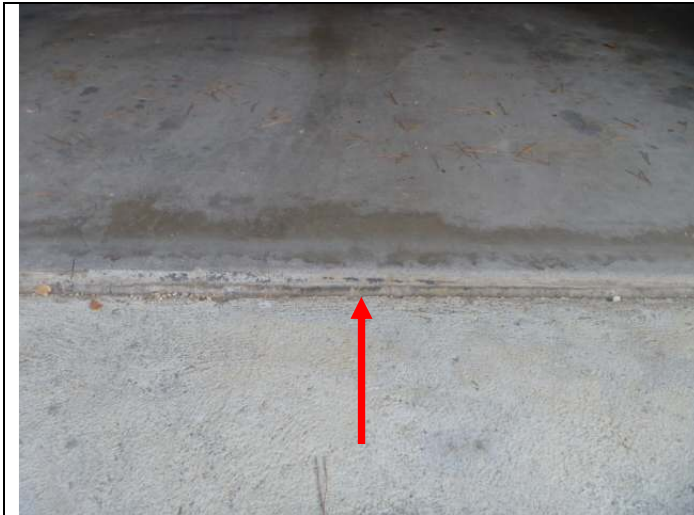
Step along the front of the garage slab floor.

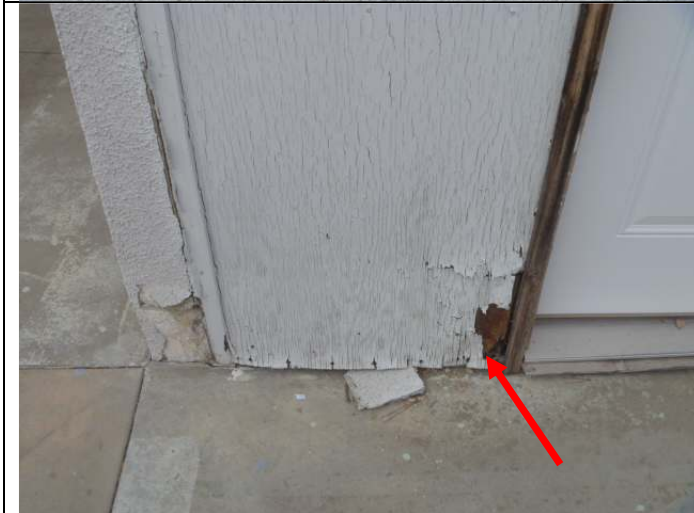
Damaged siding at the garage lower rear wall.

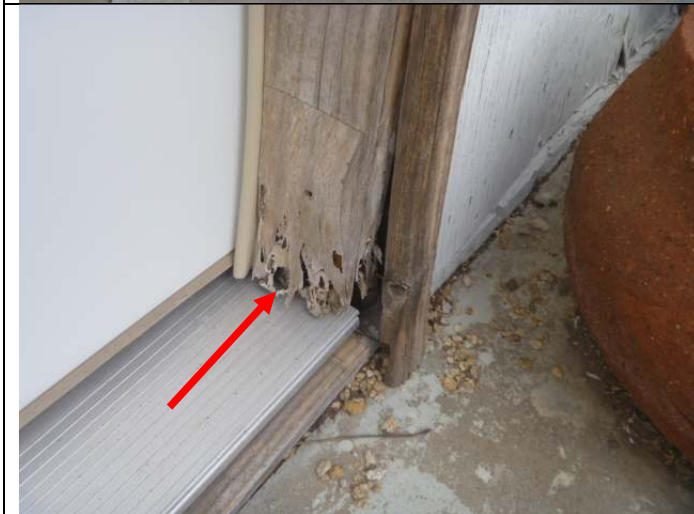
Damaged wood at the garage rear exterior doorjamb.

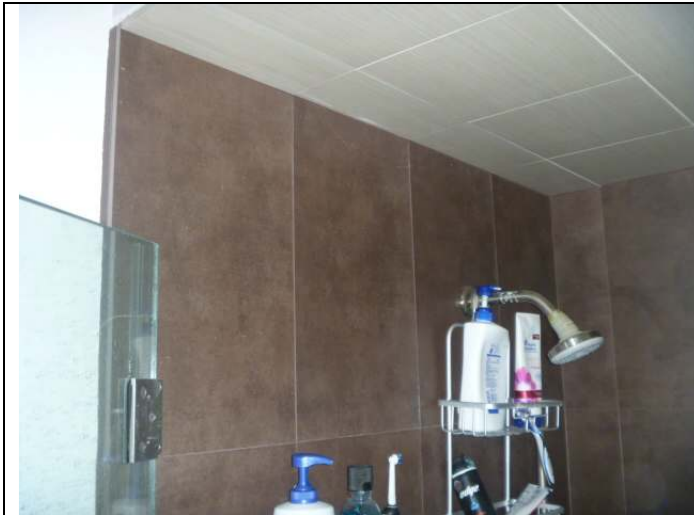
Full (primary) bathroom shower wall tiles. Note: The tiles backing type was not determined.

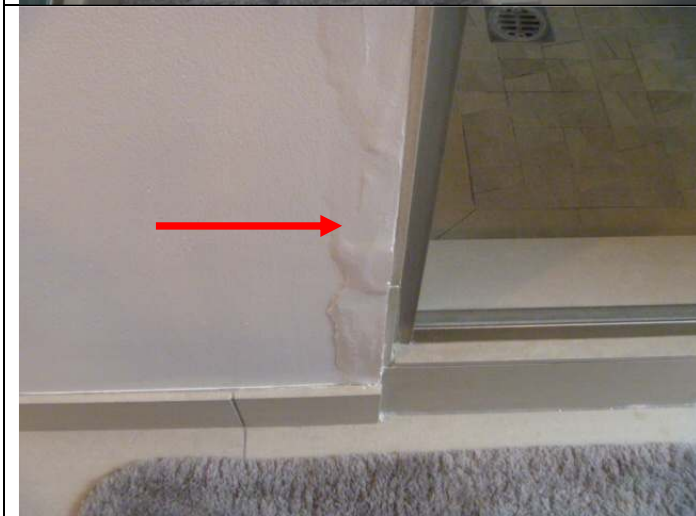
Wall damage at the lower left of the 3/4 bathroom shower door.

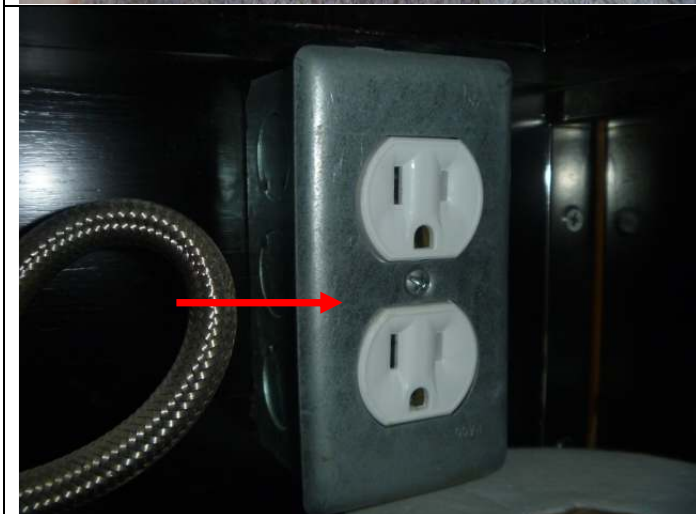
Surface mounted receptacle, without ground fault circuit interrupter (GFCI) protection, below the 3/4 bathroom sink.

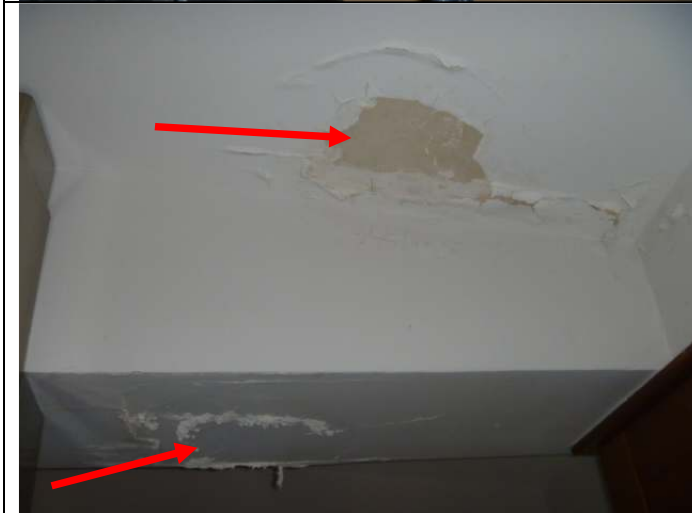
Kitchen ceiling damage to the right of the range hood.

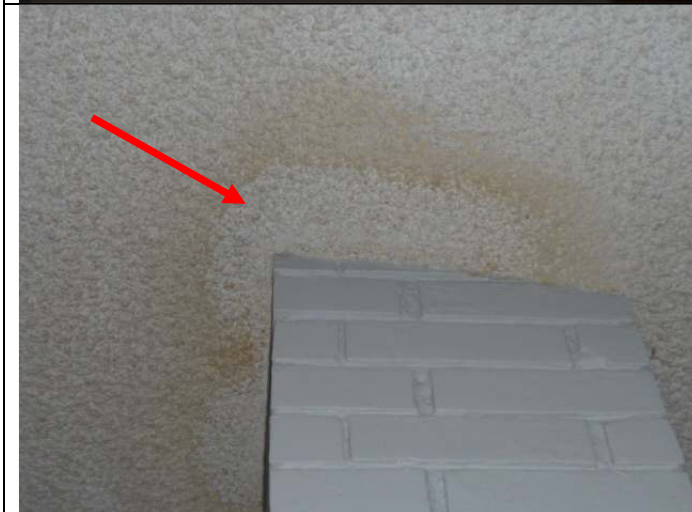
Discoloration in the living room ceiling at the fireplace.

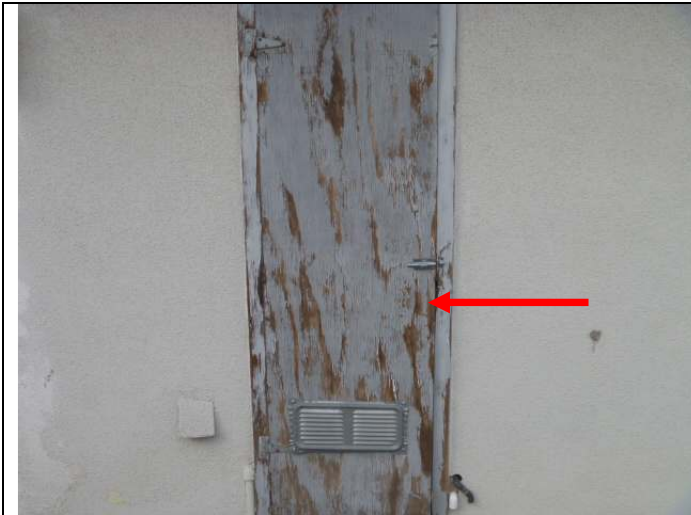
Water heater compartment door.  
Note: The door is in poor condition and without an upper combustion air opening.

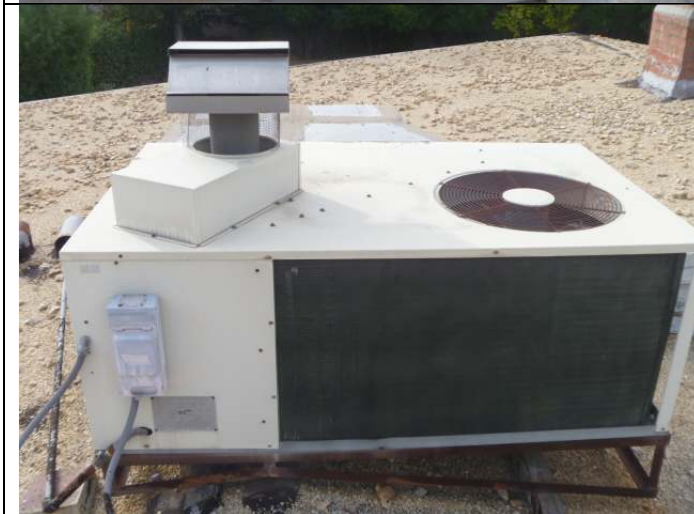
Heating/air conditioning unit.

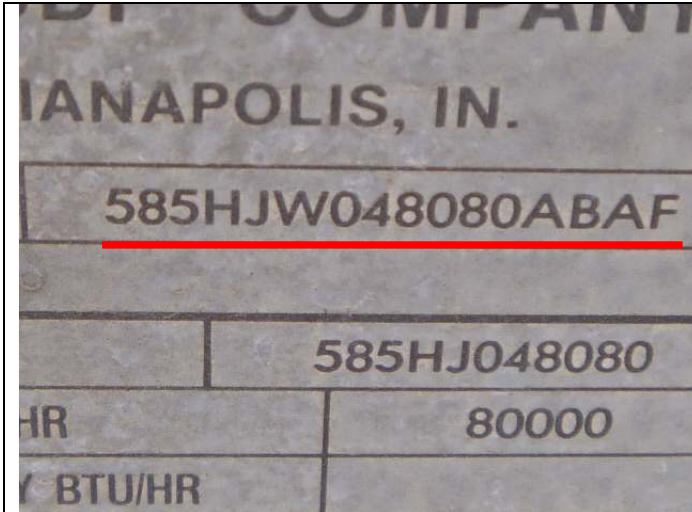
Heating/air conditioning unit model number.

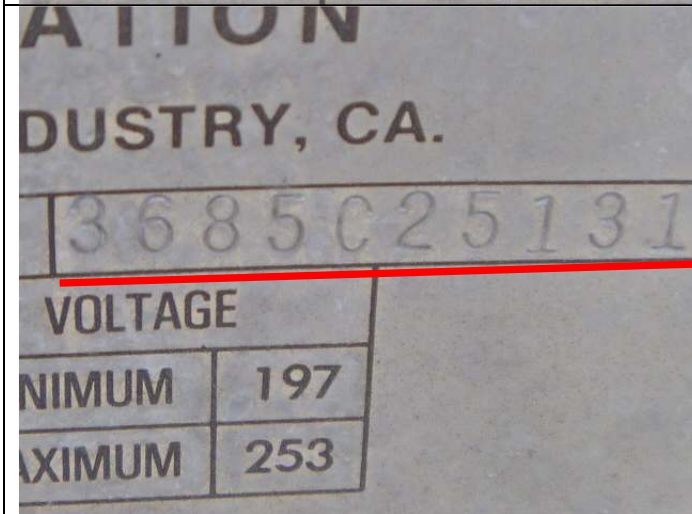
Heating/air conditioning unit serial number (indicating a 1985 build date).

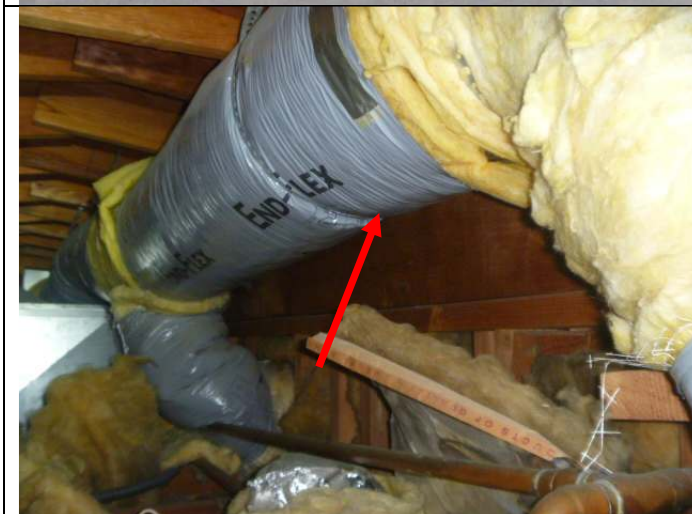
Older ductwork in the attic.

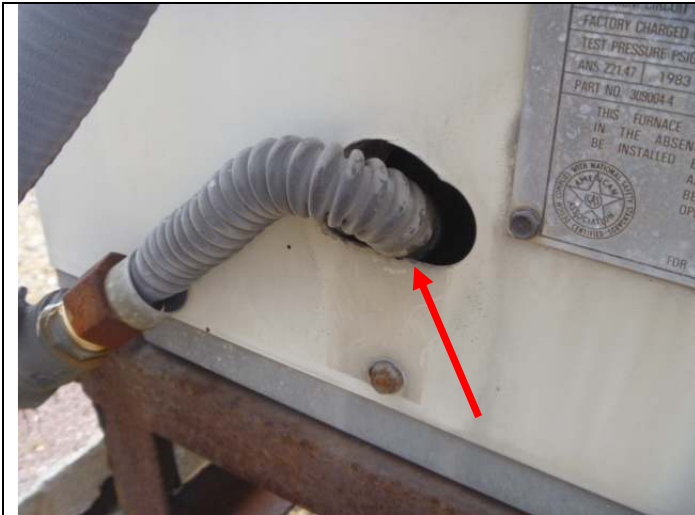
Flexible gas connector, subject to damage, routed through the heating/air conditioning unit housing.

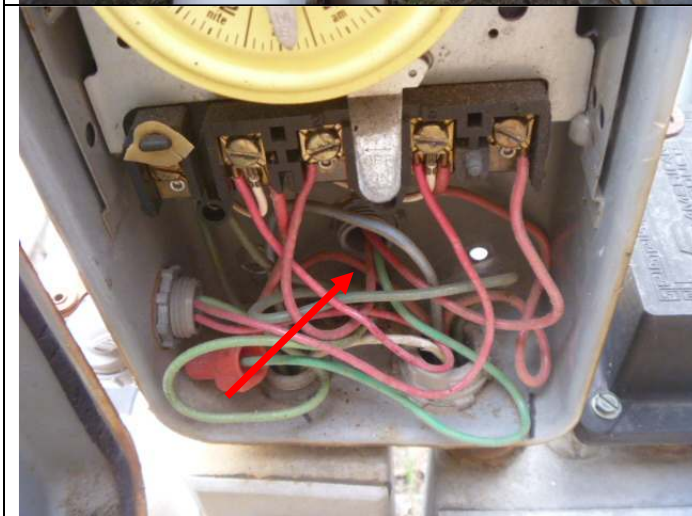
Missing insulating cover below the pool/spa timer. Note: The timer is not needed as the pump has an integral timer.
