Date: 7 March 2024

SEWER LINE INSPECTION REPORT

Client Name: Michael Barnes	Sewer Line Access: 3" cleanout in driveway.
Property Address: 9976 Tujunga Canyon Blvd, Tujunga, CA 91042

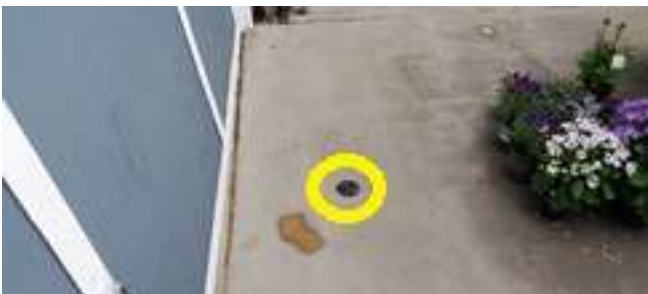
Cleanout in driveway.

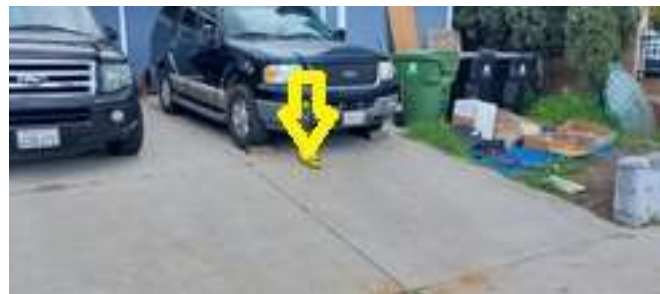
Transition from plastic to clay pipe. Depth about 5 1/2'.

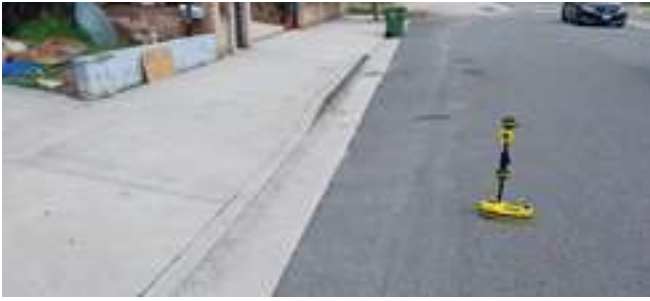
Connection to city sewer line. Depth about 6’.

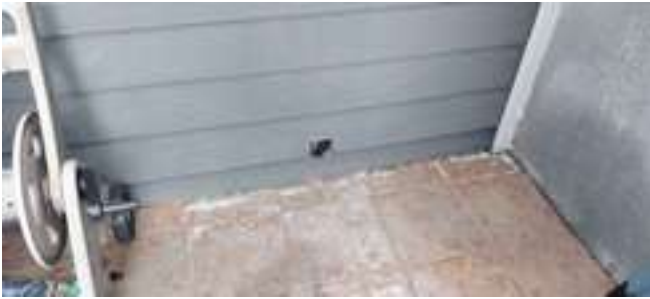
Additional small wall cleanout. Not used for today’s inspection.

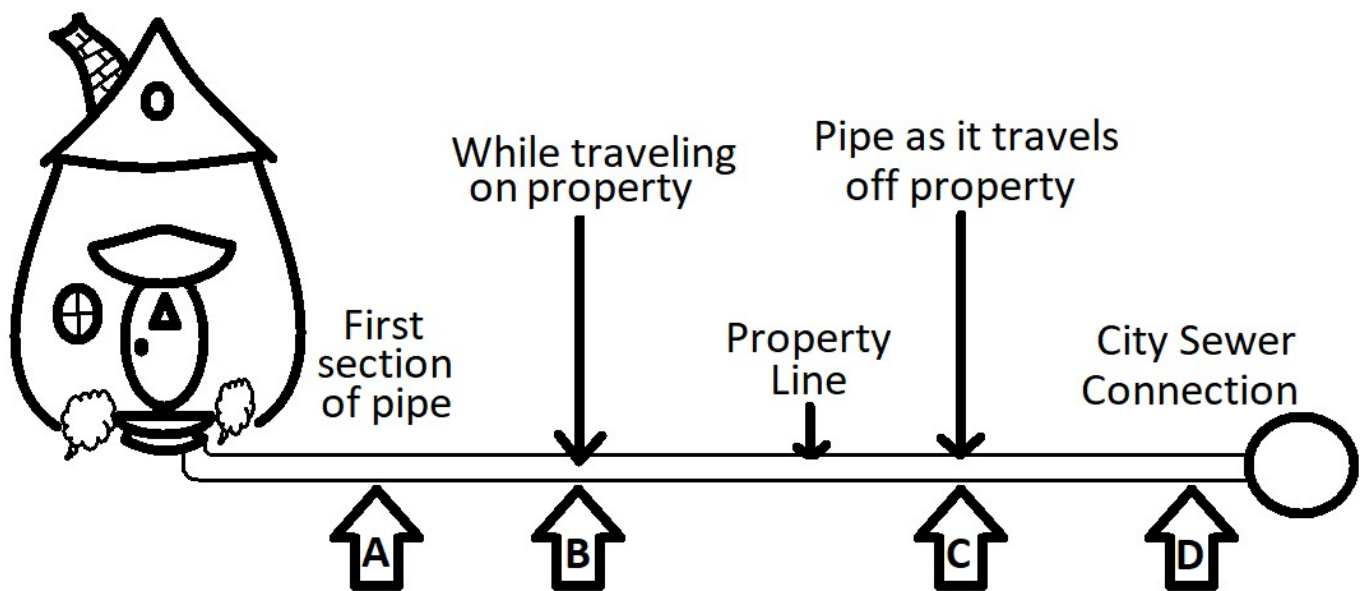
A: Plastic

B: Plastic

C: Clay

D: Clay

X	Some cracking. Average for clay		Moderate cracking; slightly below average condition		Heavy cracking allows for sewage to leak from system
X	Some misalignment in joints. Average condition for clay.		Moderate misalignment in joints; slightly below average		Heavy shifts in pipe obstruct maintenance/allow leaking
X	Few or no roots in clay pipe		Minor roots should be cleared in a year		Heavy roots should be cleared now.
X	Slope is adequate		Some pooling water in line		Slope is unacceptably poor
X	Clay is functioning well.		Clay is functioning at a slightly below average level.		Clay requires repair. Line is in unacceptable condition.
X	Clay was clearly visible to camera		Review video might show this pipe more clearly.		Review inspection required to know condition of clay pipe.

X	Functioning well		Not perfect but is functioning		Requires repair
X	Slope is acceptable	X	Some pooled water; imperfect slope; still functioning well		Slope is unacceptably poor and requires repair
X	No heavy roots in line.		Minor roots intrude through isolated joints; still functioning		Roots intruding through poorly installed joints; repair
X	No significant damage noted		Some dents without affecting function		Pipe kinked, cracked or broken and requires repair
