Inspector: Nicholas Bylsma

Date: 14 March 2024

SEWER LINE INSPECTION REPORT

Client Name: Victoria Rivera	Sewer Line Access: 4" cleanout in front of house. Not directed.
Property Address: 6501 Matilija Ave, Valley Glenn, CA 91401

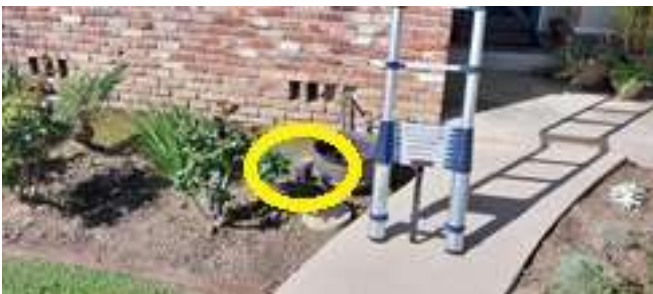
Cleanout used for today's inspection.

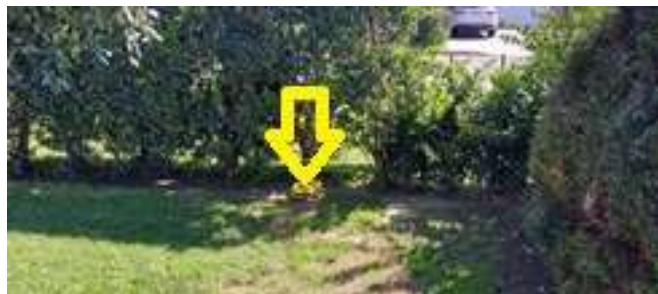
Transition from 4" to 6" diameter clay pipe. Depth about 5 1/2'.

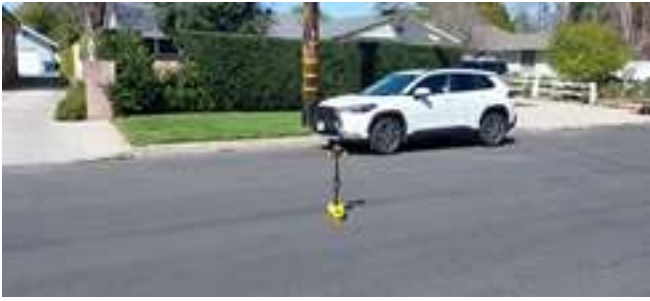
Connection to city sewer line. Depth about 10 ½’.

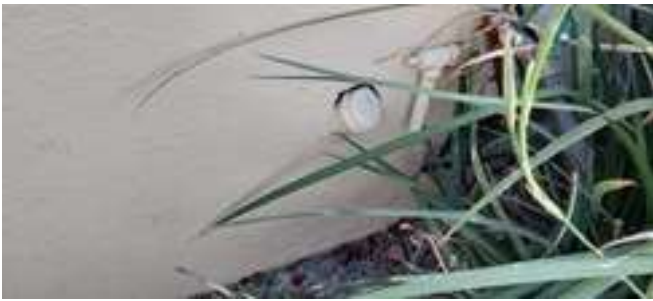
Additional small wall cleanout. Not used for today’s inspection.

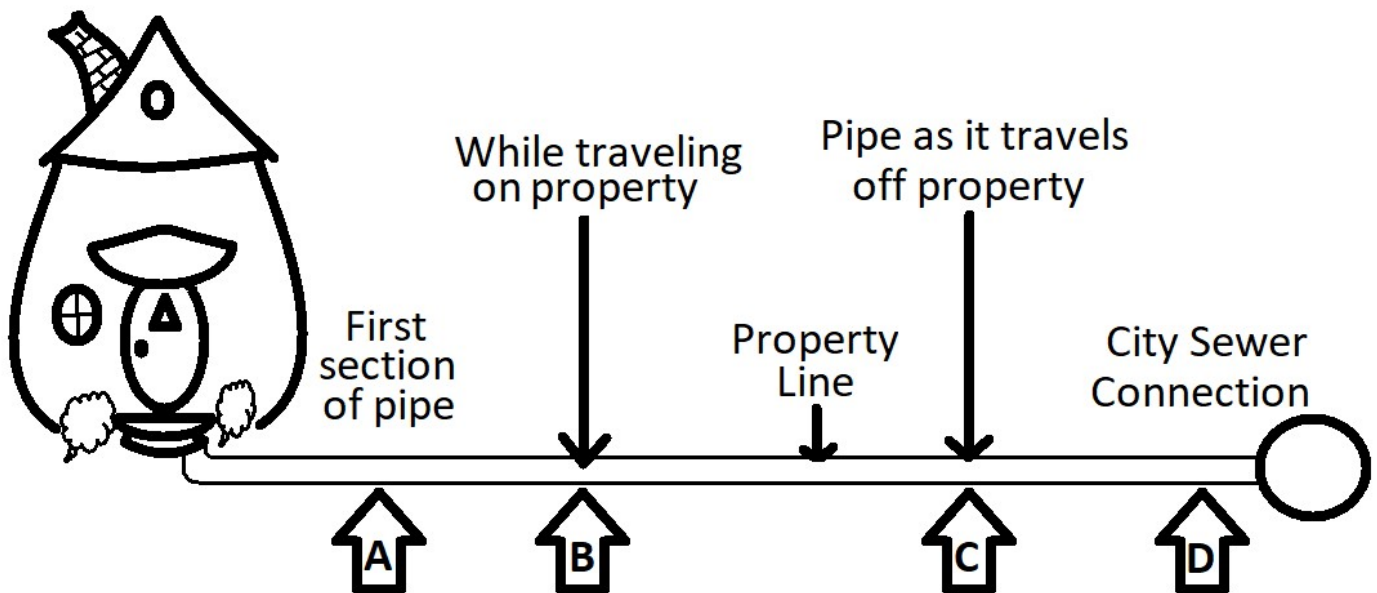
Pipe materials:

A: Cast iron

B: Plastic then clay

C: Clay

D: Clay
