Date: December 20, 2023

SEWER LINE INSPECTION REPORT

Client Name: Steve Scott	Sewer Line Access: 4 inch cleanout by driveway (Photo)
Property Address: 6742 Estepa Dr, Tujunga, CA 91042

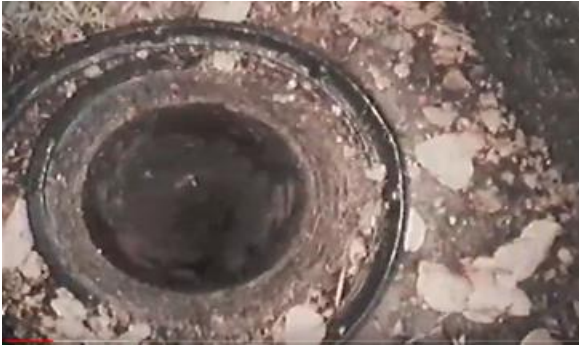
Cleanout at front left corner of garage

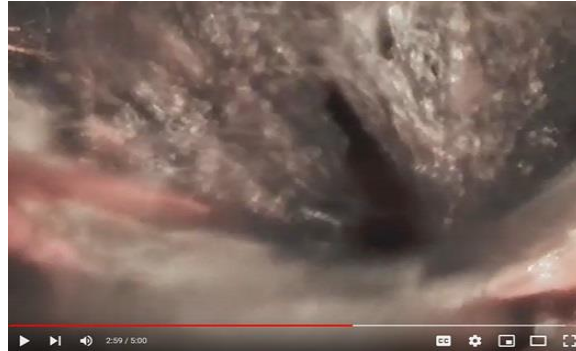
Maintenance recommendations: There are areas of root intrusion within this clay main sewer line that will need to be cleared at this time. Roots intruding into a clay system are common and can normally be maintained with regular sewer line cleanings. If neglected, roots can cause blockages in the pipe as well as potential damage.

Roots in sewerline

Hydro jetting, (like pressure washing for sewers) is usually the ideal choice for such cleanings.

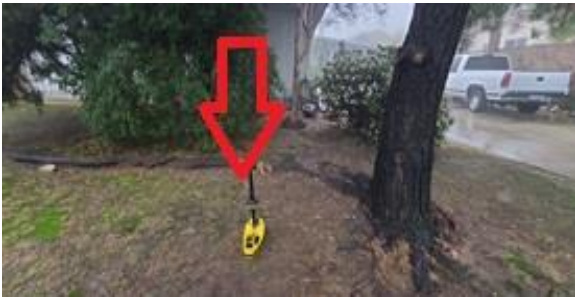
Location of heavy root in line. About 5 ft deep

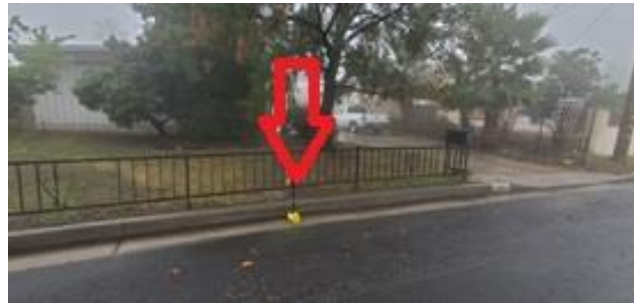
Line leaves property about 5 feet deep

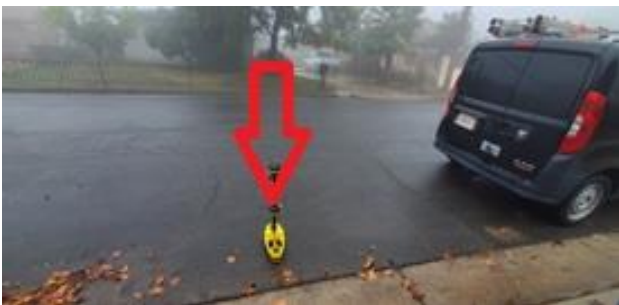
Connection to city sewer about 5 ½ feet deep

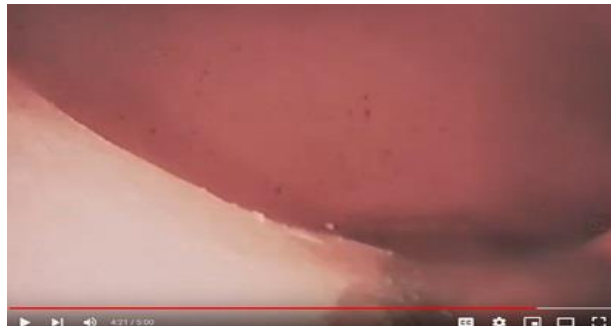
City sewer connection

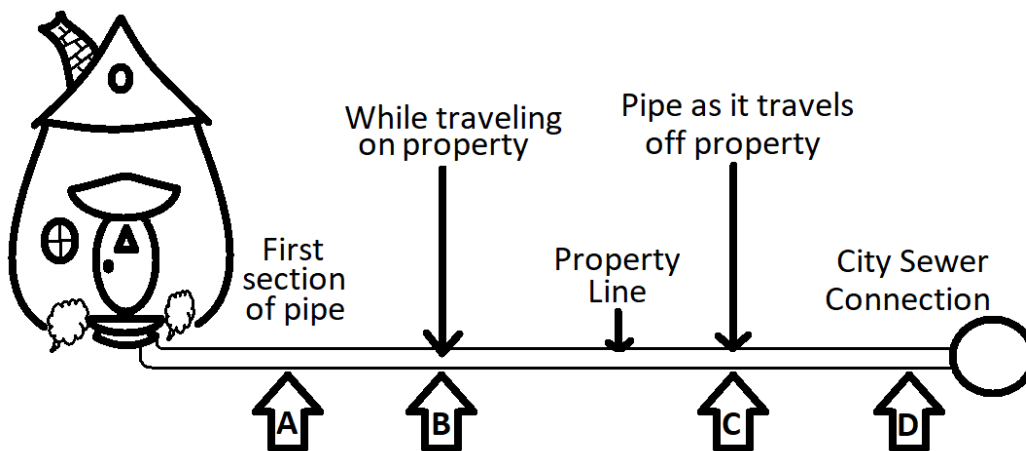
A: Plastic

B: Plastic / Clay

C: Clay

D: Clay
