9355 Skyview Terrace Tujunga, CA 91042

Reports & Pre-Market Inspections

This report provides an account of the results of a building inspection done at the above property. The purpose of the inspection is to report the general conditions of the structure and the electrical, plumbing and mechanical systems.

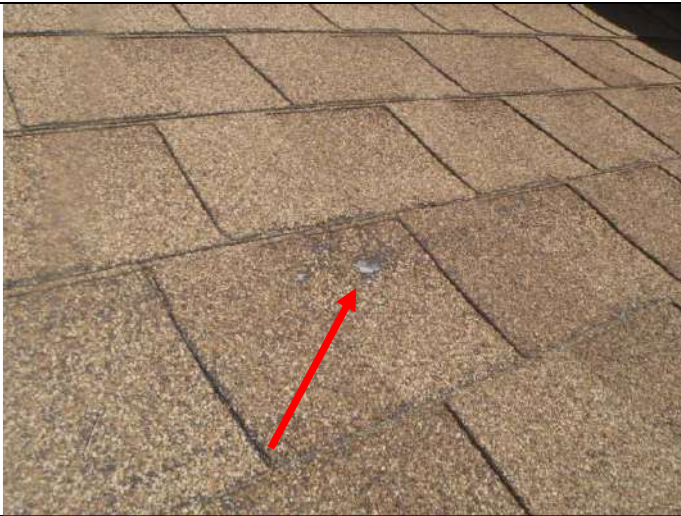
| A ROOF: | The roof is a composition shingle (30-year rated or similar) type and appeared to be in generally satisfactory condition – minor shingle deterioration is visible. Note: There is one roofing layer. Recommend resealing the vent pipe collars on the roof as needed. |

<p>Another shingle close-up (over the garage). Note: The minor surface deterioration.</p>

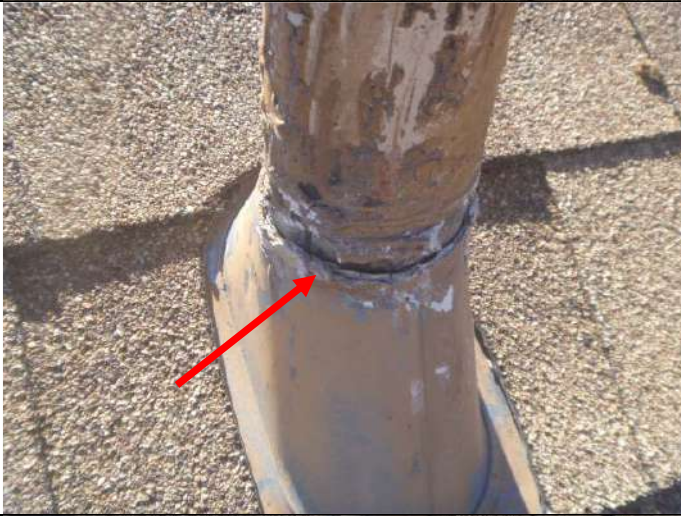
<p>Cracked sealant at a plumbing vent collar.</p>

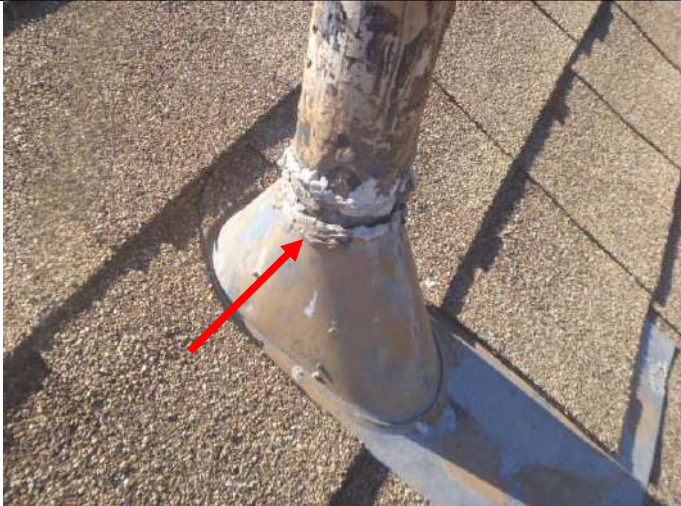
<p>Cracked sealant at a plumbing vent collar.</p>

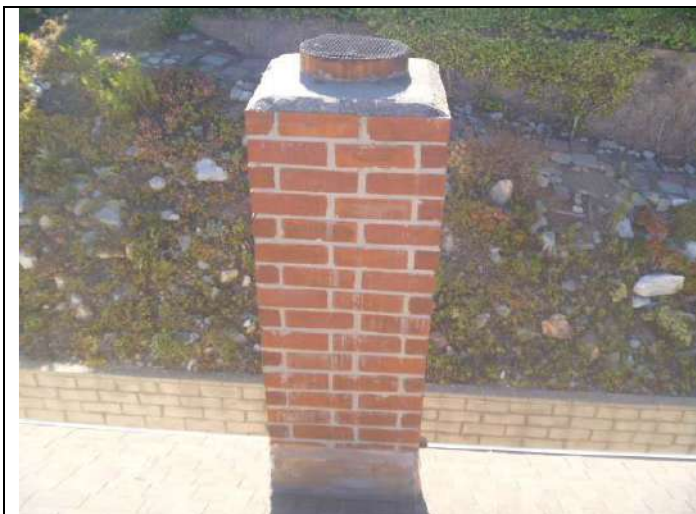
| B CHIMNEY: | The chimney (brick, with lined flue) inspection is limited. Recommend consulting a chimney specialist for further review. Note: There are sealed cracks in the chimney upper exterior. There is no spark arrestor/rain cap – older flat type spark arrestor only. The fireplace gas valve appeared to be functional but relatively stiff. Recommend securing the fireplace damper open if natural gas logs or similar are installed. |

Chimney upper exterior.

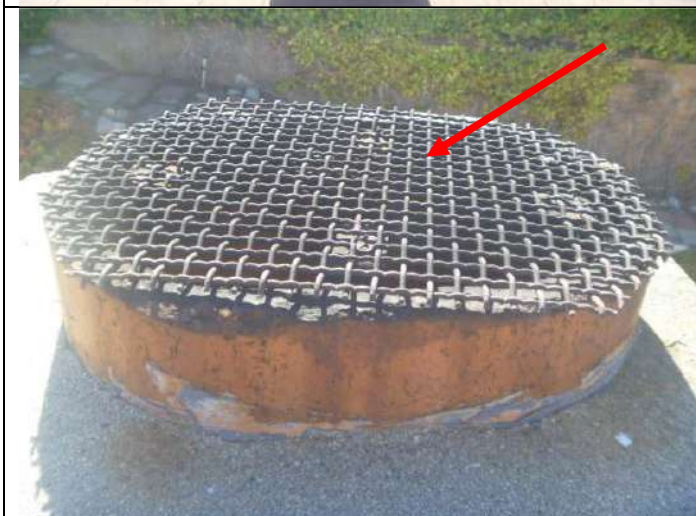
Flat type spark arrestor (vs. a spark arrestor/rain cap).

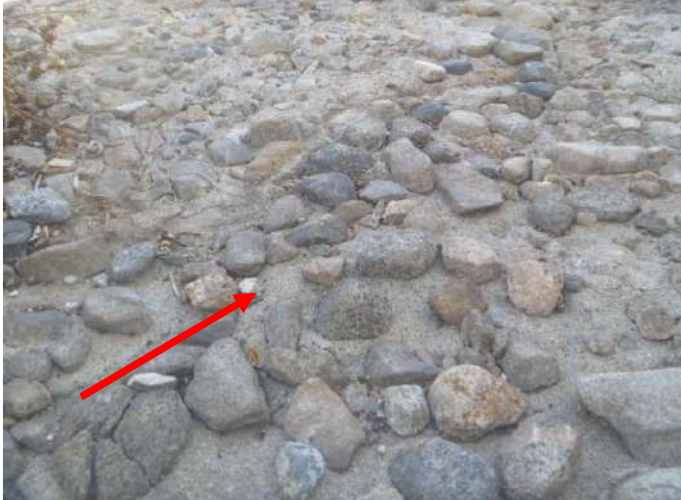
A close-up photograph of a stone patio or walkway. The surface is composed of numerous irregular, light-colored stones set in a sandy matrix. A red arrow points to a specific area on the left side of the image.	<p>A closer view of the above patio/walkway.</p>

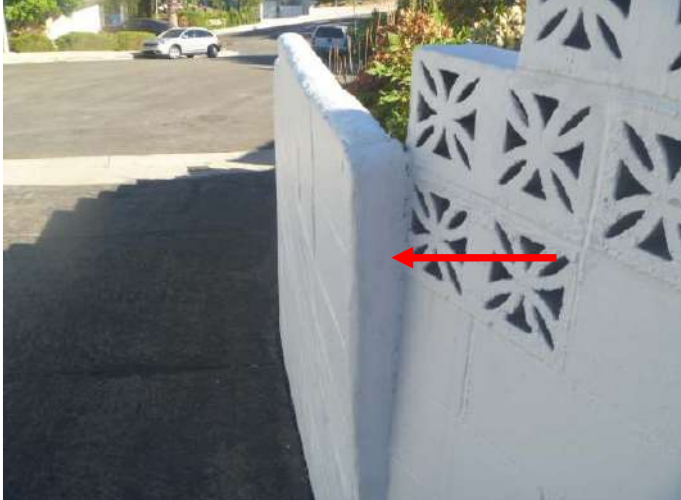
- B SPRINKLERS:** Manual. The sprinkler system is older.
- B FENCES AND WALLS:** There is some cracking and displacement in the block walls (noted adjacent to the driveway) and at the right rear.

A photograph showing a white block wall with decorative star-shaped cutouts. The wall is leaning towards the left. A red arrow points to the leaning section of the wall. In the background, a paved driveway and a white car are visible.	<p>Leaning block wall adjacent to the driveway.</p>

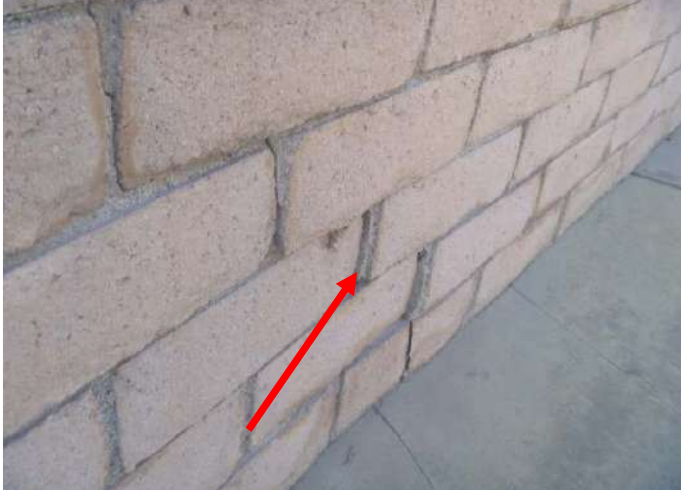
A close-up photograph of a light-colored concrete block wall. A red arrow points to a vertical crack or displacement in the mortar joint between two blocks.	<p>Displacement in the right rear block wall.</p>

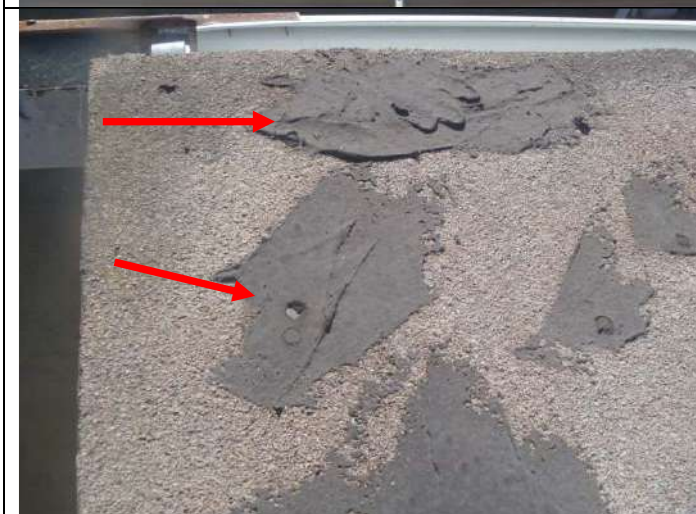
Irregular sealant on the storage structure roof.

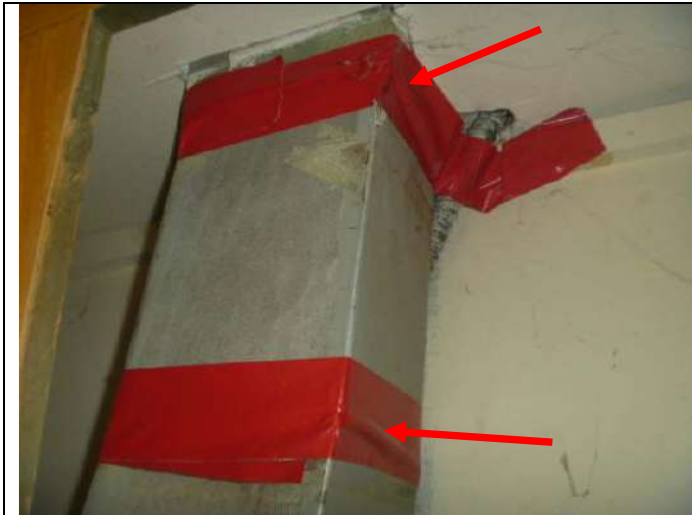
Roughly installed duct tape on the kitchen vent fan ductwork within the above cabinet.

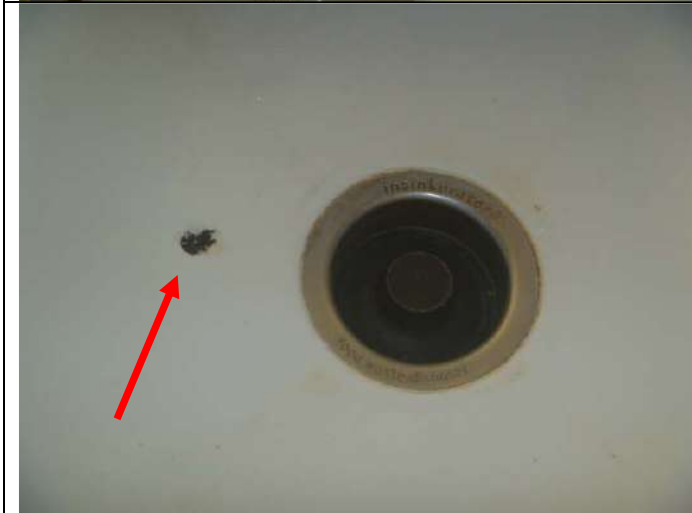
Surface chip in the kitchen sink.

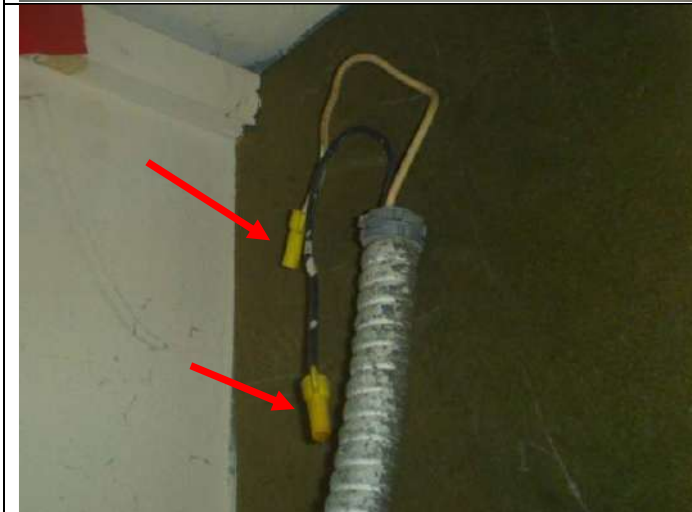
Terminated wiring within the cabinet above the range/oven/vent unit.

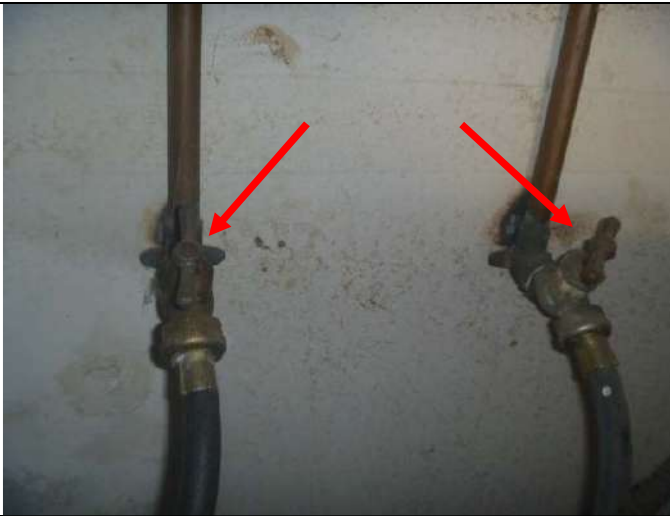
C | The washer valves slowly leak at the stem (unless the valves are off or in the fully on position). Also, there is some corrosion on the cold water valve. Note: The water piping is surface mounted. |

<p>Washer valves with surface mounted wiring. See LAUNDRY section for related comments.</p>

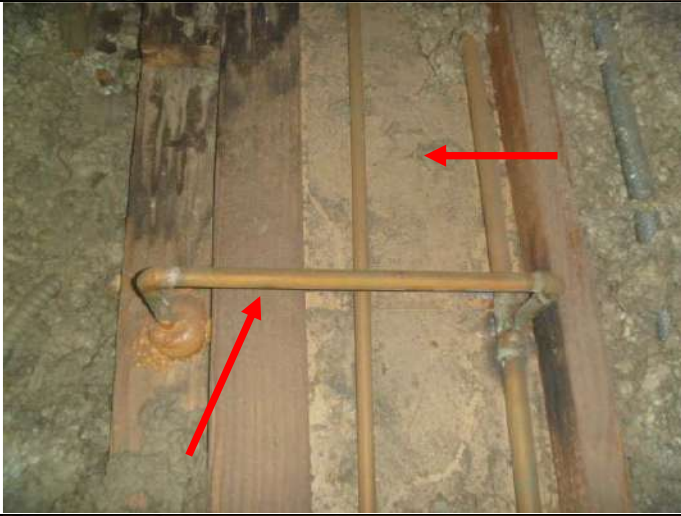
- A FRAMING:** The framing appeared to be structurally intact.
- A ROOF INTERIOR:** No indication of active roof leakage was noted. See EXTERIOR section regarding the roof.
- B VENTILATION:** The attic ventilation is limited.
- B/ DUCTS AND
C VENT PIPES:** See HEATING/AIR CONDITIONING section regarding the ducts.
- B INSULATION:** The majority of the attic insulation is an older blown-in type and thin.

<p>Replacement water piping in the attic. Note: The thin and missing attic insulation.</p>

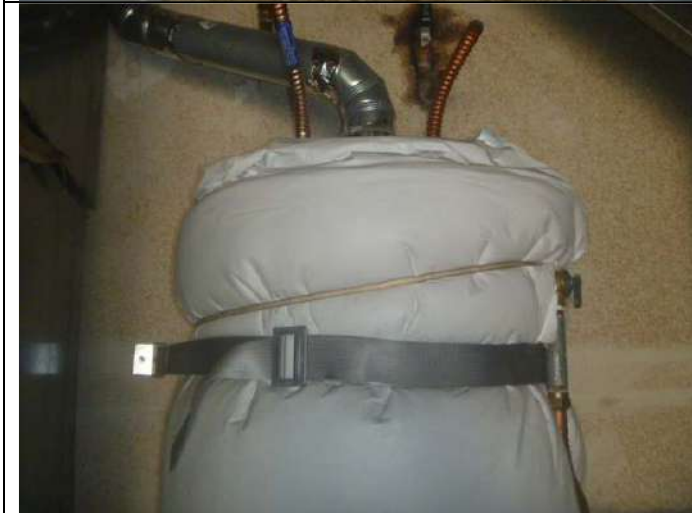
Water heater upper section.
Note: The seismic bracing is installed (vs. under) in the insulation blanket.

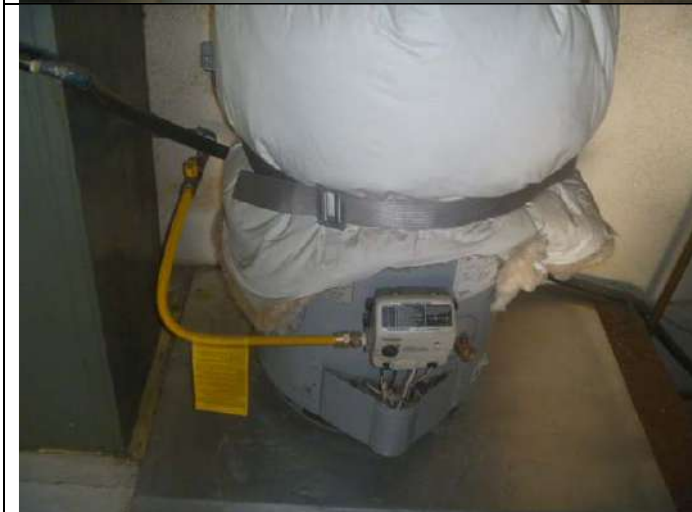
Water heater lower section.
Note: There is no catch pan.

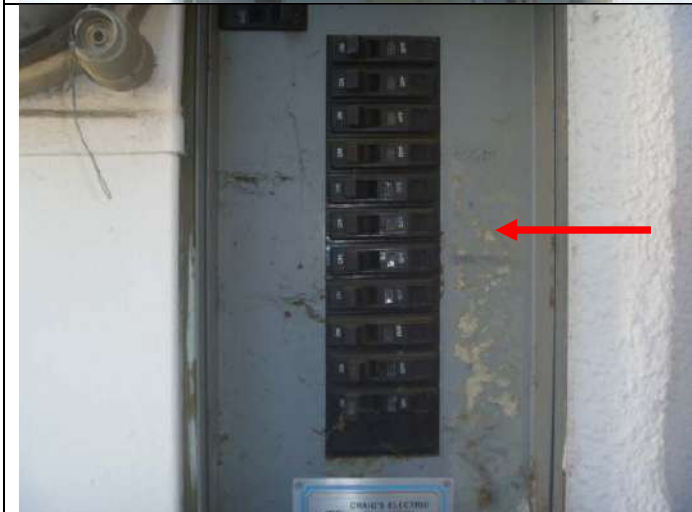
Panel interior cover without a directory.

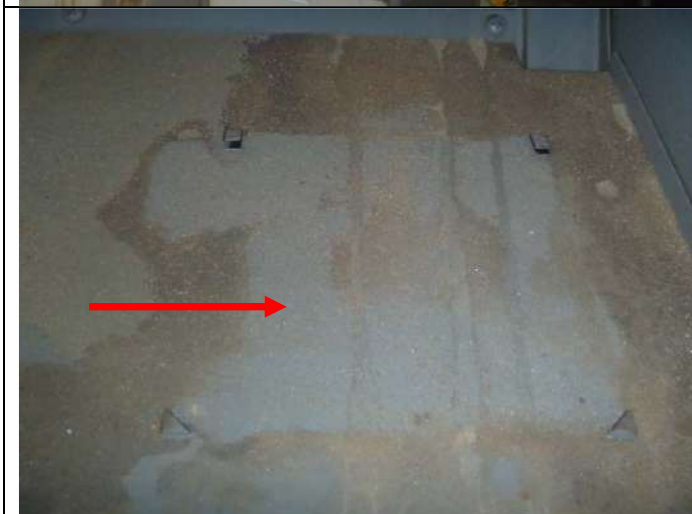
Heater/fan unit missing label.

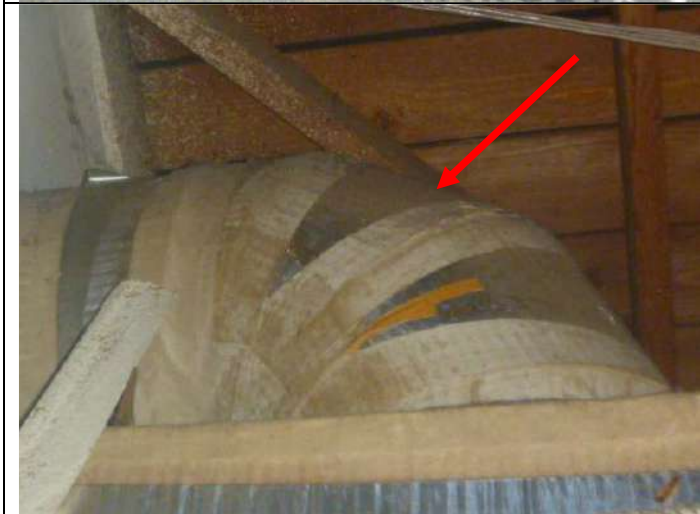
- B TYPE:** Central Forced Air (Holly brand)
- A CONTROL:** Thermostat
- B/ DUCTS:** The ductwork is the original asbestos insulated type and
C some damage was noted.

A photograph showing a junction of ductwork wrapped in a thick, light-colored, fibrous material, likely asbestos insulation. The ductwork is located in an attic space, with wooden joists visible in the background. Two red arrows point to the insulation.	<p>Asbestos insulated ductwork in the attic.</p>

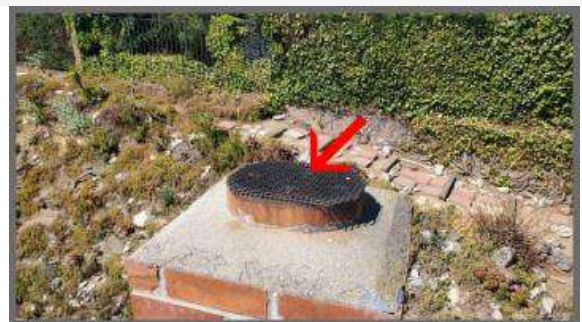
MASONRY CHIMNEY CONDITION:

NEEDS ATTENTION. The Masonry structure will move a little when pressure is applied. There is not enough evidence at this time, in my opinion, to verify that the chimney is damaged to a point where replacement is required.

The installation of an engineered brace system may be an appropriate remedy in this case.

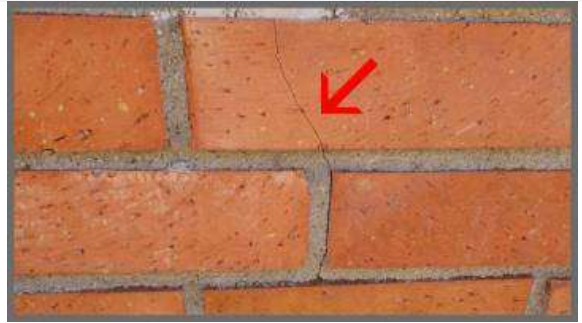
NEEDS ATTENTION. There are some minor cracking along the exterior brick surfaces.

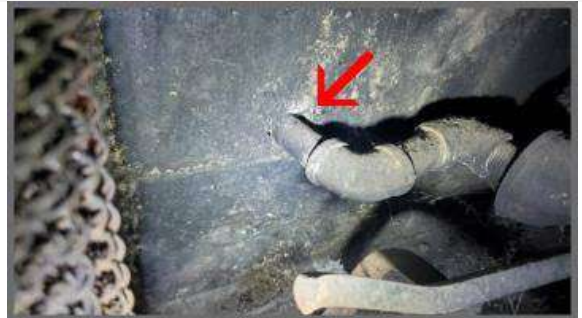
NEEDS ATTENTION. The gas log lighter is too far above the firebox floor or inner hearth area. It should be repositioned so that it is about 1 inch above the firebox floor.
