## 2176 Calle Nardo Thousand Oaks

### Pre-Market Inspections

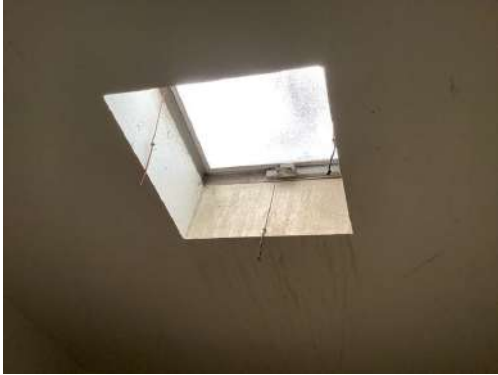
Evidence of prior leakage was noted at the skylight. It should be further investigated for active leakage and repaired or replaced, as necessary.

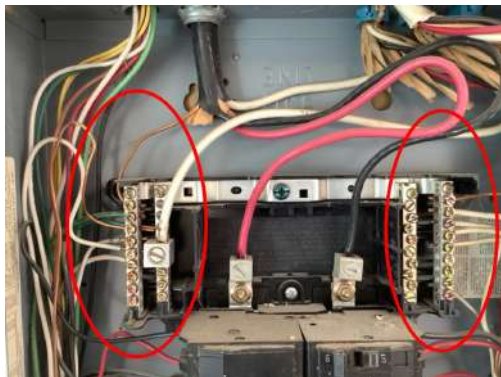
No proper ground wiring installed. We recommend repair for safety, per standards.

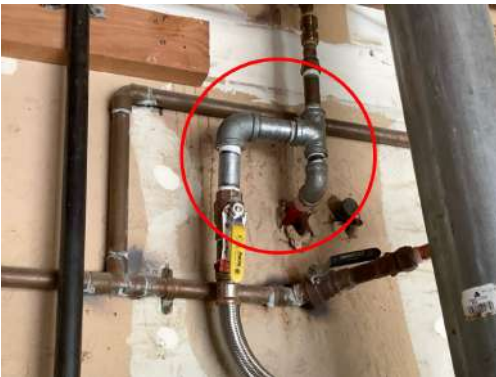
Copper piping is connected directly to galvanized piping at the water heater area piping. This configuration is not approved and can lead to deterioration of the galvanized pipe. We recommend the installation of an approved fitting at this location.

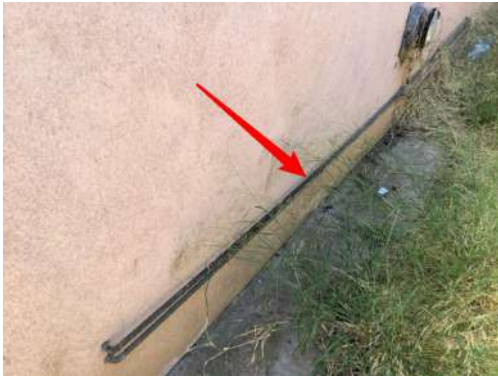
We found unsecured water piping at the exterior of the detached structure. We recommend it be fastened to the framing according to accepted standards.

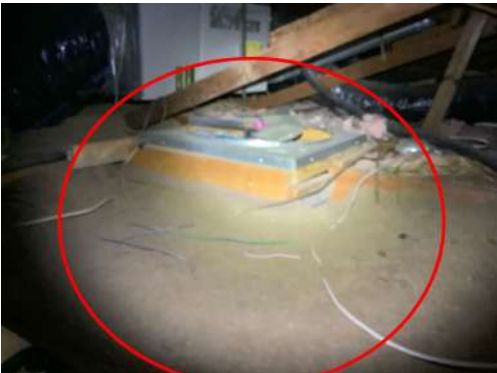
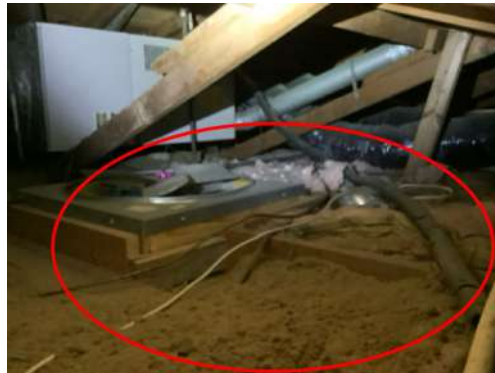
There is no access flooring and service platform installed at the attic installed HVAC unit (from access opening), making inspection/servicing unsafe. The platform shall extend 30 inches in front of the unit. This condition presents a hazard! This HVAC unit was not accessed to nor inspected. We recommend correcting this condition for safe service access in accordance with present standards.

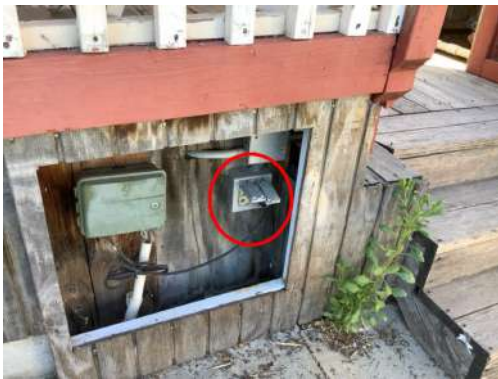
The GFCI receptacle did not trip when tested (rear deck, etc.). We recommend it be replaced, for safety.

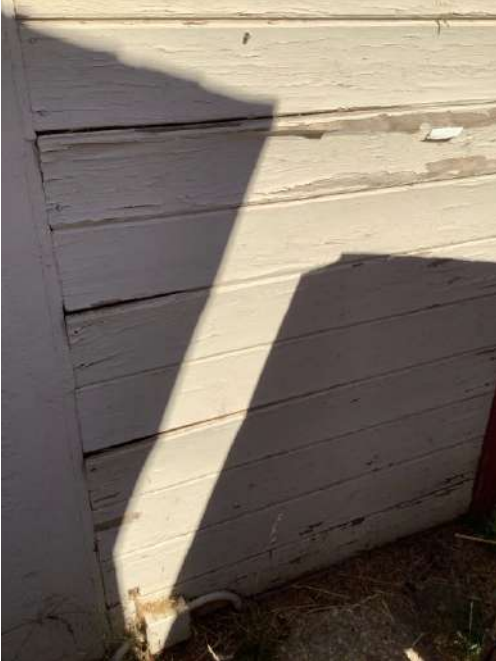
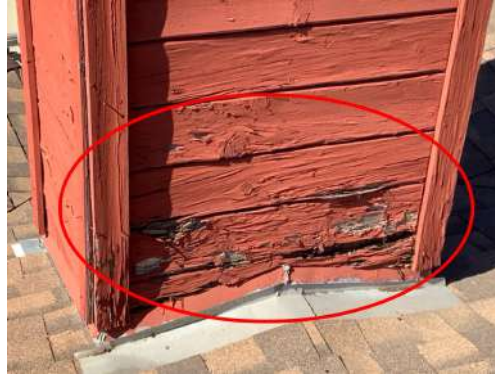
Sections of the siding are damaged. We recommend reviewing termite inspection report and these sections be repaired or replaced as recommended.

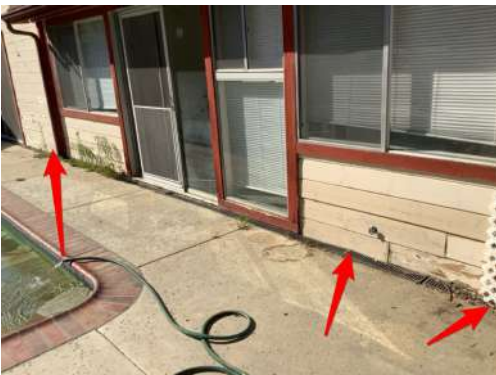
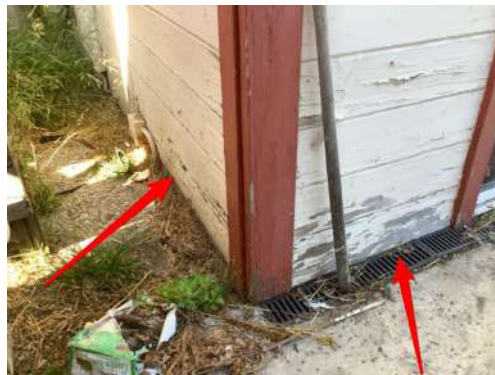
Portions of the wood sidings are in contact with concrete or don't have proper clearance. We recommend the required clearance be provided. As preventive maintenance, we recommend the area be flooded with a wood preservative from time to time.

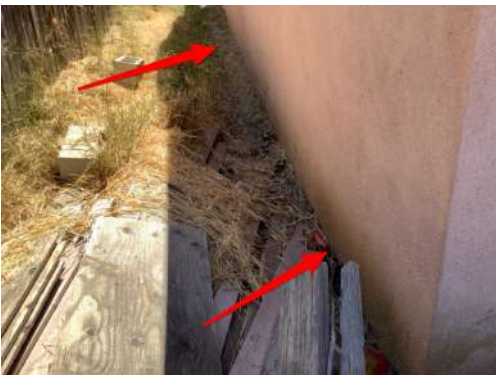
Grading is sloped toward the detached structure. Low spots and negative grading promote water accumulation near the building, leading to foundation problems (settlement, seepage, etc.). Regrading would help ensure that surface water flows away from the structure.

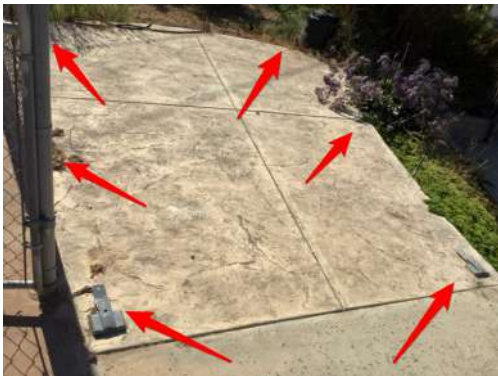
There are metal post brackets installed in concrete slab at sport court deck area. These exposed brackets present a trip hazard. We recommend to removing or properly covering them to prevent injury.

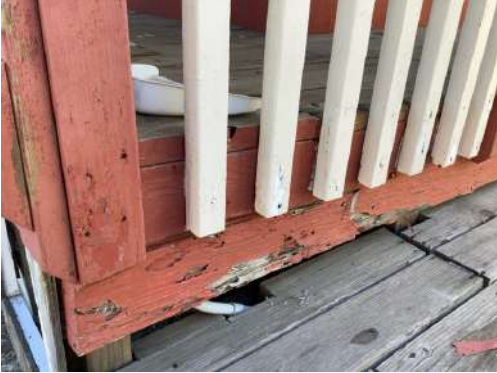
There are damaged/deteriorated deck wood elements noted. We recommend to review termite inspection report and replacement of all damaged material as recommend and necessary.

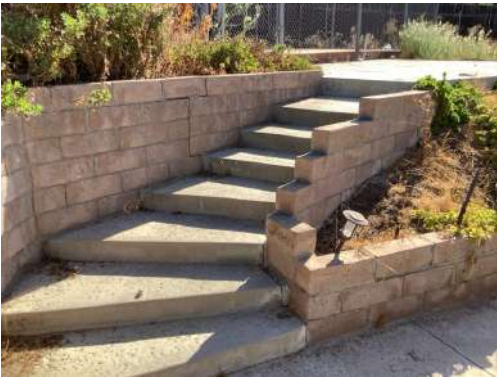
**DNGR** There are no hand railings installed at the rear spa deck, sport court and driveway access area stairs. As a safety measure, we recommend that hand railings be installed, per standards.

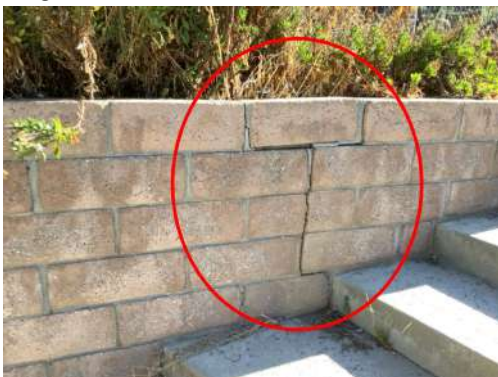
The retaining wall has cracks. We recommend further evaluation of this condition by a structural engineer, before the close of escrow and repair be made as recommended.

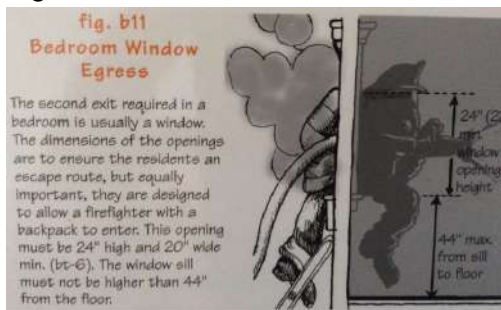
**DNGR** There is no openable window in this room. An emergency egress meeting certain requirements is mandatory for all sleeping areas. The opening must be a minimum of 20 inches wide and 24 inches high. We recommend installation of such an egress in accordance with present standards, for safety!

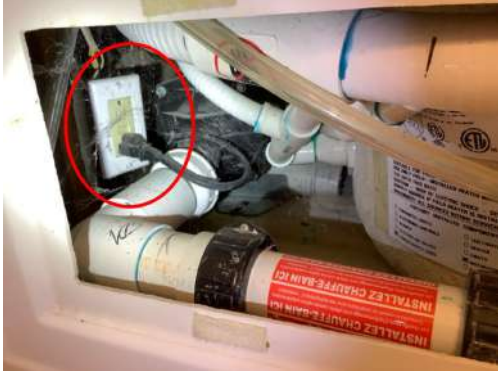
The pump housing lacks a proper body bond (gauge/#8 bare copper wire connected to pool vessel reinforcing steel rebar system). It is recommended that this installation be corrected for safety, per standards.

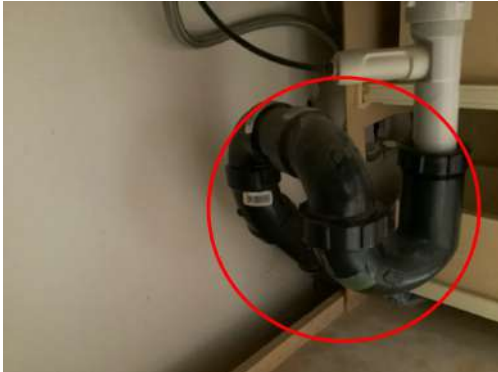
The drain trap has been installed in a substandard manner. We recommend it be repaired or replaced.

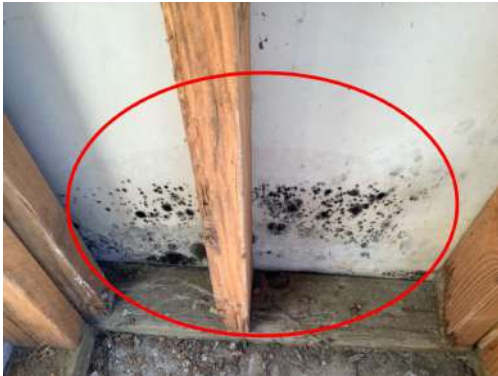
There is what appear to be a "black substance" built up noted on the exposed wall surfaces in adjacent storage room area. Because of the apparent moisture intrusion, we recommend to retain an environmental specialist before the close of escrow to test for toxic molds and evaluate this condition. Repair and remediation should be made as recommended.

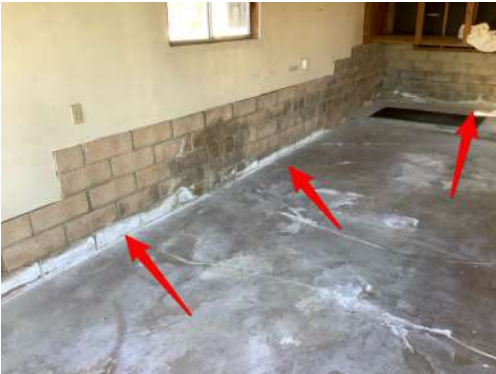
There are signs of water seepage at exterior walls/footing, suggesting inadequate drainage. We recommend the owner be consulted regarding the cause, extent, and frequency of seepage that has occurred and corrective repairs that may have been performed.

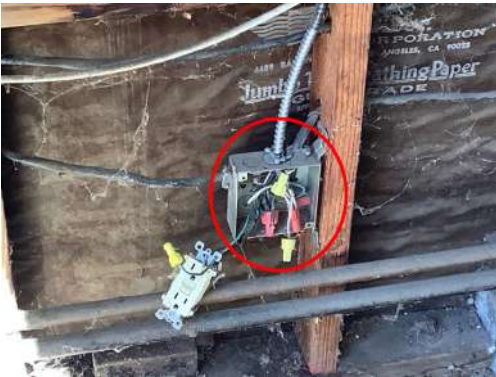
There is an open junction box noted. We recommend this box be covered to protect the wiring connections.

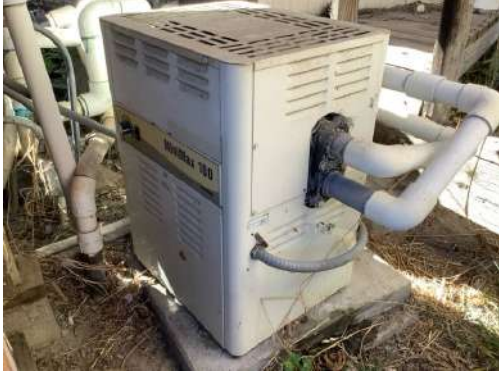
The heating system was turned on with its regular controls and found to be inoperative at the time of inspection. Further evaluation, testing of this system is recommended prior to close of escrow.

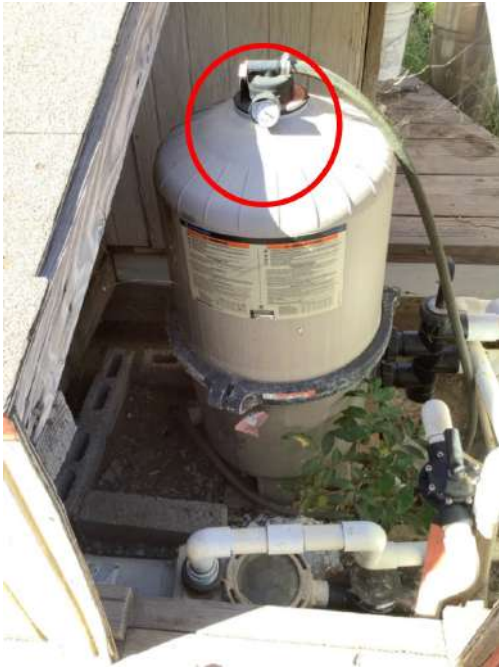
No glass was observed at the face of the pressure gauge. We recommend replacing this gage for proper operation.

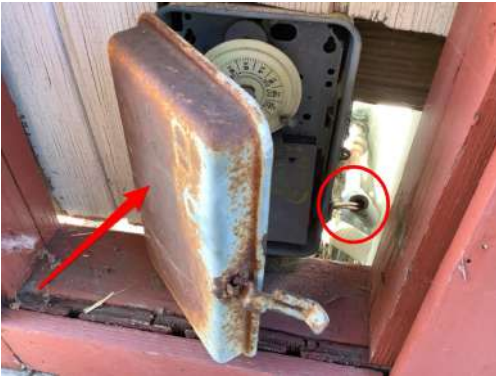
Loose/damaged conduit was noted at the timer box, presenting a hazard. We recommend these connections be repaired for safety.

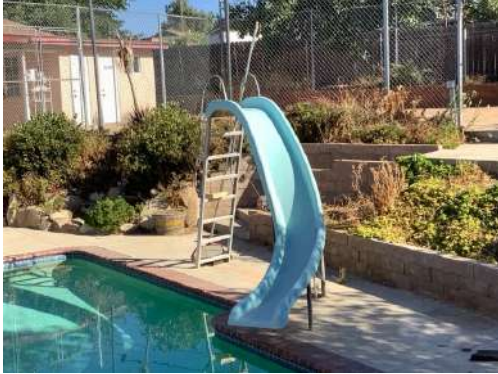
**DNGR** Our inspection does not include the slide! Water slides have a history of safety issues. Safety requirements may have changed since the installation of this slide. We recommend to check present standards with local building authorities. For safety reasons, discontinuing usage and removal of this equipment is strongly recommended.

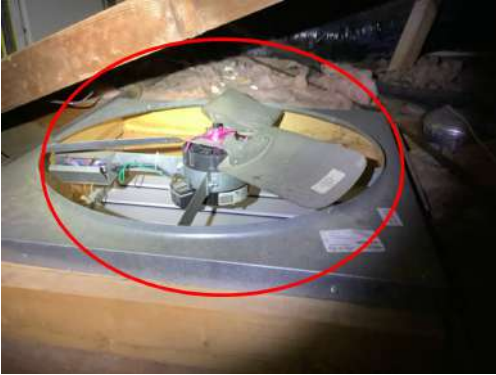
There is a whole house fan installed in hallway ceiling. There is no safety barrier around it in attic. We urge extra caution around this fan in attic, to prevent injury!!

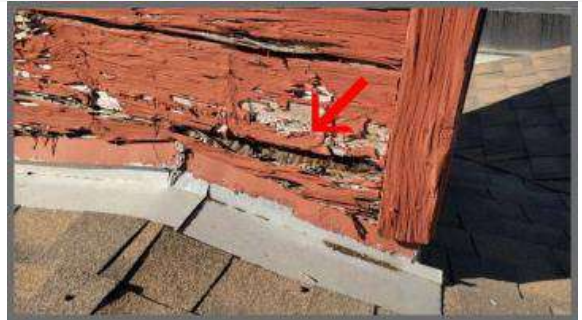
**NEEDS ATTENTION.** There is damage to the wood surfaces of the chase.
