CHIMNEY CHECK

6501 Matilija Ave Van Nuys, 91401

Inspector: Laszlo Draskoczi.

March 15, 2024.

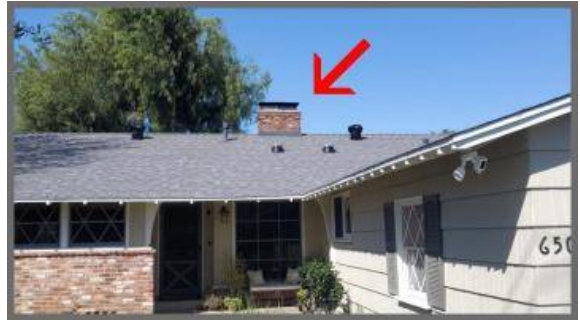
MASONRY CHIMNEY TYPE:

This is a reinforced masonry structure (this is when the chimney has metal reinforcements built into the system, otherwise known as rebar).

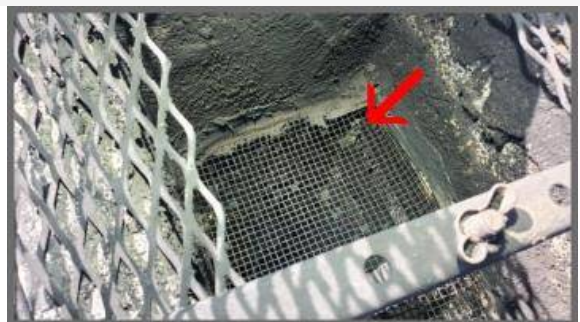
SPARK ARRESTER/CAP:

FIRE SAFETY RISK. Despite a proper spark arrester with rain cap installed, the chimney still has the older, flat screens with small holes jammed into the flues. These old screens can clog and prevent proper operation.

The old flat screens jammed into the flues should be removed.

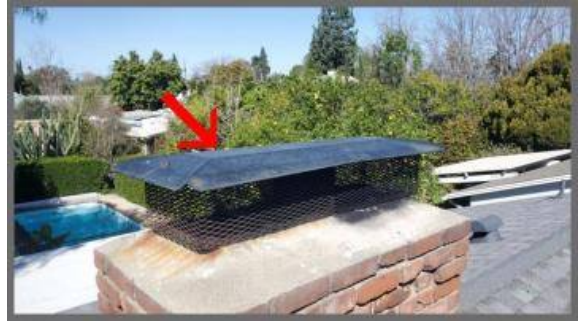
Otherwise, proper spark arresters and rain caps have been placed at the top of the flues.

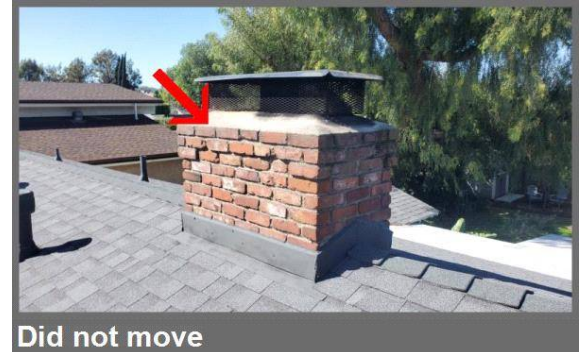
MASONRY CHIMNEY CONDITION:

NOTE. The structure did not move when pressure was applied. In my opinion the chimney does not require replacement to achieve a viable system.

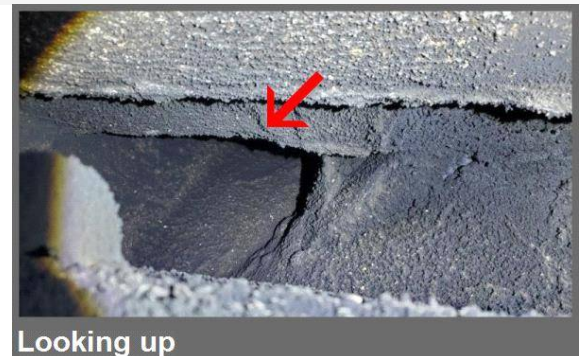
FAMILY ROOM MASONRY FLUE:

FIRE SAFETY RISK. The Family Room flue system is very dirty.

NOTE. I was not able to view the inner surfaces of the flue.

The Family Room system should be cleaned and the flue re-evaluated. If any defects or errors are discovered then additional corrections would need to be performed, at additional costs.

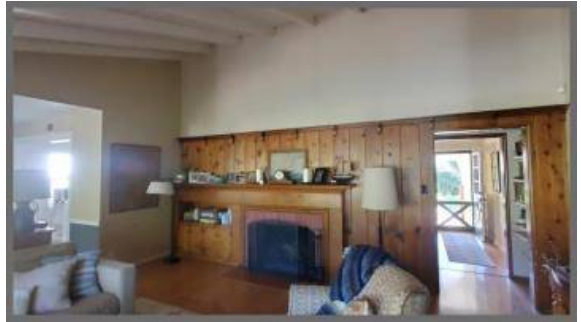
APPLIANCE TYPE:

This is a masonry wood burning fireplace. This unit has a gas log lighter.

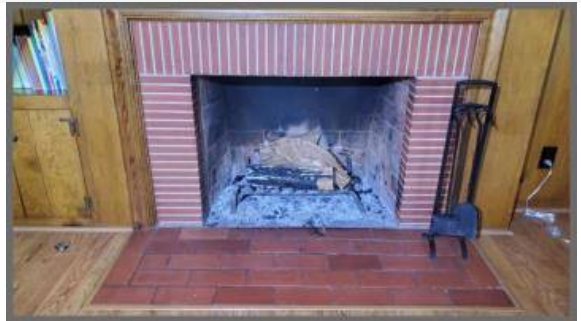
SMOKE CHAMBER CONDITION:

FIRE SAFETY RISK. The smoke chamber is dirty.

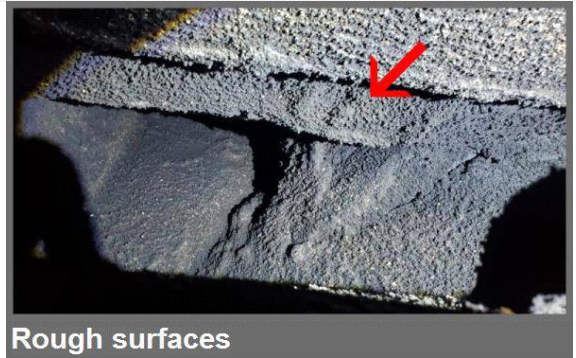
SMOKE CHAMBER CHARACTERISTICS:

FIRE SAFETY RISK. The smoke chamber surfaces are also uneven and jagged/rough, hindering the drafting characteristics of the system.

The smoke chamber surfaces should be smoothed with heat rated mortar as much as possible to create a more gradual transition into the flue.

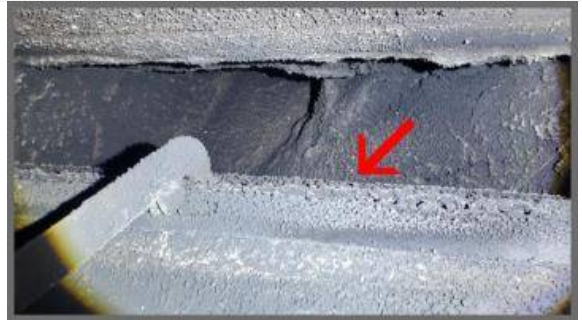
MASONRY FIREPLACE:

FIRE SAFETY RISK. The breast area above the firebox have some gaps along it's surface.

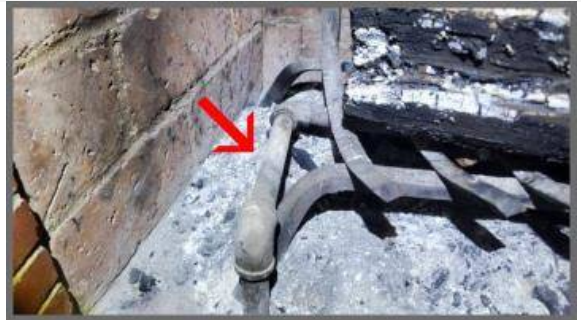
MASONRY FIREBOX ADDITIONAL:

NOTE. The firebox is constructed of Red Brick and therefore would require that the minimum thickness of the firebox walls to be 10 inches. It is not part of this inspection to determine the thickness of the firebox walls.

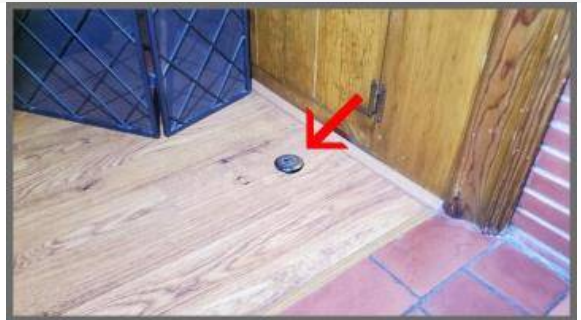
LOG GRATE:

The grate is needed so that the fuel can be positioned appropriately within the firebox.

A screen is present and is required for fire safety.

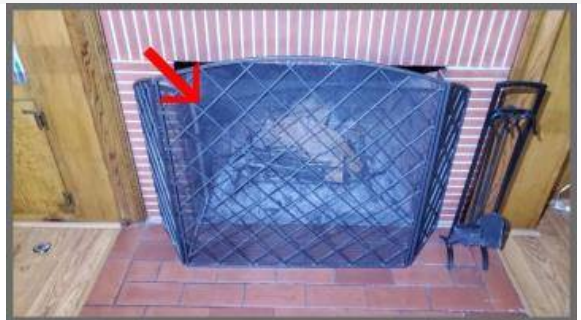
HEARTH EXTENSION:

NOTE. It is beyond this inspection to determine the type of construction that supports the hearth extension nor to determine whether or not the Hearth extension is adequately constructed to provide proper heat protection, such as a correct thickness in materials.

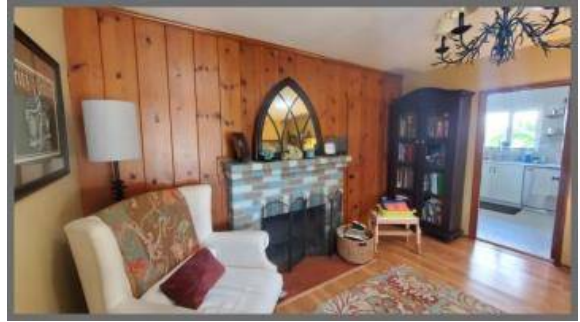
APPLIANCE TYPE:

This is a masonry wood burning fireplace. This unit has a gas log lighter.

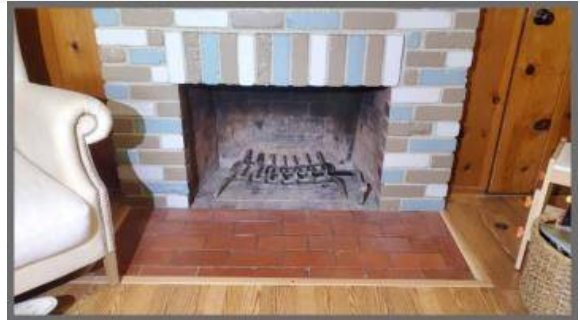
SMOKE CHAMBER CONDITION:

FIRE SAFETY RISK. The smoke chamber is dirty.

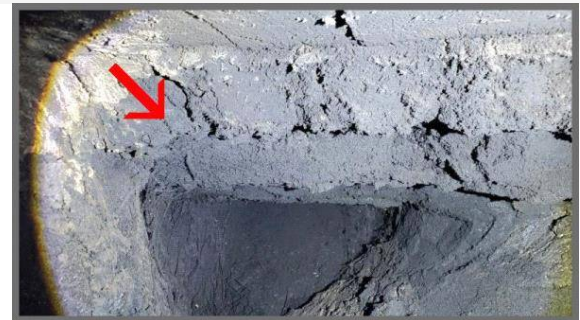
SMOKE CHAMBER CHARACTERISTICS:

FIRE SAFETY RISK. The smoke chamber surfaces are also uneven and jagged/rough, hindering the drafting characteristics of the system.

The smoke chamber surfaces should be smoothed with heat rated mortar as much as possible to create a more gradual transition into the flue.

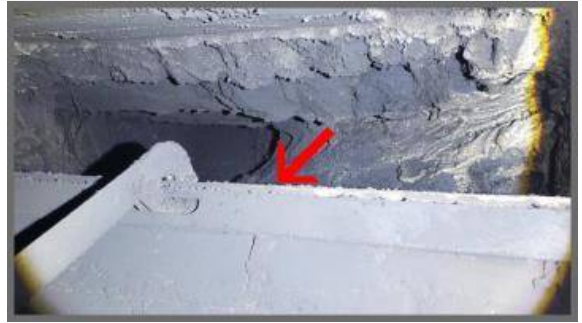
MASONRY FIREPLACE:

FIRE SAFETY RISK. The breast area above the firebox have some gaps along it's surface.

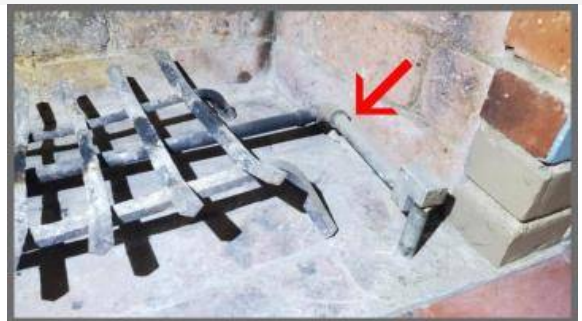
MASONRY FIREBOX ADDITIONAL:

The firebox is constructed of Red Brick and therefore would require that the minimum thickness of the firebox walls to be 10 inches. It is not part of this inspection to determine the thickness of the firebox walls.

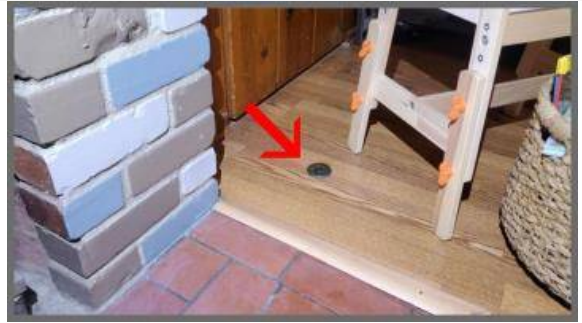
LOG GRATE:

PRESENT. The grate is needed so that the fuel can be positioned appropriately within the firebox.

A screen is present and is required for fire safety.

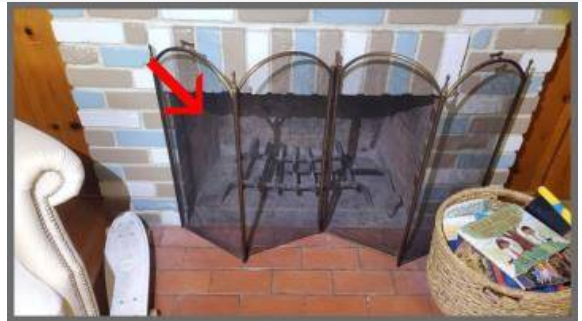
HEARTH EXTENSION:

NOTE. It is beyond this inspection to determine the type of construction that supports the hearth extension nor to determine whether or not the Hearth extension is adequately constructed to provide proper heat protection, such as a correct thickness in materials.
