# CHIMNEY CHECK

9976 Tujunga Canyon Blvd Tujunga 91042

Inspector: Chris Richeson

March 07, 2024.

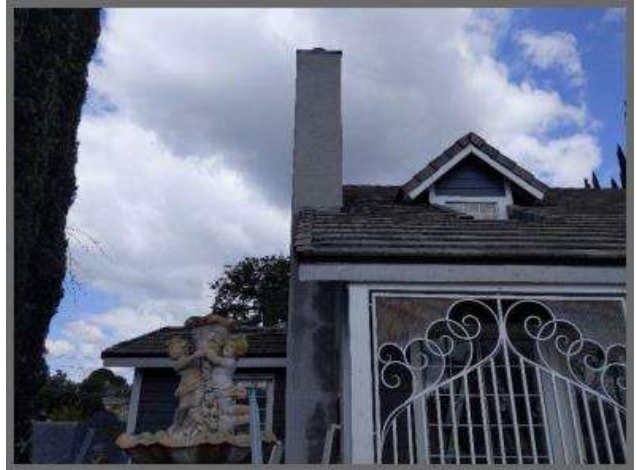
### METAL CHIMNEY TYPE:

This is a prefabricated metal chimney system within a chase or enclosure, designed for a specific fireplace.

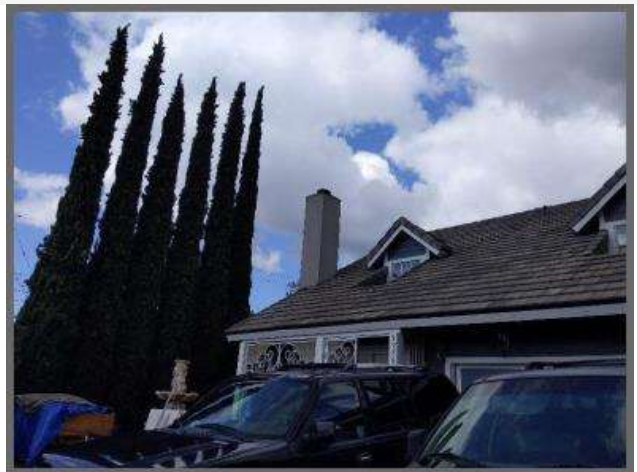
### RELATIONSHIP TO THE STRUCTURE:

This is a one story fireplace/chimney system. This chimney is taller than typical.

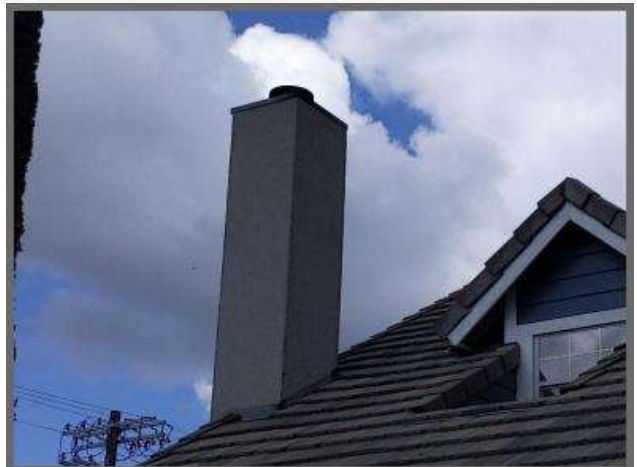
## TERMINATION CAP:

This appears to be the approved termination cap.

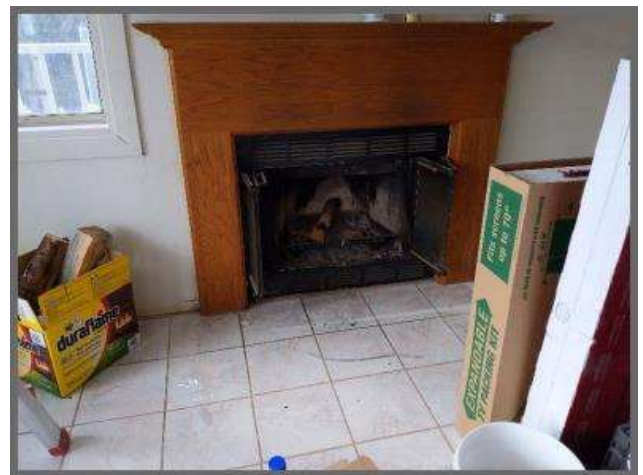
### APPLIANCE TYPE:

This is a factory built wood burning fireplace. This unit has a gas log lighter.

It is my recommendation (due to the age of the current system, its condition and a lack of replacement parts) that this fireplace system be fully removed and replaced with an approved unit.

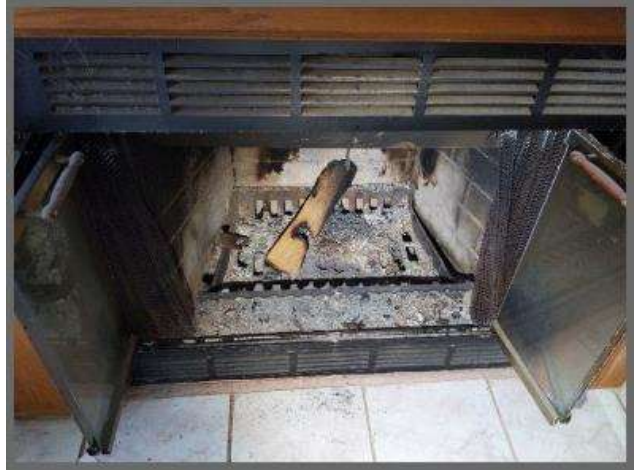
### DAMPER:

A damper is present. It is beyond this inspection to determine the efficiency of the damper to seal the throat.

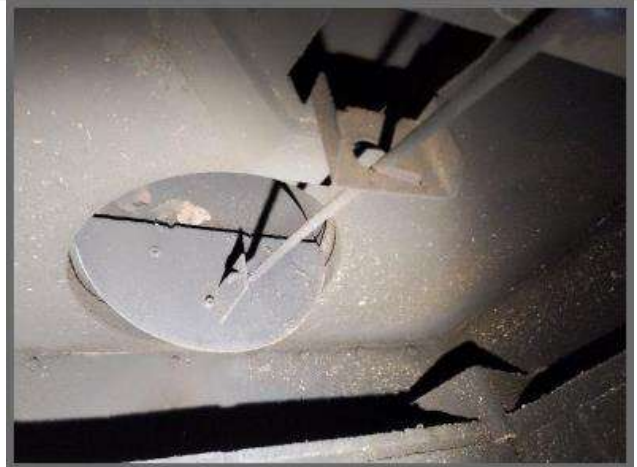
**BRAND OF UNIT:**

TEMTEX/TEMCO: The model was not determined.

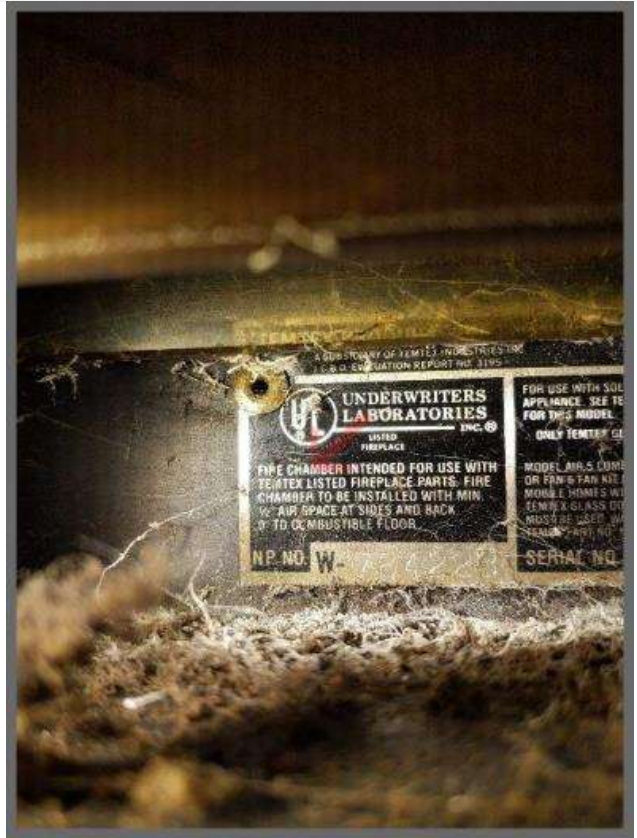
### PREFABRICATED UNIT:

**FIRE SAFETY RISK.** The firebox has rusting in areas. This rusting will continue to worsen over time.

### PREFABRICATED FIREPLACE DRAFTING:

**FIRE SAFETY RISK.** There are smoke stains at the side walls of the firebox and just outside the firebox area which indicates improper drawing of the chimney flue (and smoke entry) during operation.

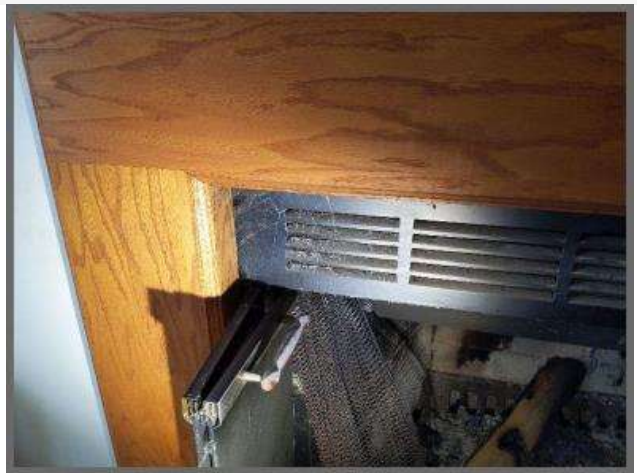
## SCREEN:

**FIRE SAFETY RISK.** The screen is damaged.

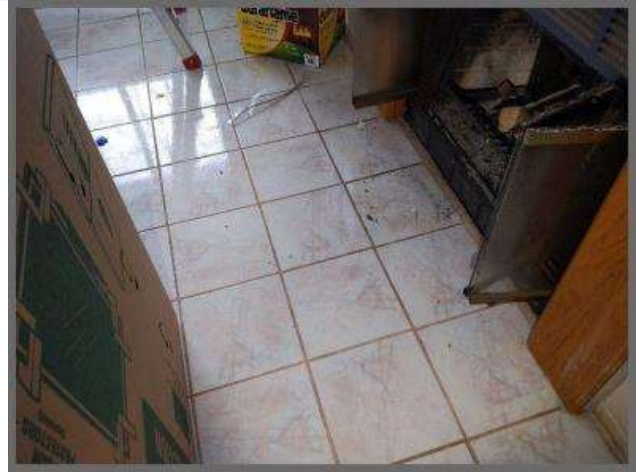
## HEARTH EXTENSION:

**FIRE SAFETY RISK.** There is not a "distinguishable" hearth extension in front of the fireplace. Technically, the hearth extension is supposed to be "defined" (even if only with tape) so as to help prevent placing combustible materials within the proximity of the fireplace.
