7347 Valaho Dr. Tujunga, CA 91042

Reports & Pre-Market Inspections

Report Summary	3-5
Inspection Details	6
Interior Areas	7-11
Bedrooms	12-17
Bathroom	18-22
Kitchen	23-27
Laundry	28-30
Heat/AC	31-34
Water Heater	35-37
Garage	38-41
Electrical	42-45
Roof	46-50
Attic	51-52
Exterior Areas	53-57
Foundation	58
Grounds	59-63
Glossary	64

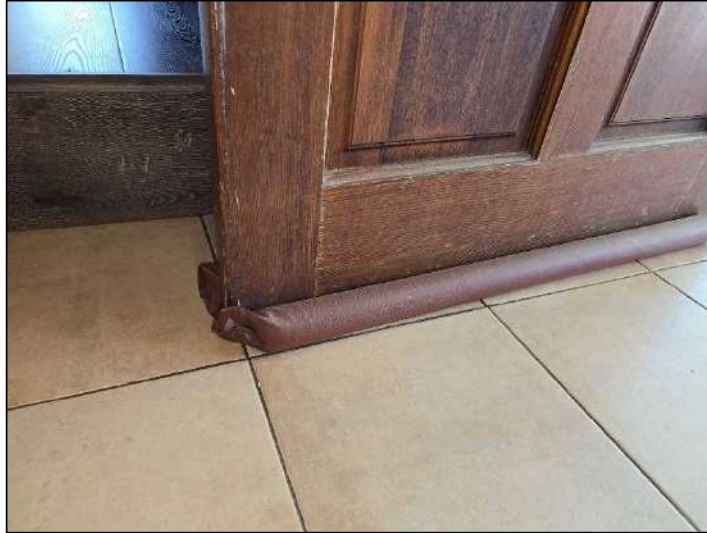
- Improper weatherstripping on front door recommend repair

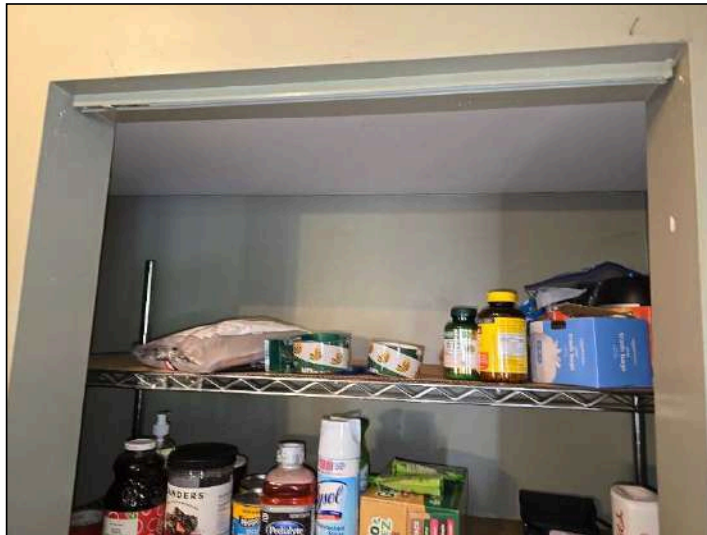
5. Closets

- Worn closets with loose/worn hardware
- Missing closet doors, recommend repair

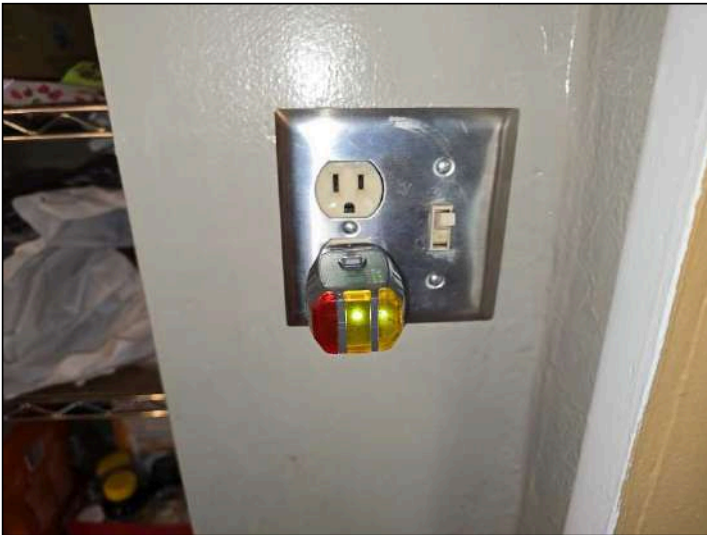
6. Electrical

- Loose/worn outlets/switches, typical for age, consider upgrading.
- Some bulbs defective/missing/lights did not function, check bulbs/consult electrician for further evaluation

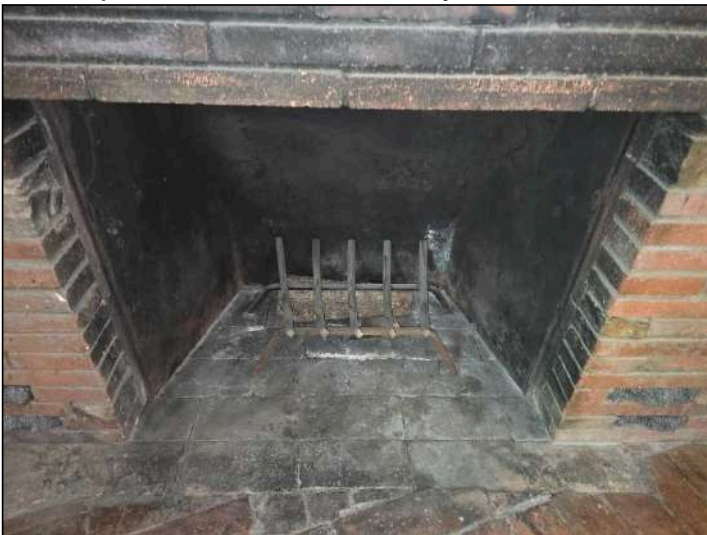
7. Fireplace

- Smoke detector missing in the same area as the fireplace, recommend installing
- Damper was worn/rusted/dirty, recommend cleaning and maintenance

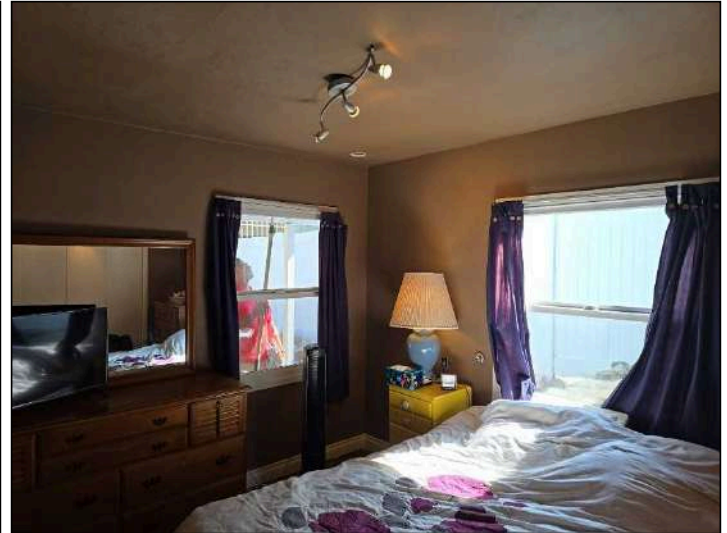
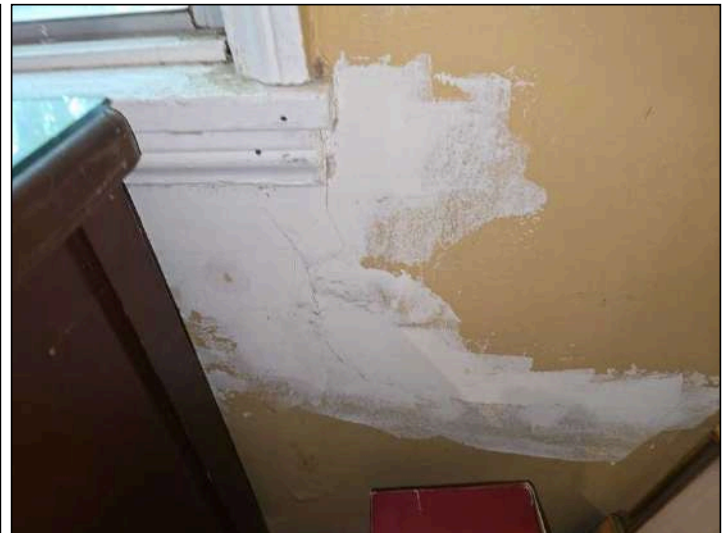
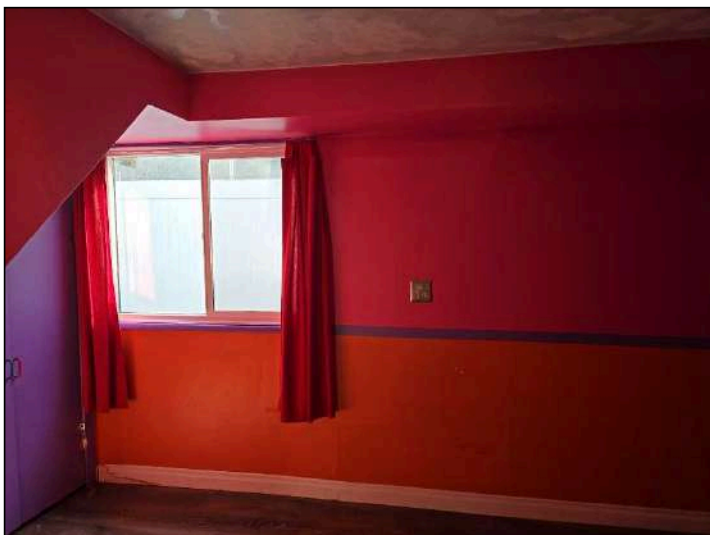
2. Wall Condition

- Small cracks/holes/chipped/dirty areas/ cosmetic blemishes observed, typical for age and material
- Patched areas observed consult seller regarding previous repairs
- Evidence of moisture entering from exterior wall east bed. We recommend contacting a contractor experienced in exterior systems to evaluate the area and suggest repair options.

Evidence of moisture entering from exterior wall east bed. We recommend contacting a contractor experienced in exterior systems to evaluate the area and suggest repair options.

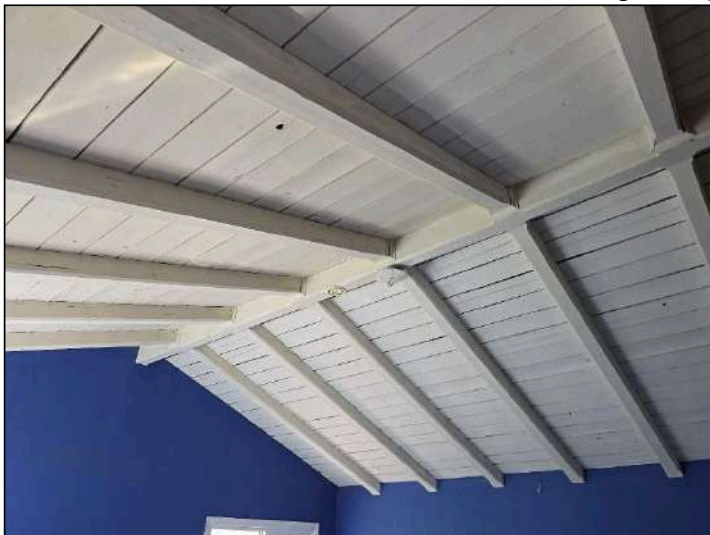
3. Ceiling Condition

- Patched areas observed consult seller regarding patched areas.

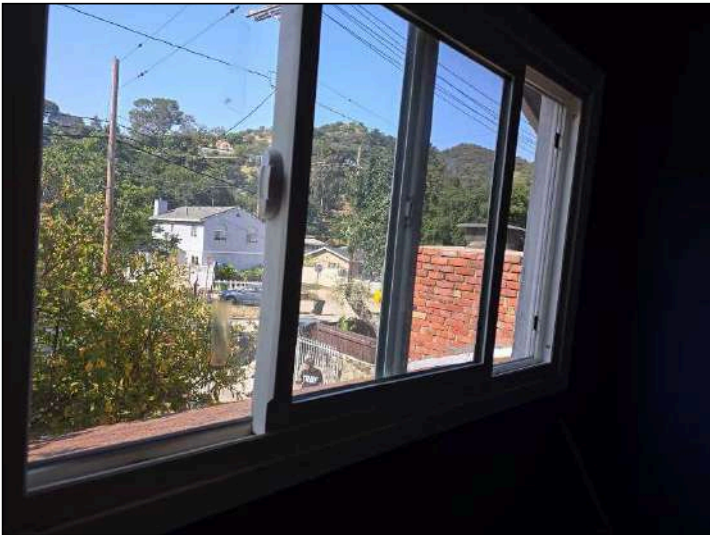
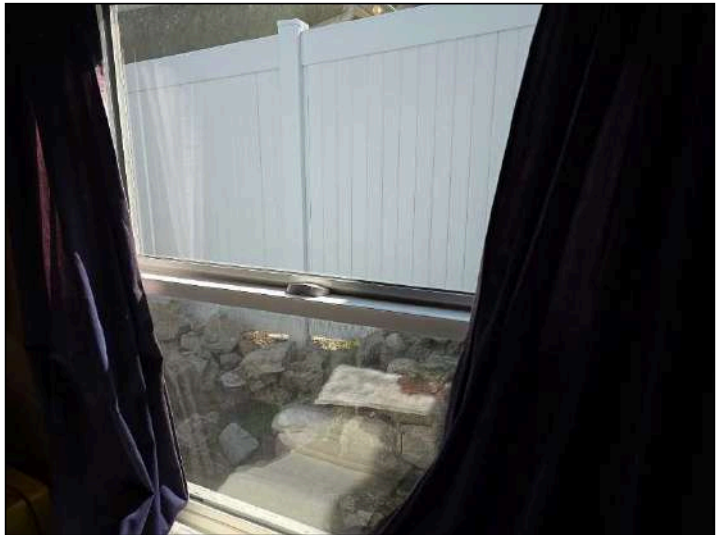
5. Window Condition

- **Deteriorated frame(s) recommend further evaluation east bedroom**

Deteriorated frame(s) recommend further evaluation east bedroom

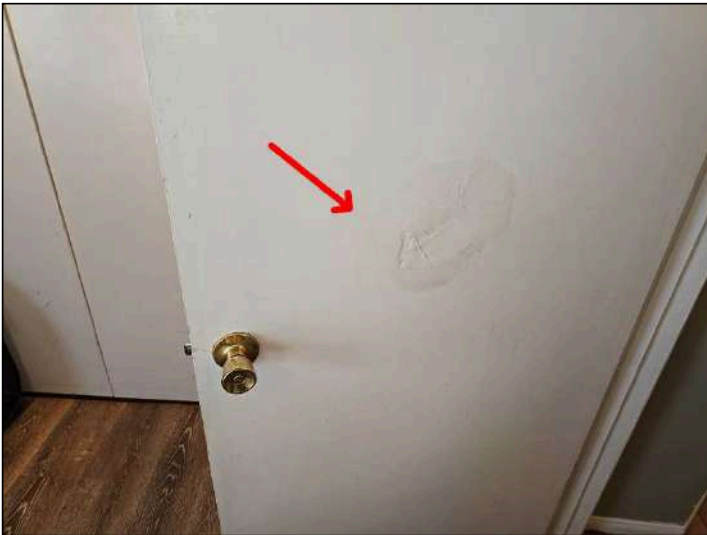
Patched door

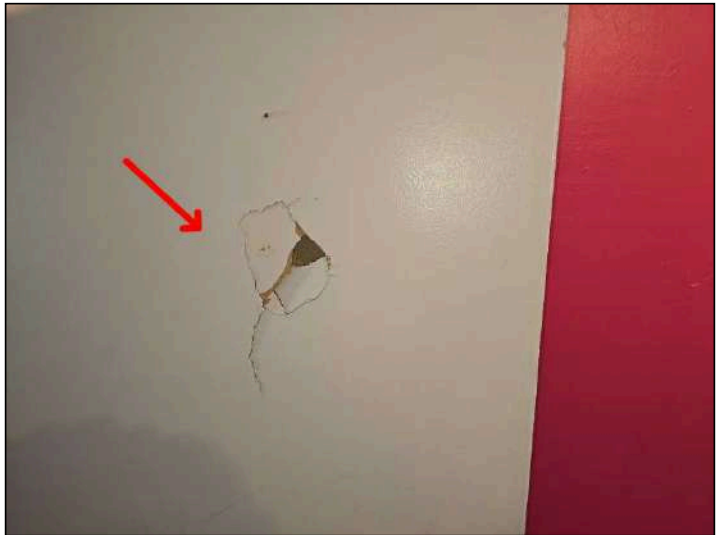
Large hole(s) present, recommend repair or replace east bedroom

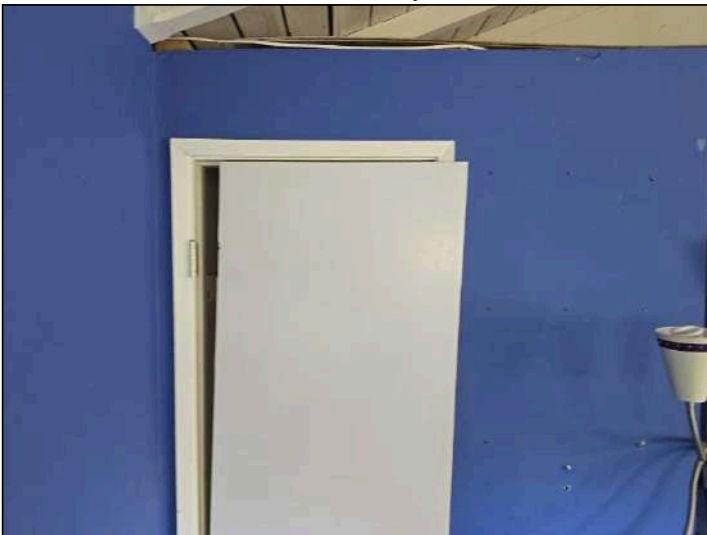
Door off hinges 2nd floor bedroom recommend repair

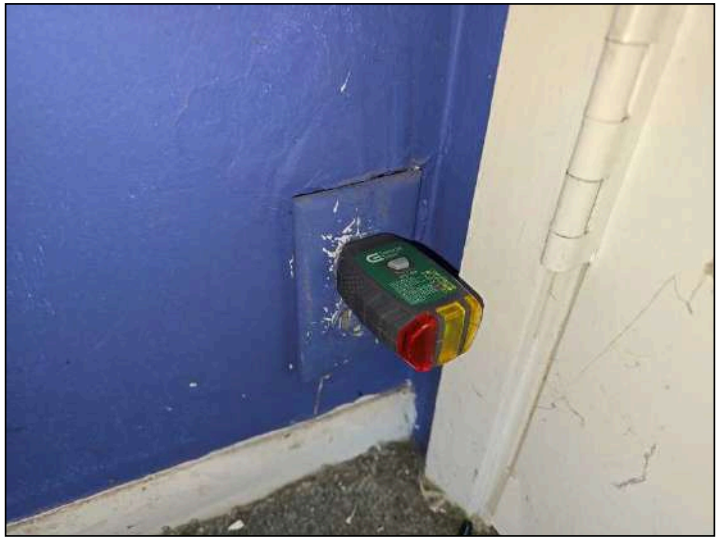
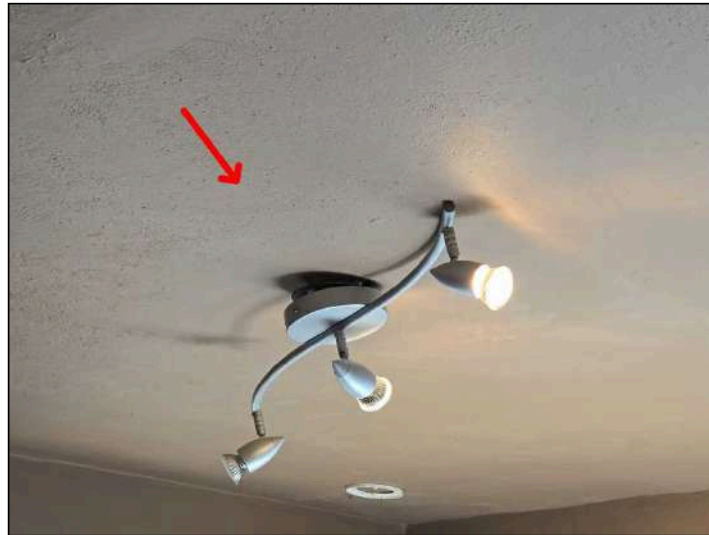
- Loose/worn outlets/switches, typical for age, consider upgrading.
- **Loose fixtures, recommend repair**

Loose fixtures, recommend repair

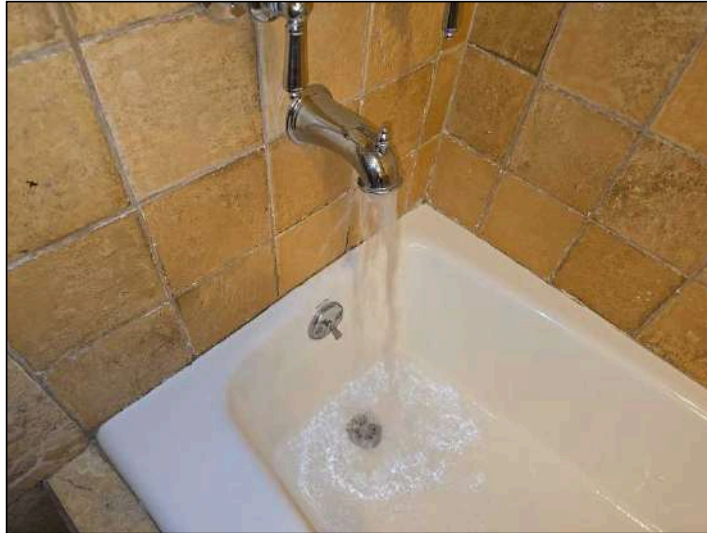
7. Bath Tubs

- Fixtures/tub tested and operating at the time of the inspection
- Drain stopper not operating properly, recommend repair
- Hot water does not operate properly, recommend repair

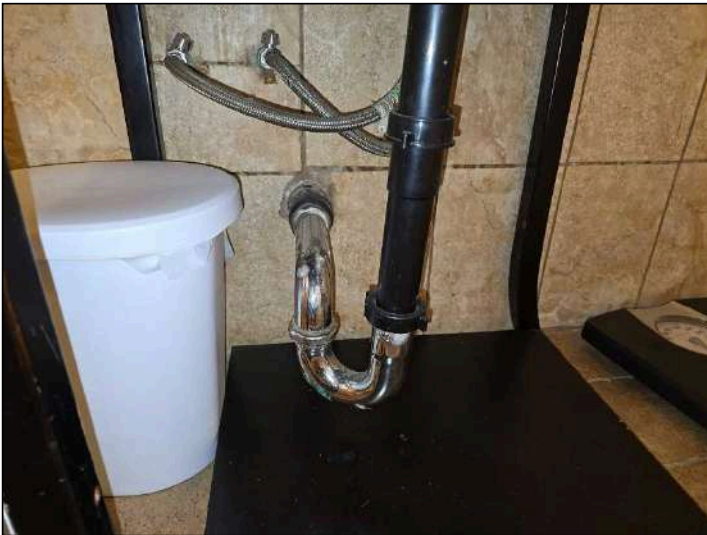
12. Plumbing

- Older style metal traps noted. Buyer is cautioned that these traps can leak at any time due to corrosion.
- **Drain piping under sink corroded recommend repair**

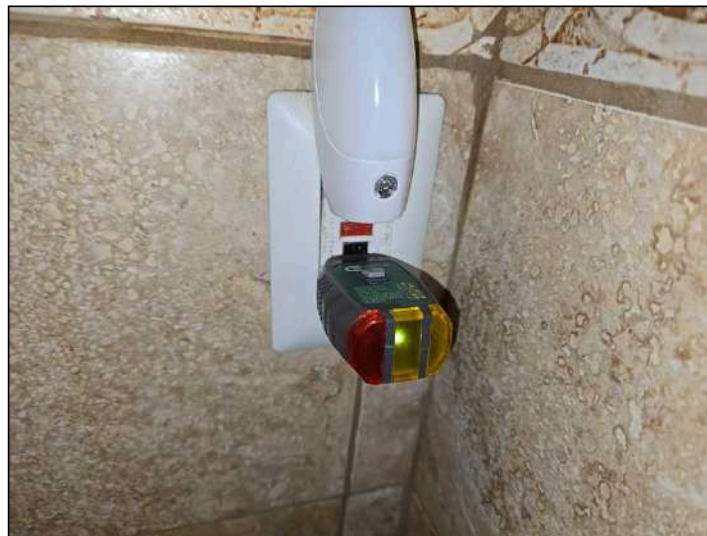
13. GFCI

- **GFCI** not grounded, recommend repair

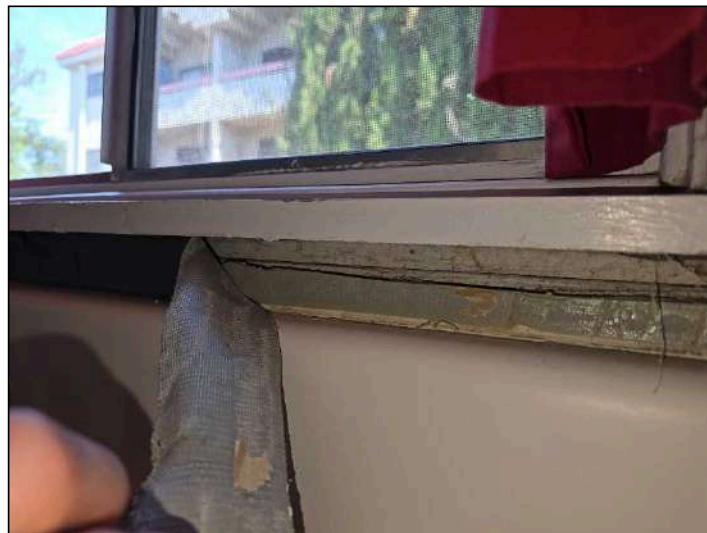
Large gap at bottom of window recommend repair

Kitchen		
Page 23 Item: 4	Window Condition	<ul style="list-style-type: none"> Large gap at bottom of window recommend repair
Page 24 Item: 6	Sinks	<ul style="list-style-type: none"> Sink loose in counter top, recommend repair
Page 24 Item: 8	Garbage Disposal	<ul style="list-style-type: none"> Unit not on a dedicated circuit recommend repair
Page 26 Item: 14	Vent Condition	<ul style="list-style-type: none"> No exhaust/filtration system present, recommend installing an exhaust vent system
Page 27 Item: 16	GFCI	<ul style="list-style-type: none"> GFCI not grounded, recommend repair
Laundry		
Page 28 Item: 1	Wall Condition	<ul style="list-style-type: none"> Evidence of moisture entering from exterior wall. We recommend contacting a contractor experienced in exterior systems to evaluate the area and suggest repair options.
Page 28 Item: 2	Ceiling Condition	<ul style="list-style-type: none"> Evidence of a possible roof leak from above this area recommend further evaluation

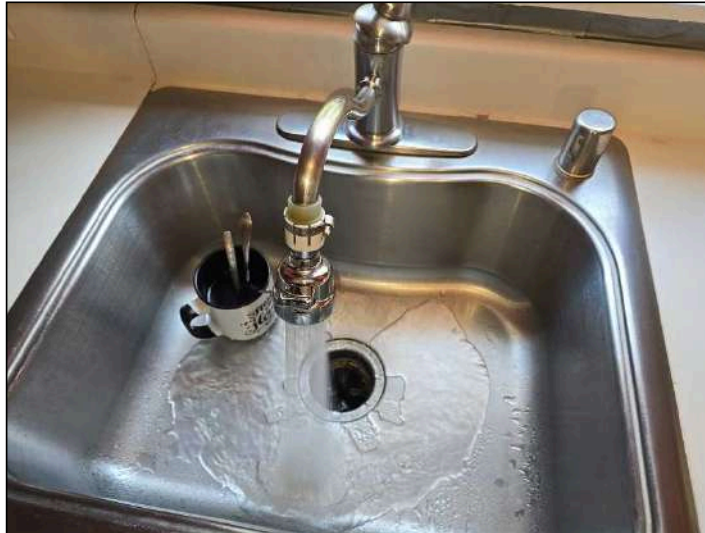
- Fixture operated at the time of the inspection
- Sink loose in counter top, recommend repair

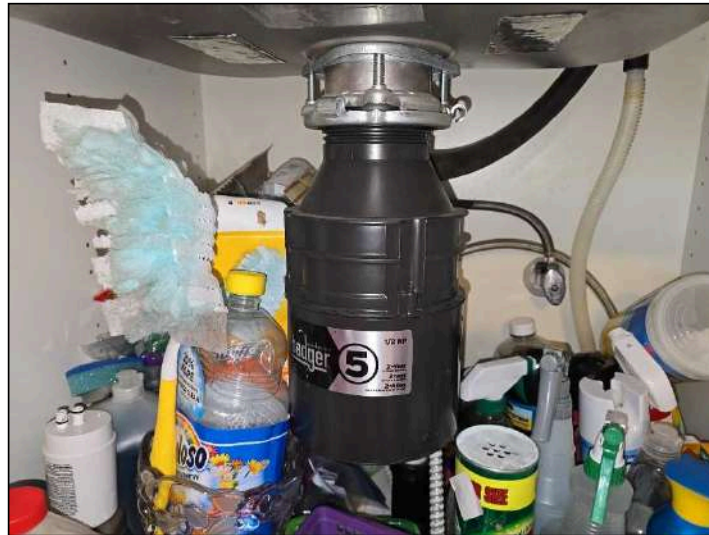
- Tested and operational
- Unit not on a dedicated circuit recommend repair

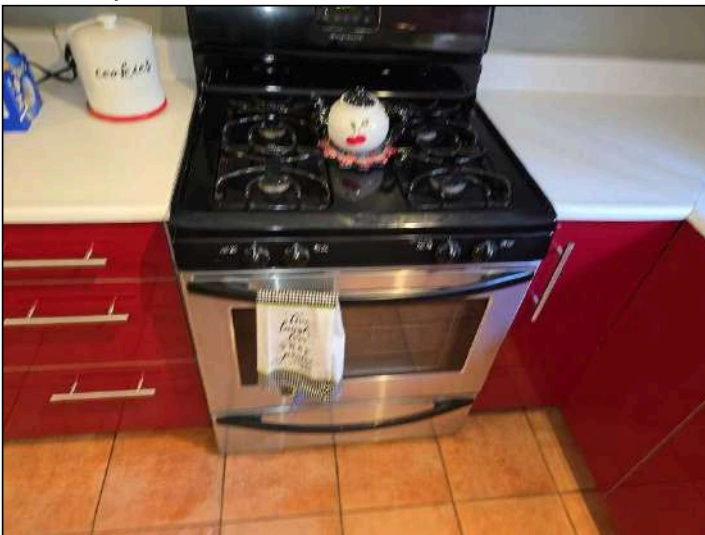
11. Oven & Range

- Gas supplied unit
- Tested and operated normally
- Normal wear
- Anti tip device is not visible/not tested, we recommend that an anti tip device be installed

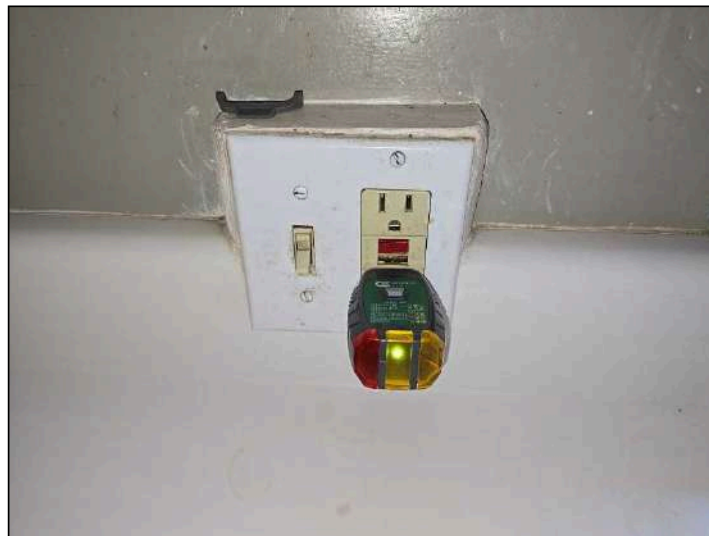
16. GFCI

- GFCI not grounded, recommend repair

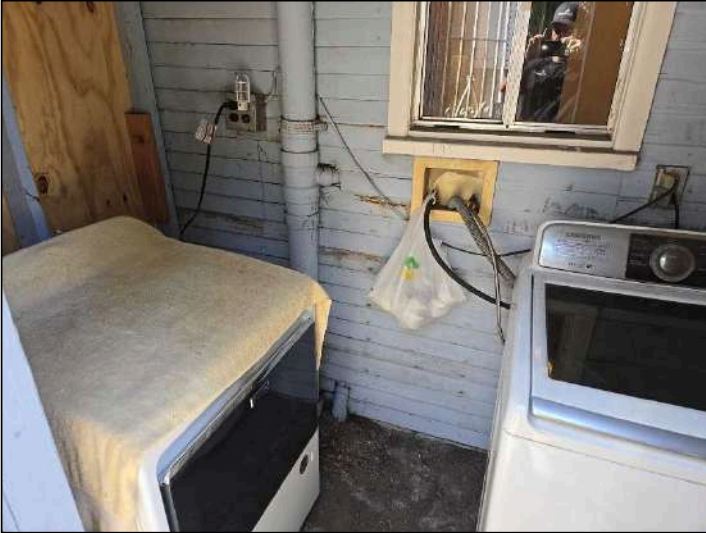
1. Wall Condition

- Evidence of moisture entering from exterior wall. We recommend contacting a contractor experienced in exterior systems to evaluate the area and suggest repair options.

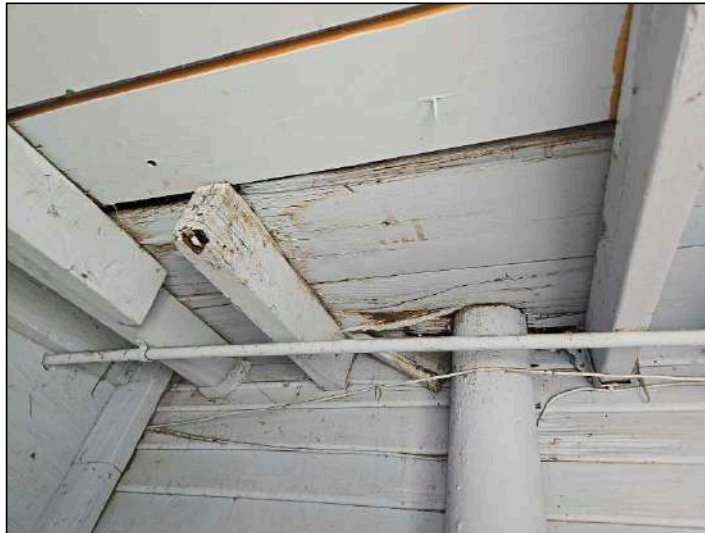
2. Ceiling Condition

- Evidence of a possible roof leak from above this area recommend further evaluation

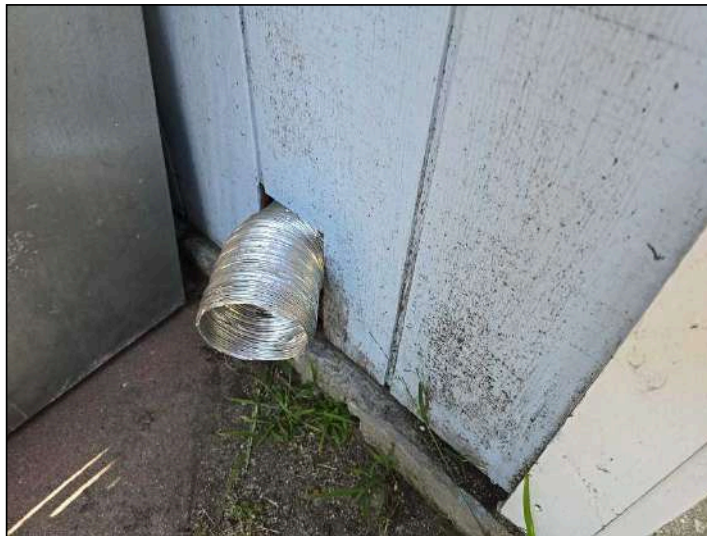
- Missing the exterior cover, recommend repair

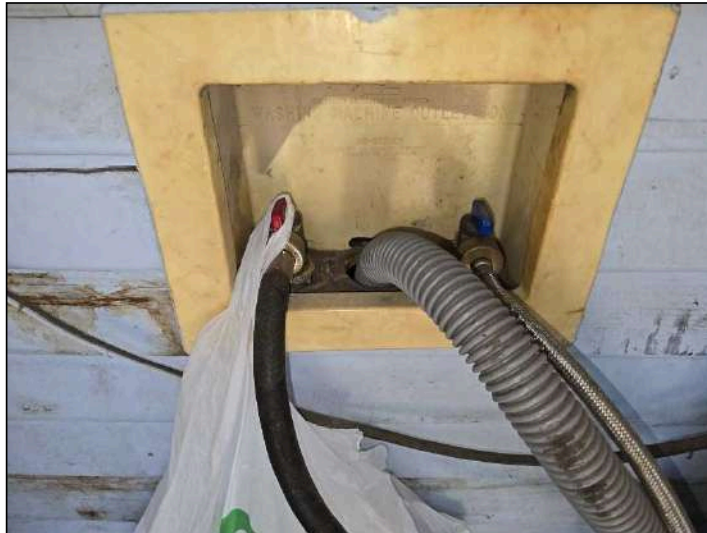
6. Plumbing

- Operated normally at the time of the inspection
- Plastic flex line used as part of drain, recommend upgrading to a correct material

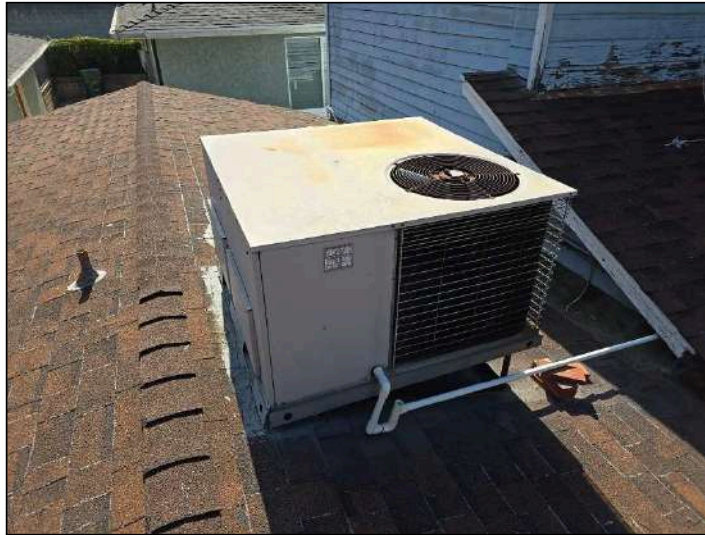
1. Heater Condition

- Visible areas of the unit are worn/older, recommend standard service/maintenance

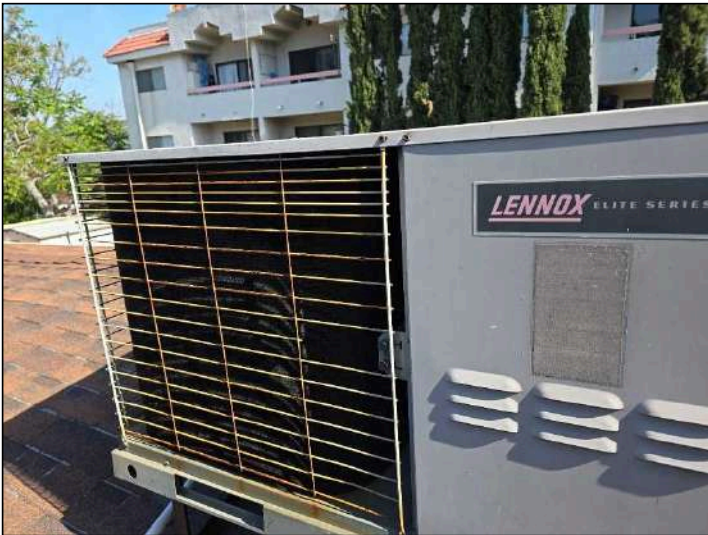
6. AC Compress Condition

Location: Roof, electric unit (dual pack)

- Operated at the time of inspection
- Visible areas are worn and weathered, recommend standard maintenance
- Unit appears to be an R-22 unit, these types of units are no longer in production. Parts may not be available if maintenance is needed. Recommend contacting an HVAC contractor to evaluate

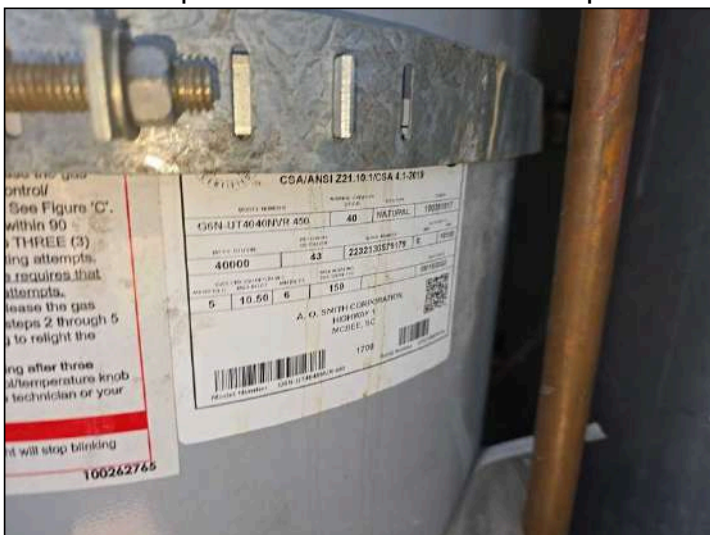
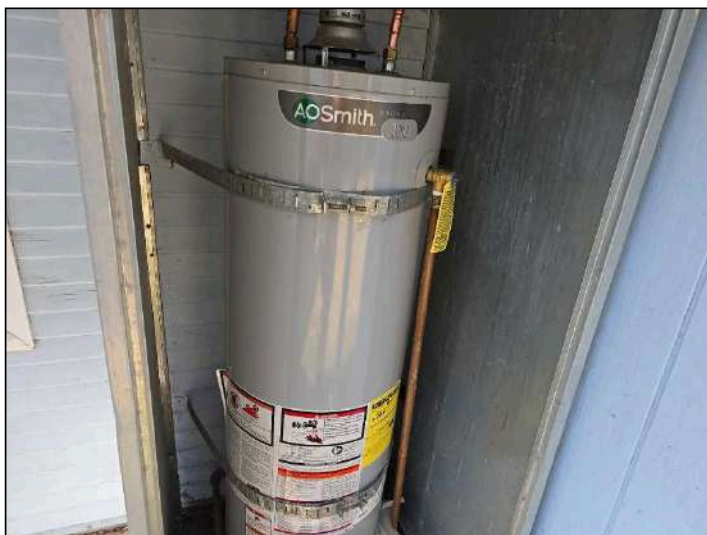
1. Water Heater Condition

- Water heater(s) at this structure appear to be newer/not original to structure, check for permits
- Gas unit operated at the time of the inspection

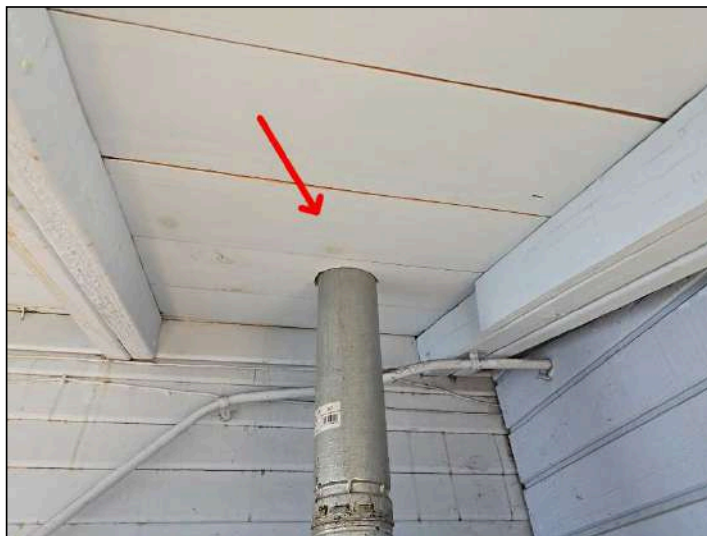
- Vent too close/touching combustibles, recommend repair

Vent too close/touching combustibles, recommend repair

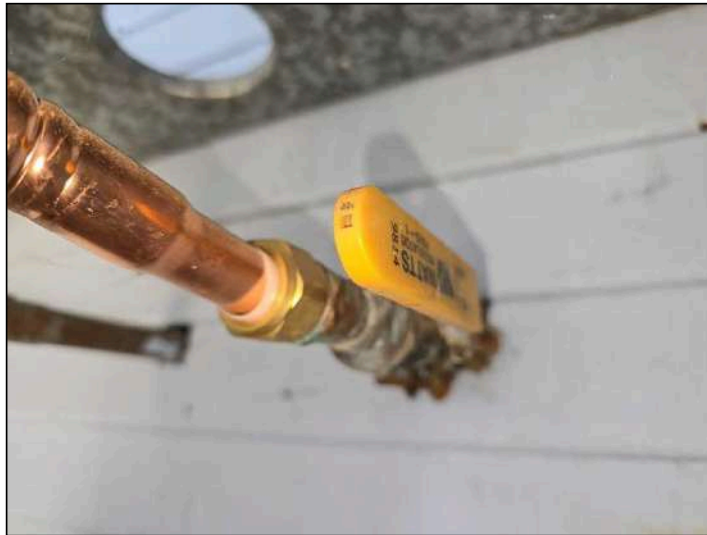
3. Plumbing

Materials: Copper • Copper flex lines

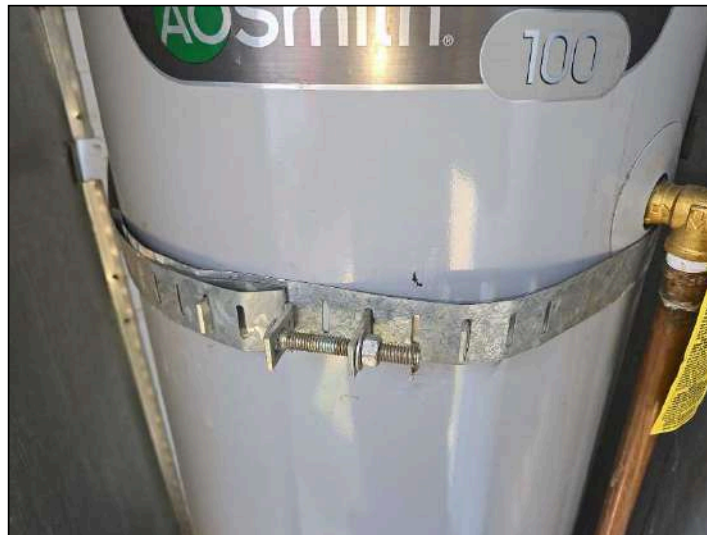
- Standard metal/steel type straps present

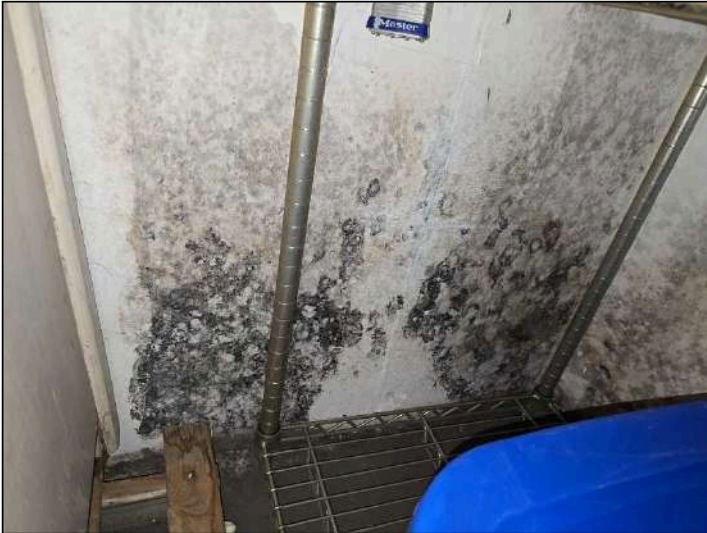
- Microbial growth/irregular staining present, recommend further evaluation

Microbial growth/irregular staining present,
recommend further evaluation

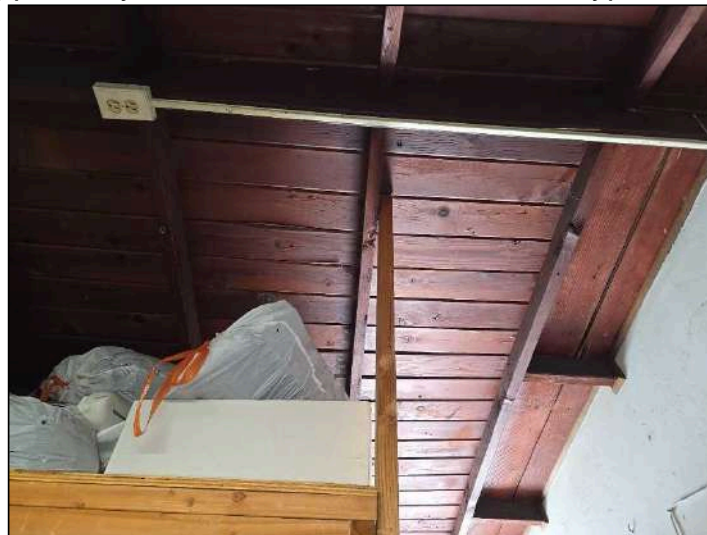
2. Rafters & Ceiling

- Small cracks/holes/chipped/dirty/cosmetic blemishes observed, typical for age

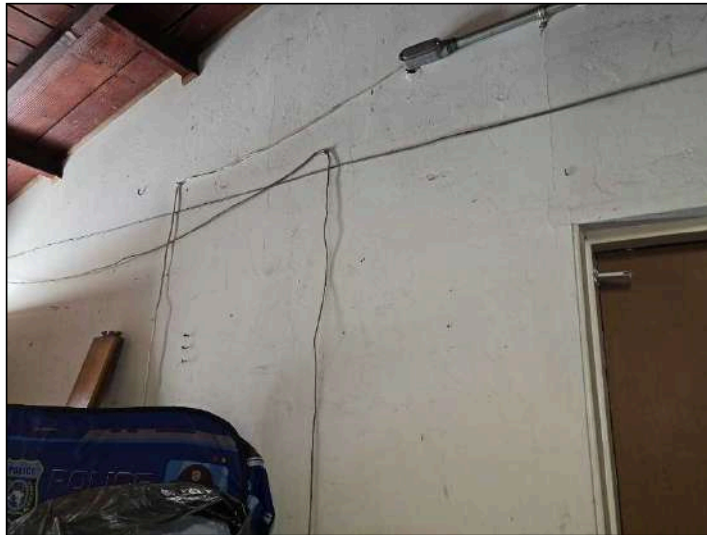
3. Firewall

- Small cracks/holes/chipped/patching/cosmetic blemishes observed, typical for age
- Recommend sealing any holes/gaps/cracks/loose tape, all areas of the firewall should be properly sealed with the correct fire-rated materials

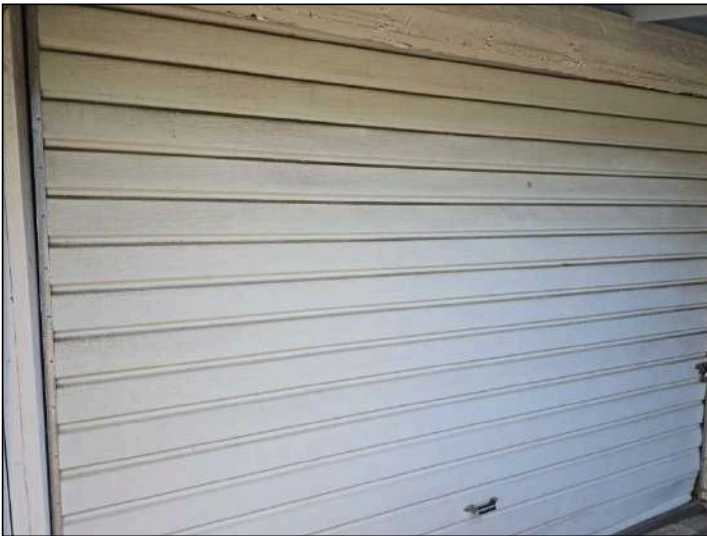
4. Automotive Doors

- Metal tilt-up
- Worn/weathered door, typical for age and weather exposure
- Did not close completely/properly, recommend repair

Did not close completely/properly, recommend repair

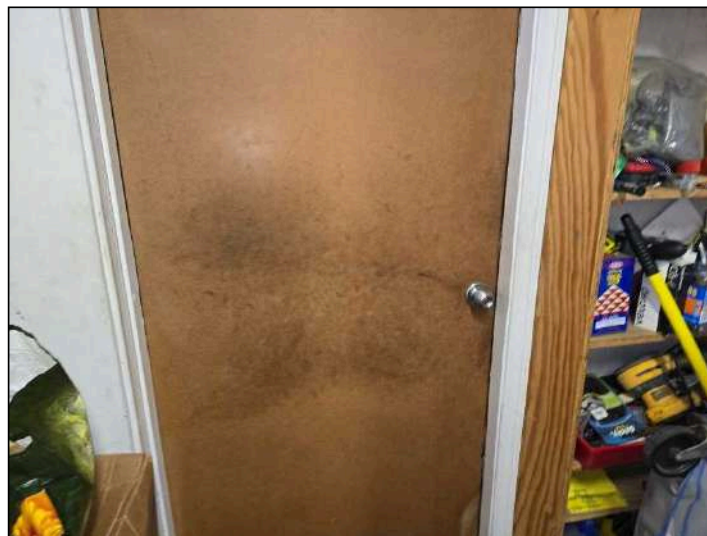
- Does not appear to be a fire rated door, recommend further evaluation

Does not appear to be a fire rated door, recommend further evaluation

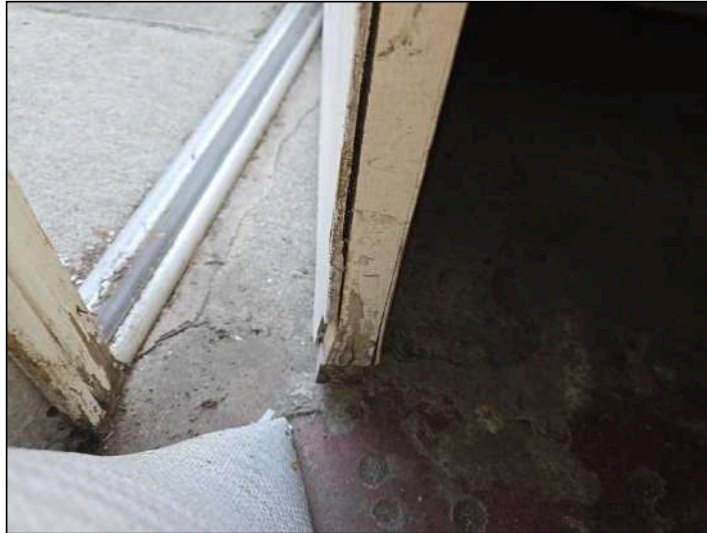
8. Exterior Door

- Moisture damaged door, recommend repair

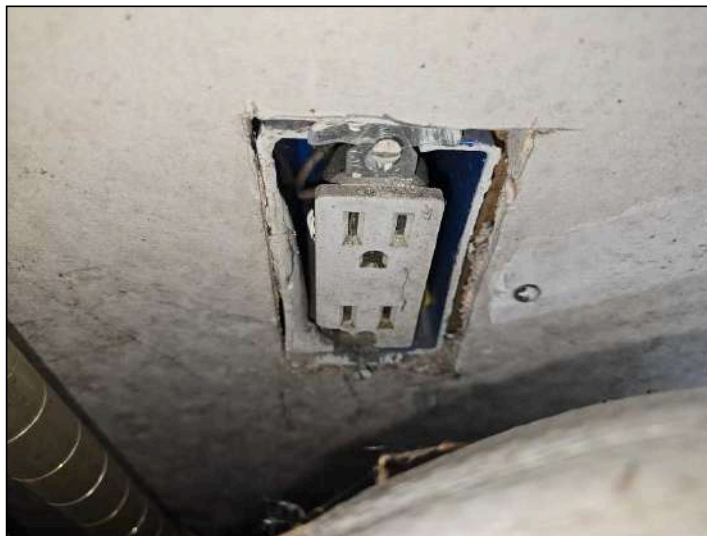
9. Electrical

- Broken outlet(s) Potential hazard, recommend repair

Broken outlet(s) Potential hazard, recommend repair

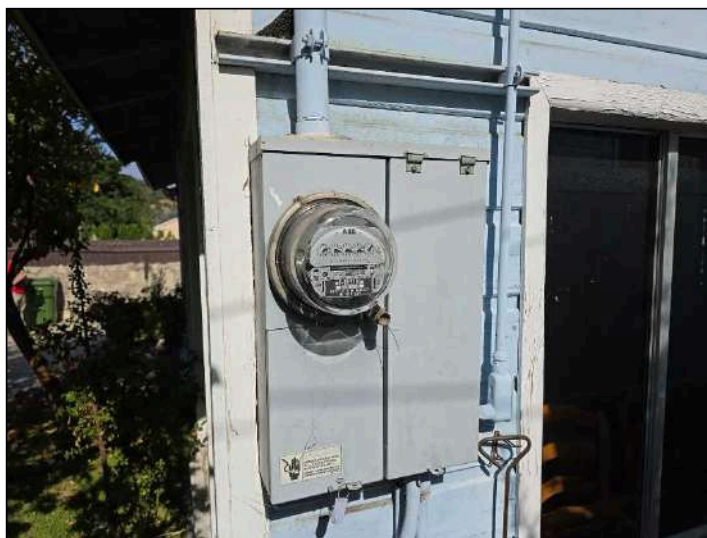
1. Electrical Panel

Location: East side of the house.

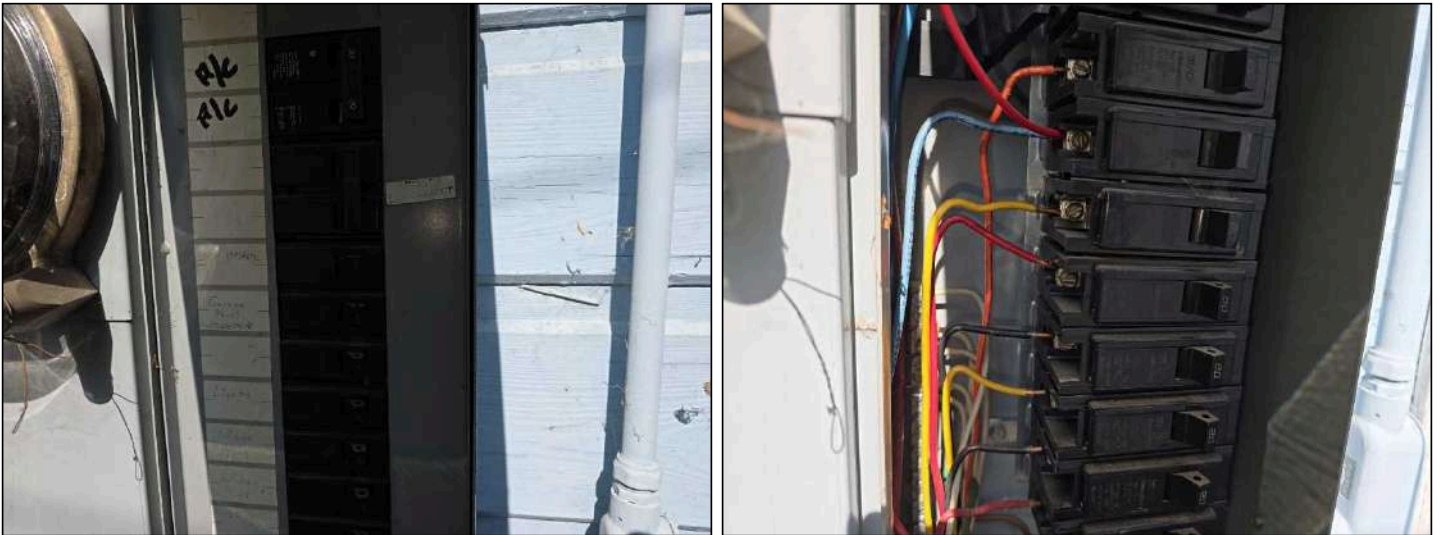
2. Breakers

Materials: Copper • Grounded panel, main ground/bonding wire observed and appears to be normal for the age of the panel • Ungrounded outlets may be present in older structures pre 1965 even if the main or sub panels have been upgraded. The inspector cannot determine if all wiring has been updated. Expect to find ungrounded outlets in older homes pre 1965 • Visible wiring has normal wear for age

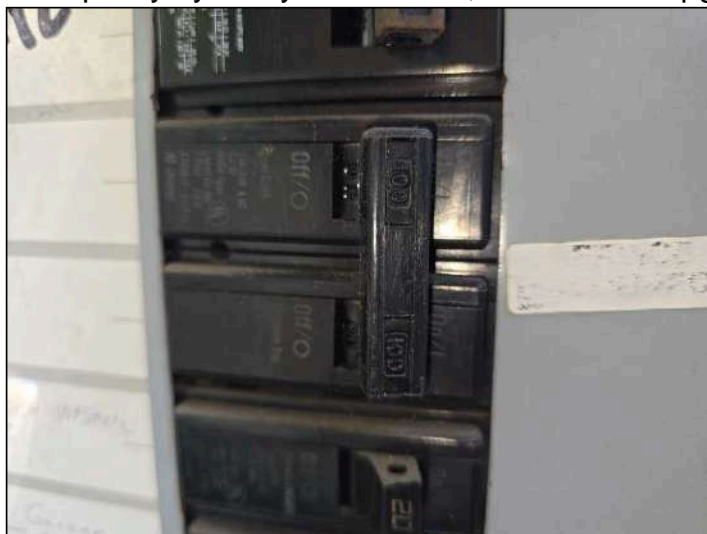
3. Main Amp Breaker

- 100 amp, Considered low capacity by today's standards, recommend upgrading service

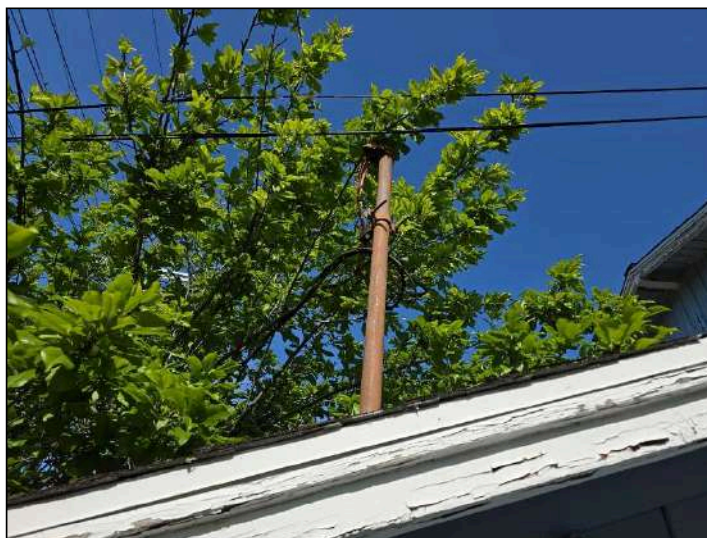
- **Trees/vegetation close/in contact with service entrance/wires, recommend repair**

Trees/vegetation close/in contact with service entrance/wires, recommend repair

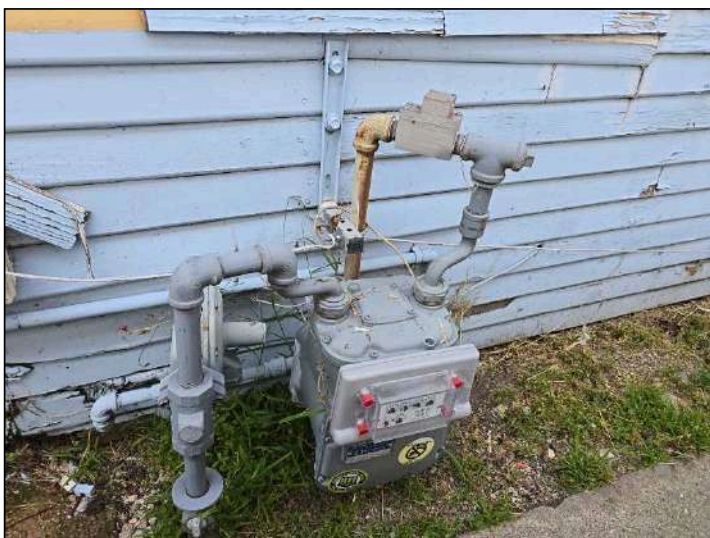
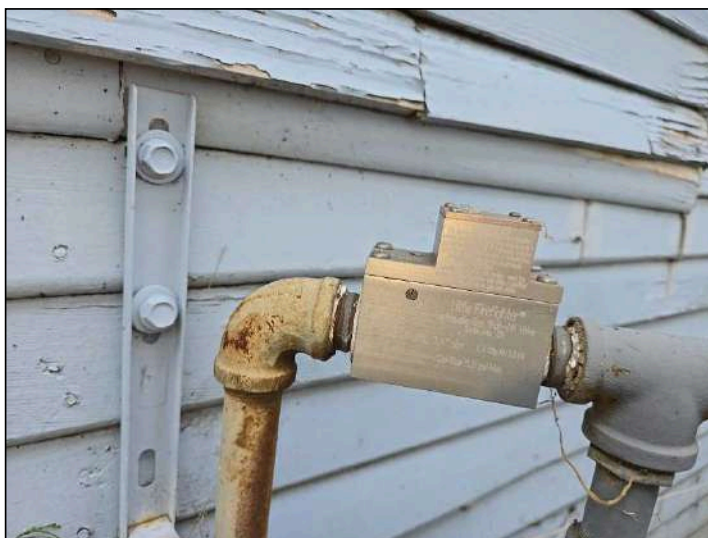
6. Main Gas Valve Condition

- Natural gas present
- Minor rusting, typical for exterior weathering, recommend rust treatment
- **There is a gas smell present at the main valve. We recommend contacting the gas utility company to repair.**

There is a gas smell present at the main valve. We recommend contacting the gas utility company to repair.

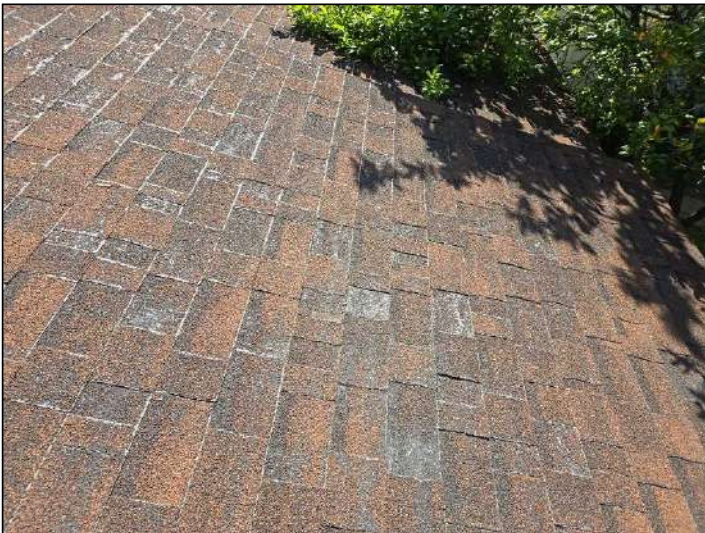
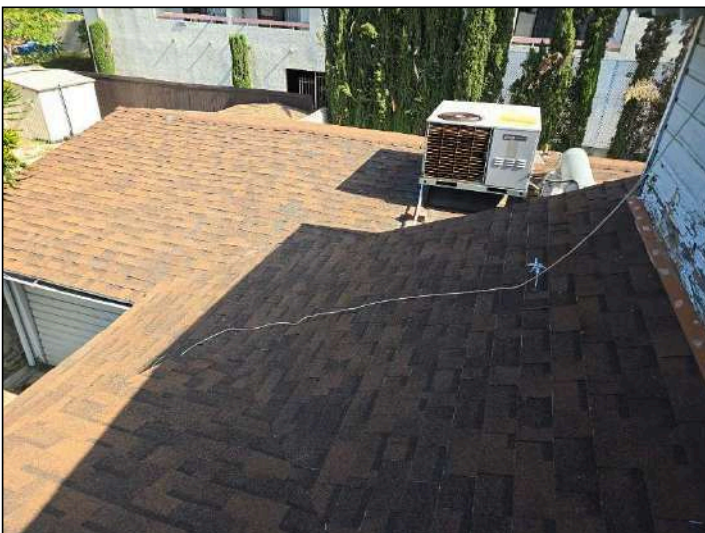
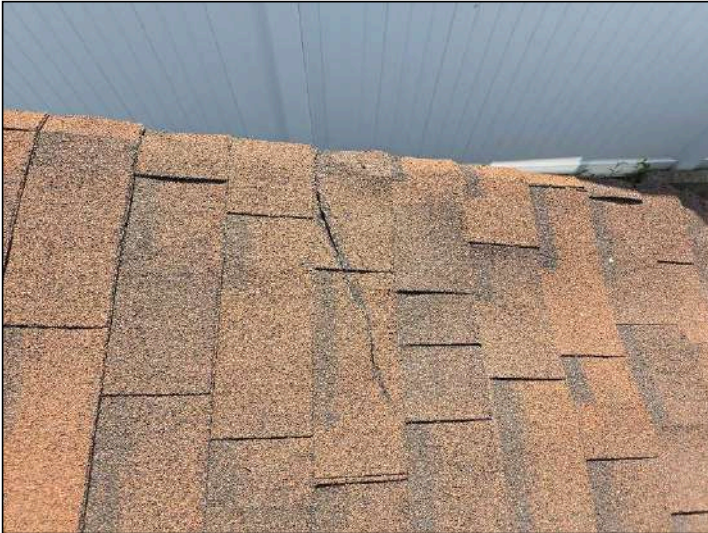
- Asphalt shingle
- Evidence of repairs/patching observed, cannot determine if installed properly, consult seller regarding known issues for all past repairs
- Shingles exhibited extensive/abnormal granule loss, recommend further evaluation by a (C-39) Roofing Contractor
- Missing/damaged shingles in areas, recommend repair
- Ponding/evidence of past ponding in areas, recommend a roofer to evaluate
- Exposed nails/staples, recommend sealing all fastener heads
- Trees overhang roof, recommend trimming away from structure
- Abnormal wavy areas present, recommend further evaluation
- Materials appear to be nearing end of useful life, recommend further evaluation
- Torn shingles in areas recommend repair
