7347 Valaho Dr. Tujunga, CA 91042

Reports & Pre-Market Inspections

Report Summary	3-5
Inspection Details	6
Interior Areas	7-11
Bedrooms	12-17
Bathroom	18-22
Kitchen	23-27
Laundry	28-30
Heat/AC	31-34
Water Heater	35-37
Garage	38-41
Electrical	42-45
Roof	46-50
Attic	51-52
Exterior Areas	53-57
Foundation	58
Grounds	59-63
Glossary	64

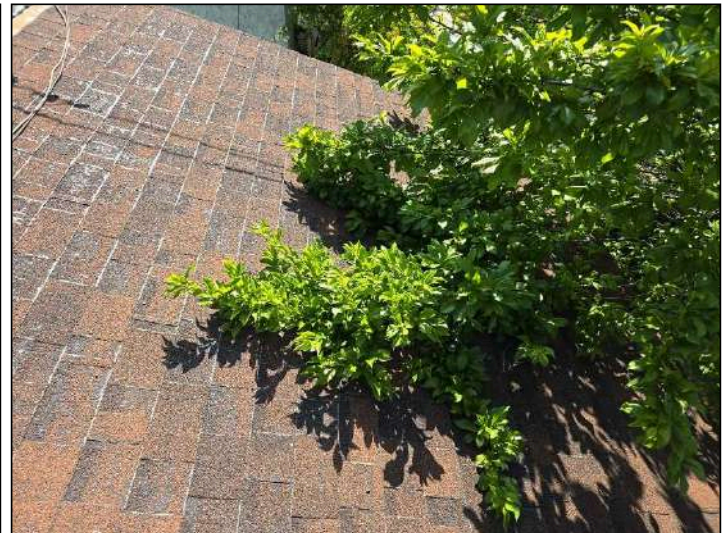
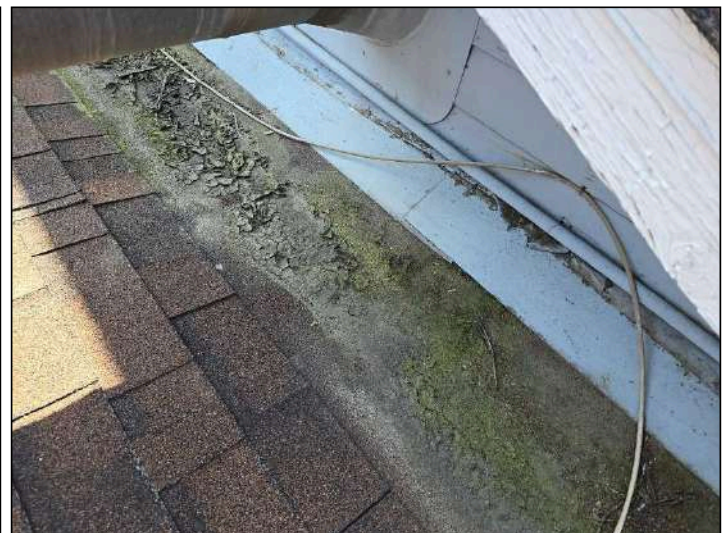
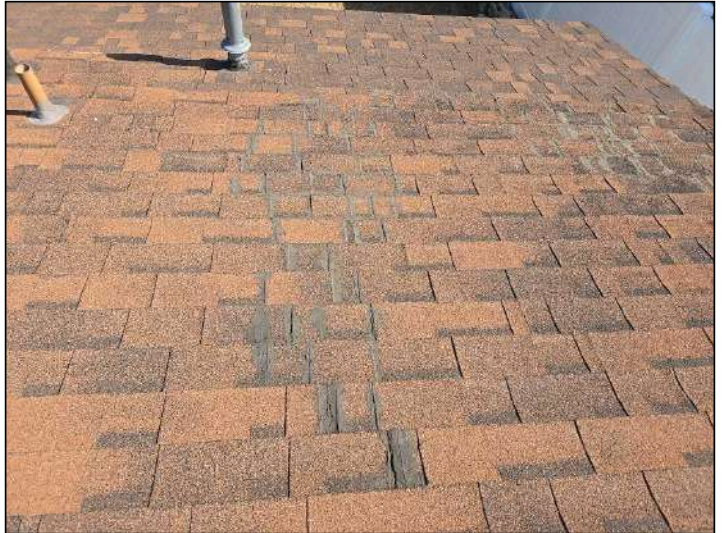
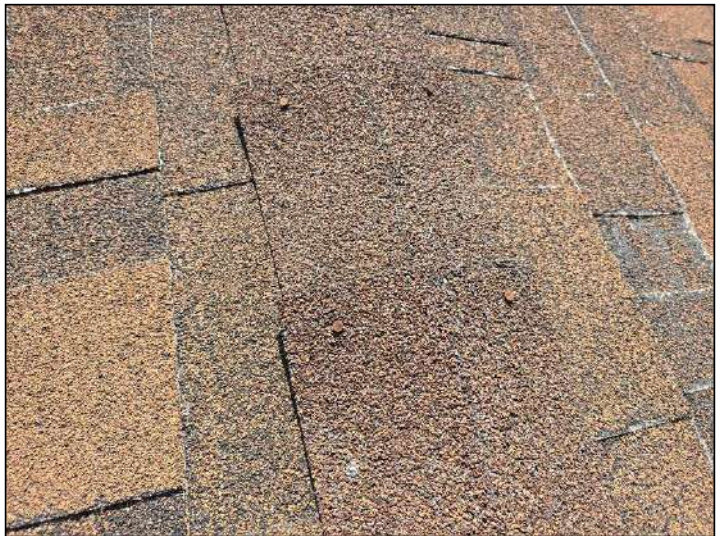
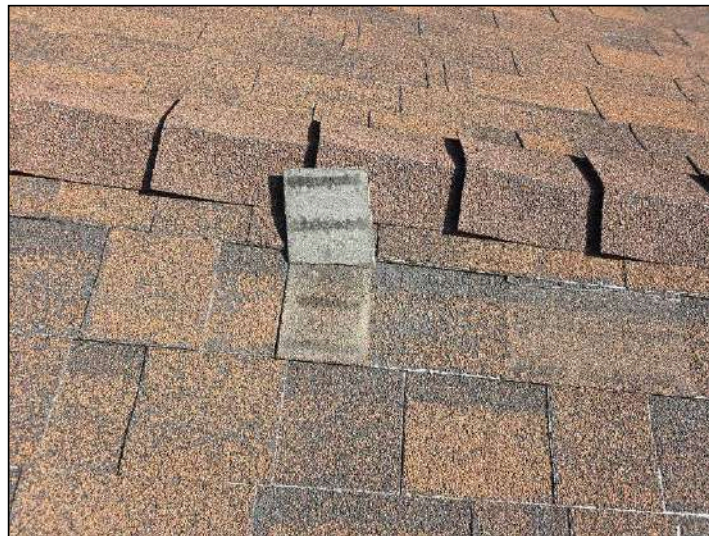
- Asphalt shingle
- Evidence of repairs/patching observed, cannot determine if installed properly, consult seller regarding known issues for all past repairs
- Shingles exhibited extensive/abnormal granule loss, recommend further evaluation by a (C-39) Roofing Contractor
- Missing/damaged shingles in areas, recommend repair
- Ponding/evidence of past ponding in areas, recommend a roofer to evaluate
- Exposed nails/staples, recommend sealing all fastener heads
- Trees overhang roof, recommend trimming away from structure
- Abnormal wavy areas present, recommend further evaluation
- Materials appear to be nearing end of useful life, recommend further evaluation
- Torn shingles in areas recommend repair

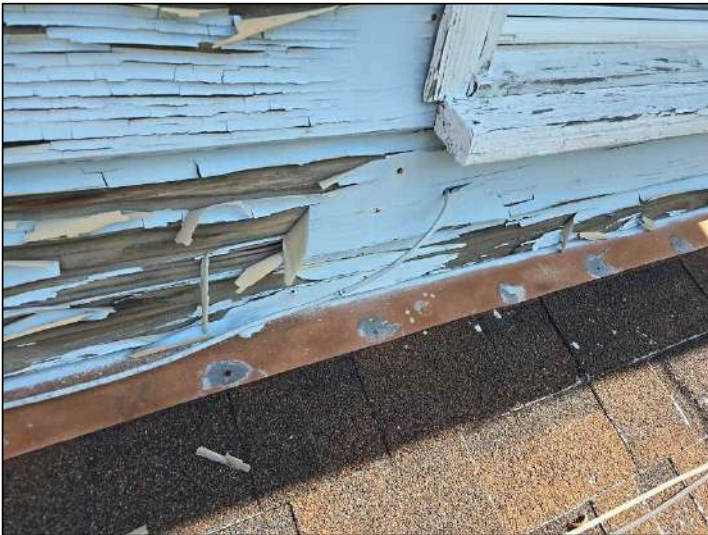
2. Flashing

- Worn/weathered/rusted/bent, typical for age, recommend seasonal maintenance
- **Missing sidewall flashing, recommend repair**
- **Mising at pipe/vent penetration(s), recommend repair**

Missing sidewall flashing, recommend repair

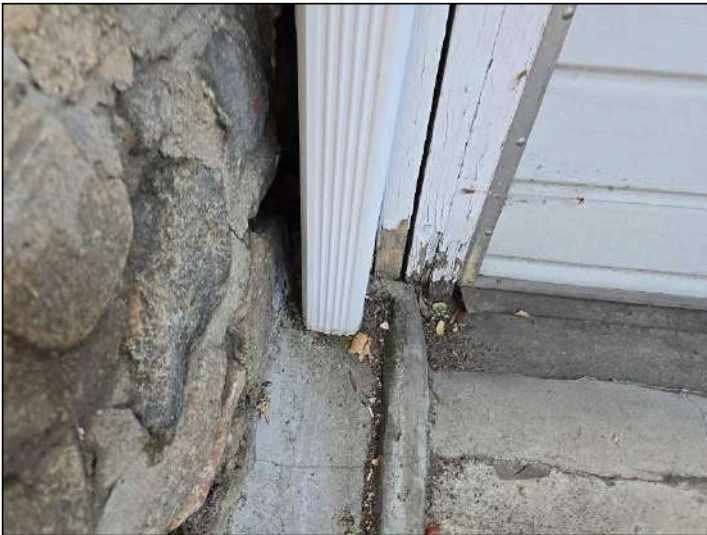
3. Gutter

- Extensions/splashblocks needed at downspout terminations to direct water away from foundation
- **Clogged/restricted by debris in areas, recommend cleaning and maintenance**

Extensions/splashblocks needed at downspout terminations to direct water away from foundation

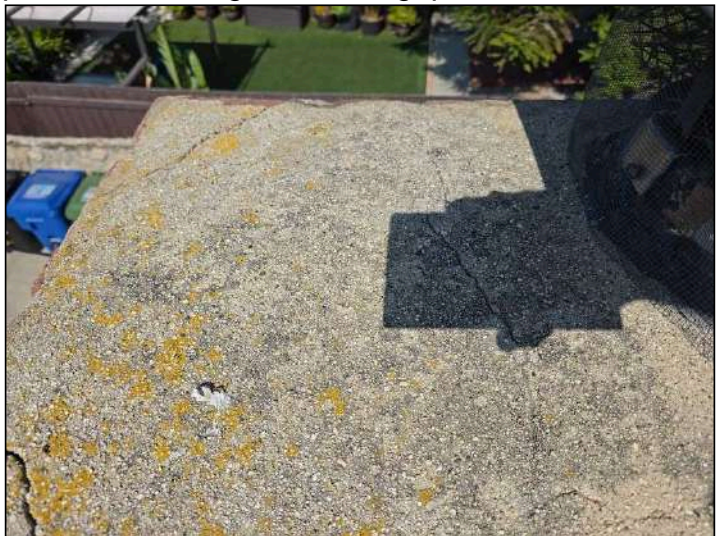
4. Chimney

- Worn/weathered chimney, recommend seasonal maintenance
- Flashing/mastic at base of chimney worn/loose/cracked, recommend maintenance
- Cracks in bricks, aesthetic but monitor
- Chimney cap is cracked in areas, recommend repairs and sealing all cracks/gaps

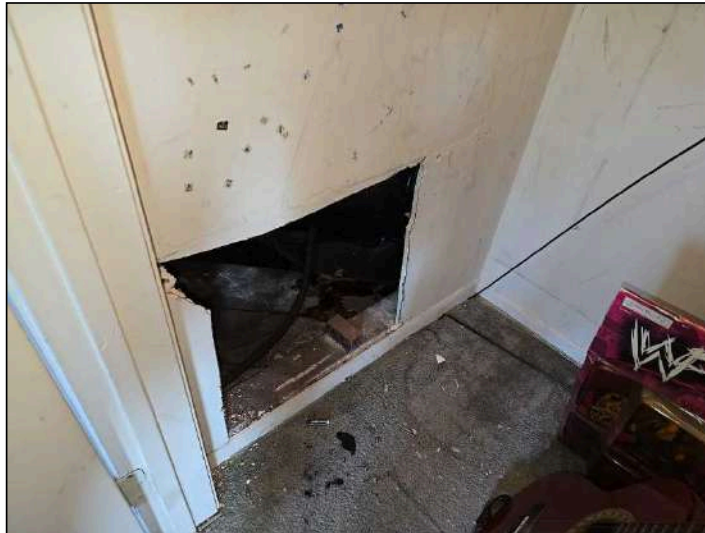
- Bedroom
- Attic was partially visible/inspected, some areas not visible or accessible due to limitations

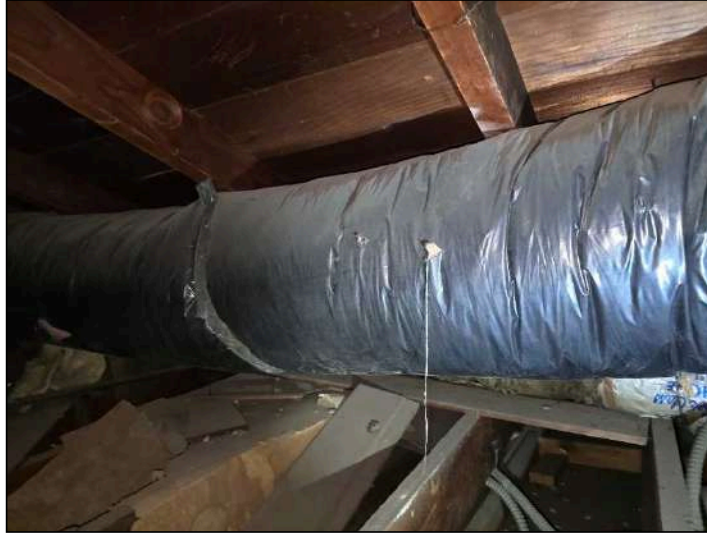
- **DISCLAIMER PRE 1978** - Structures built prior to 1978 may contain asbestos in air ducts. This is beyond the scope of the home inspection to evaluate and is recommended that you contact an asbestos specialist at your discretion for a full evaluation of the air ducting system if the home was built prior to 1978
- Ductwork has been added/remodeled/altered, recommend a (c-20) HVAC Contractor to verify proper installation/consult local authority/check for permits
- Older/worn ducts present, recommend routine maintenance and cleaning of air ducts
- **Holes in ducts, recommend repair**

Holes in ducts, recommend repair

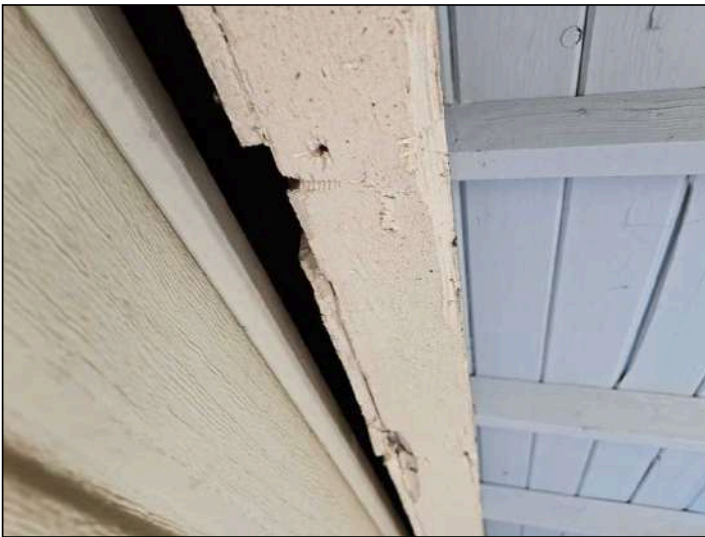
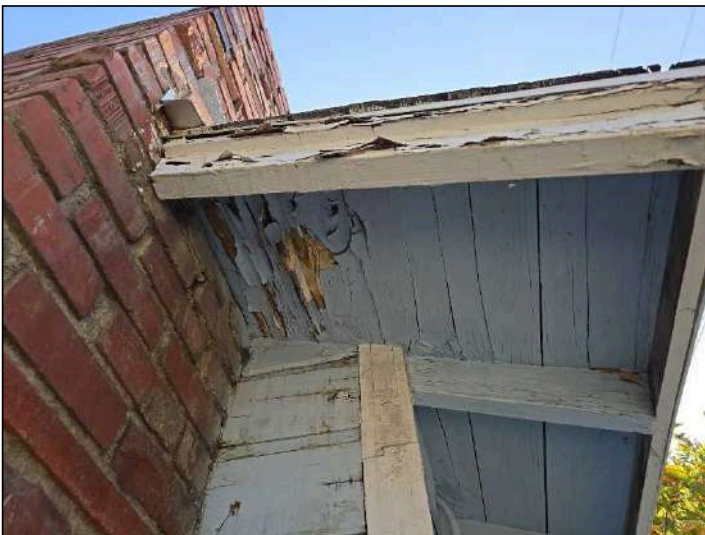
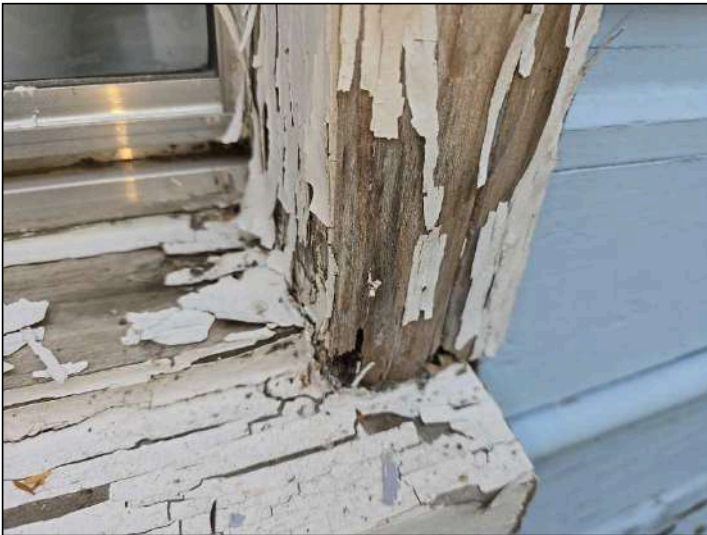
1. Siding Condition/Trim

- Worn/weathered/cracked materials, recommend siding maintenance
- Gaps present in some areas, recommend maintenance to seal all holes/gaps/cracking
- **Deteriorated wood trim, consult termite report**
- **Damaged in areas recommend repair**

Deteriorated wood trim, consult termite report

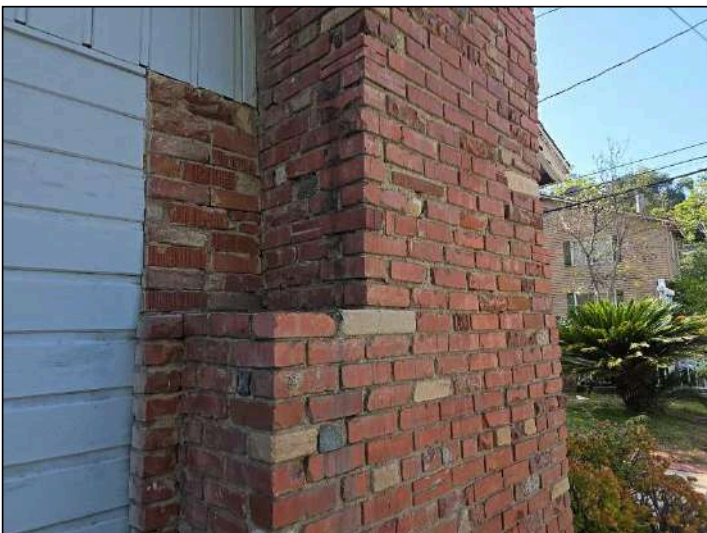
2. Chimney Overall

- Worn/weathered chimney, typical for age and material
- Small cracking or chipping observed, typical for age, recommend maintenance
- **Bricks missing replaced with stones recommend correcting**

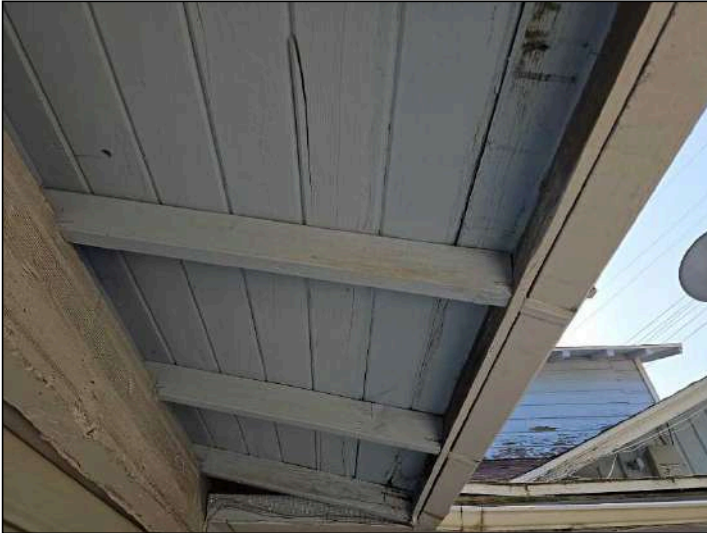
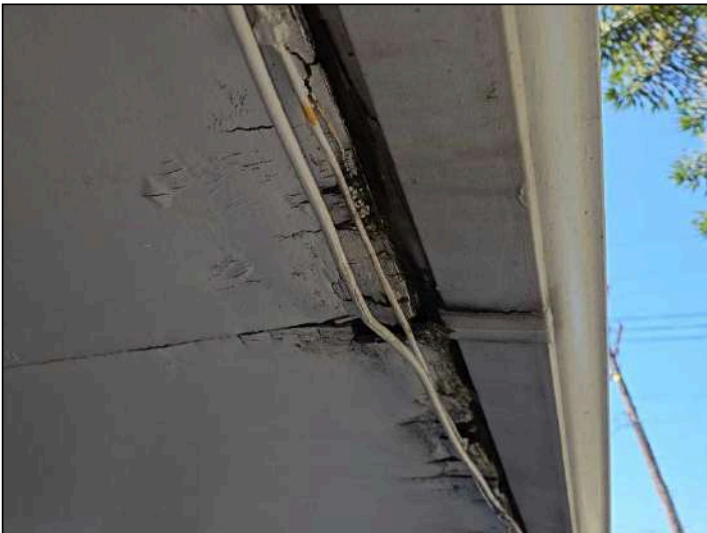
3. Eaves & Fascia

- Weathering and staining present in areas, typical for age and material
- **Deteriorated wood observed, recommend repair, consult termite report**

Deteriorated wood observed, recommend repair, consult termite report

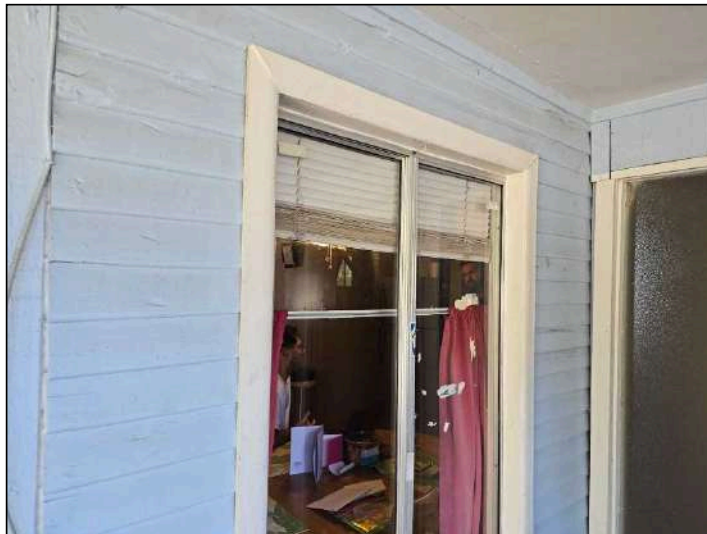
5. Window Condition

- See interior section for additional information, some exterior window areas may not be visible due to height/limited access/vegetation/etc.

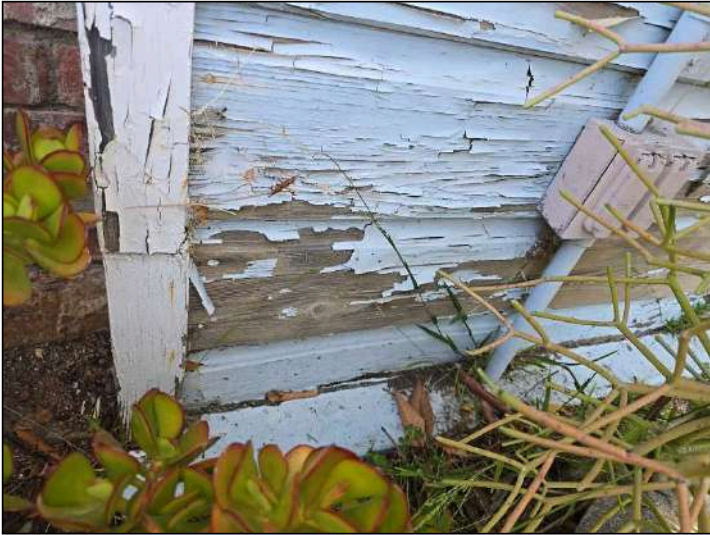
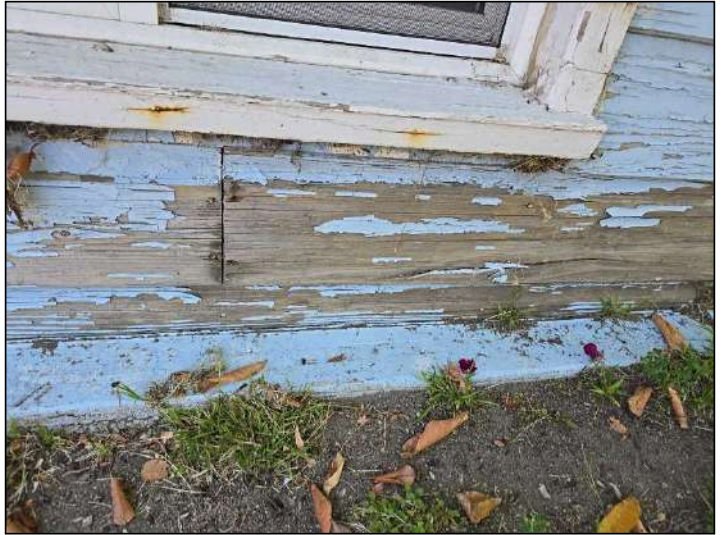
- Blistered and peeling in areas, recommend repair
- Exposed wood surfaces, wood rot and deterioration can occur, recommend repair

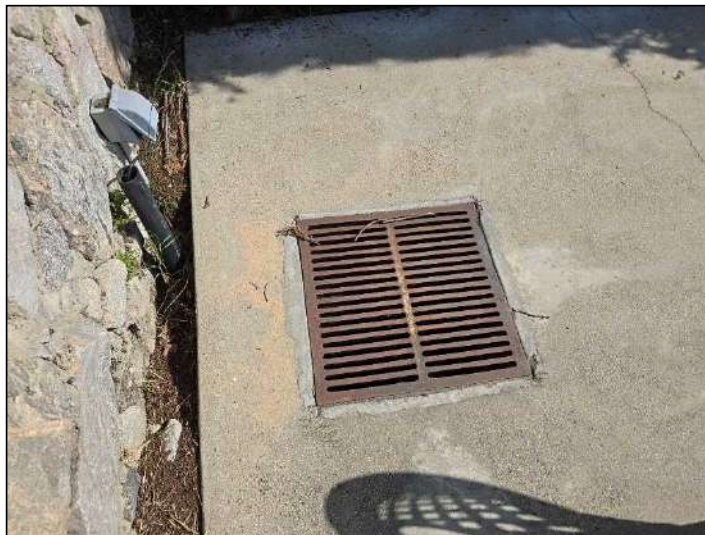
- Present, not tested, inquire with seller regarding operation, drain termination location, and function capability
- **Does not appear to be functioning properly recommend repair**

Does not appear to be functioning properly recommend repair

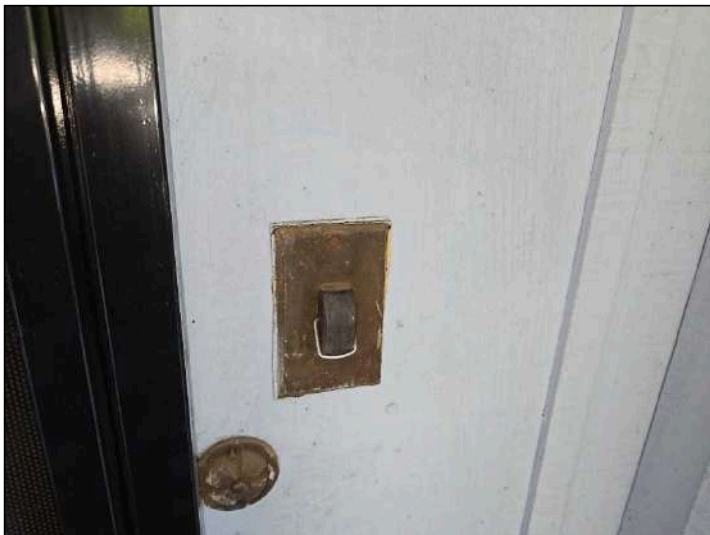
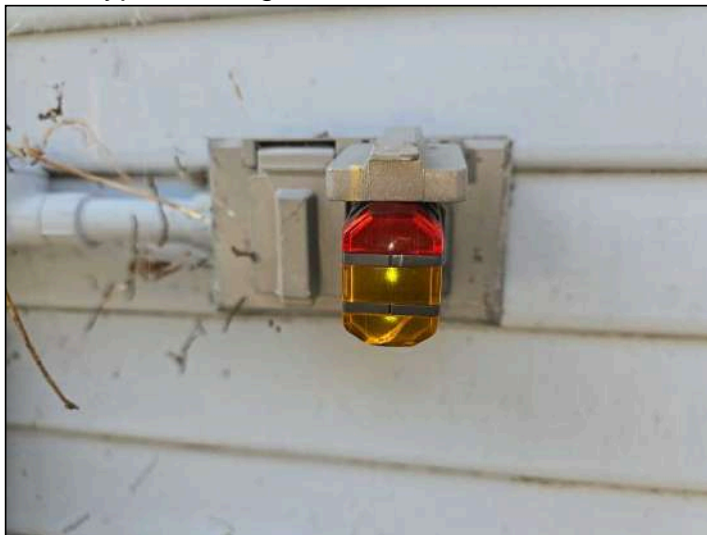
- Fixtures/switches/outlets were in loose/worn condition, typical for age

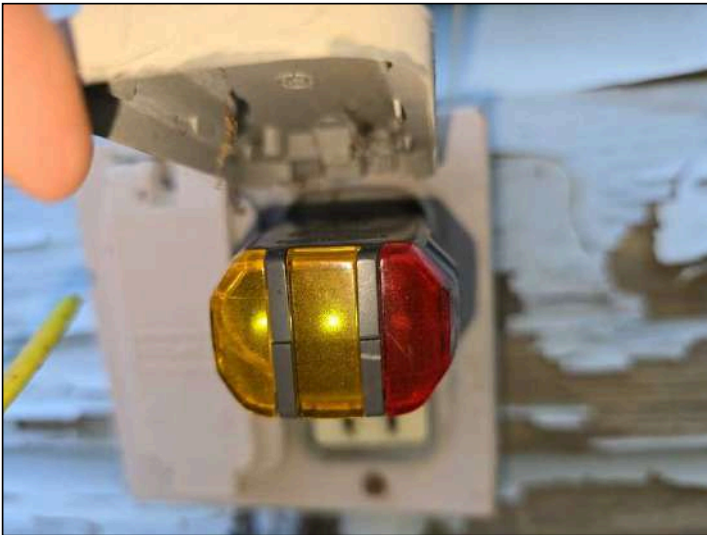
3. GFCI

- Weather proof cover improper east side recommend repair

Weather proof cover improper east side
recommend repair

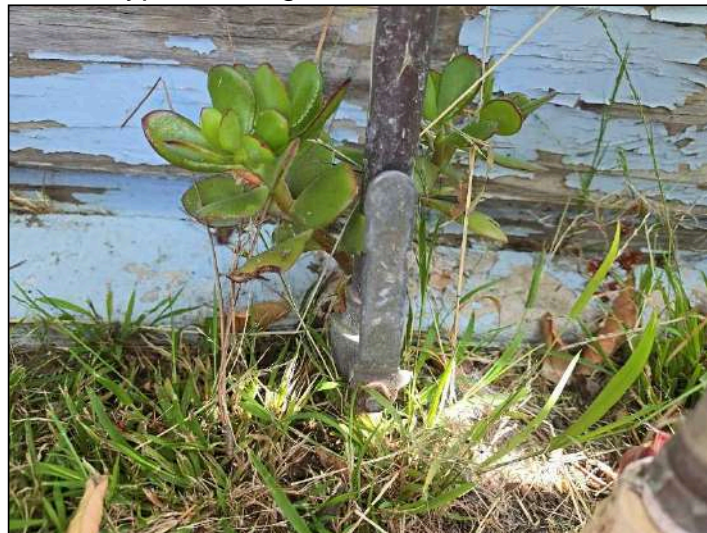
- Main ball valve is worn/rusted, typical for age

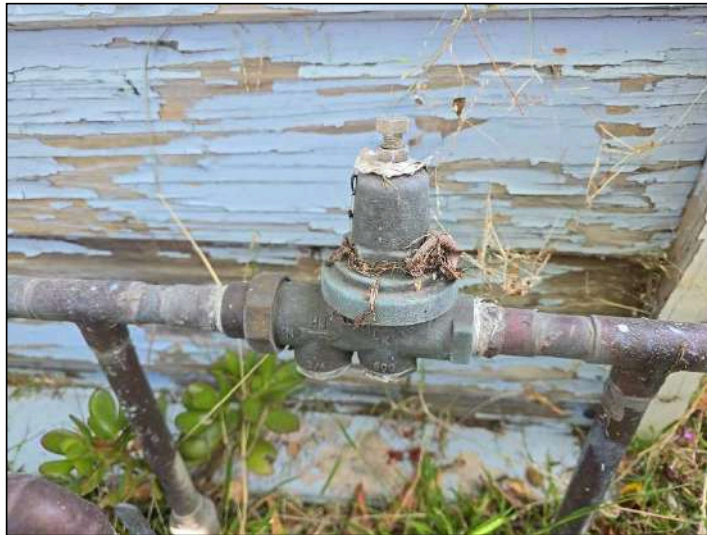
- Regulator appears to have normal wear on the day of the inspection

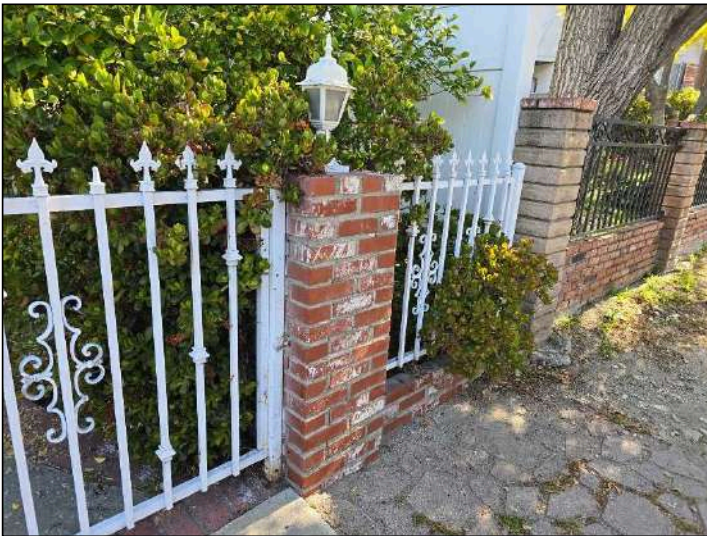
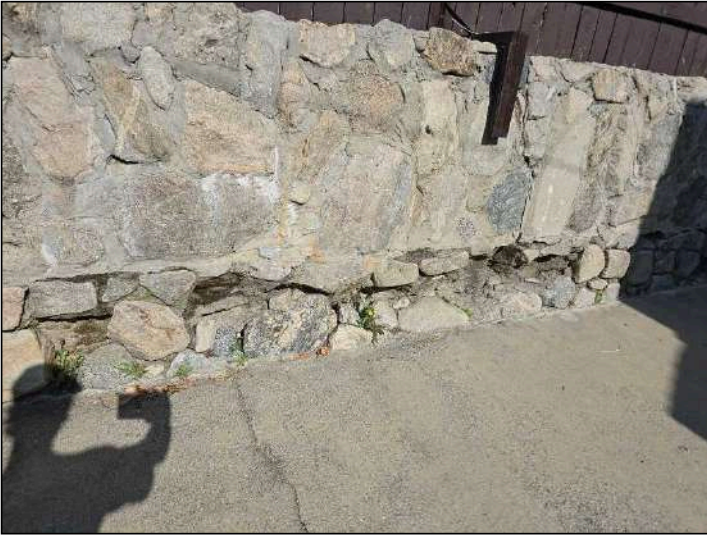
7. Fence Condition

- Rust/rust damage at metal fence materials, recommend repair
- **Damaged areas recommend further evaluation**

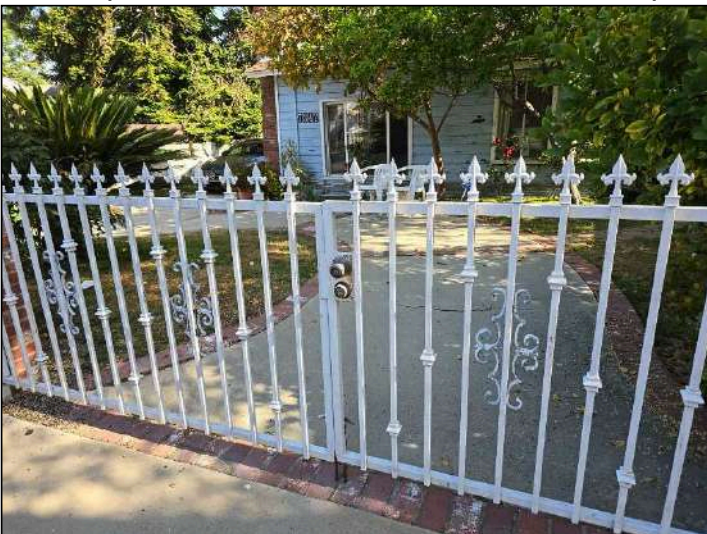
8. Gate Condition

- Rust present, recommend rust treatment to prolong the life of materials

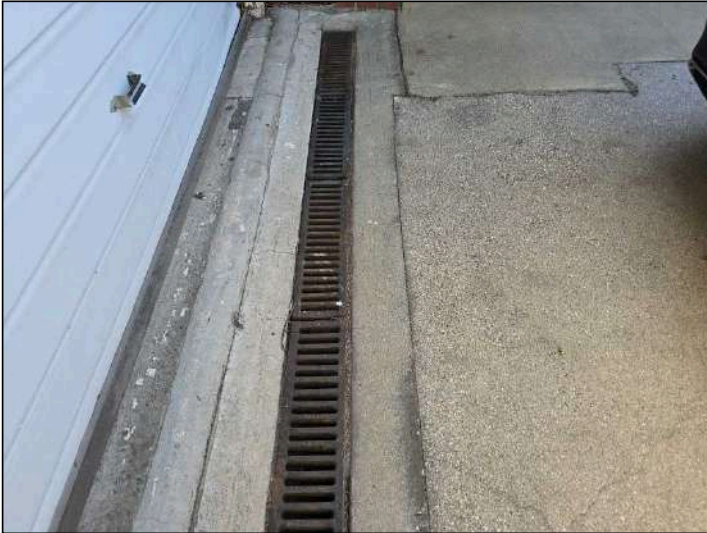
9. Grading

- Area drains present, not tested, recommend periodic maintenance
- Stains present, evidence of ponding water east & North side, recommend further evaluation

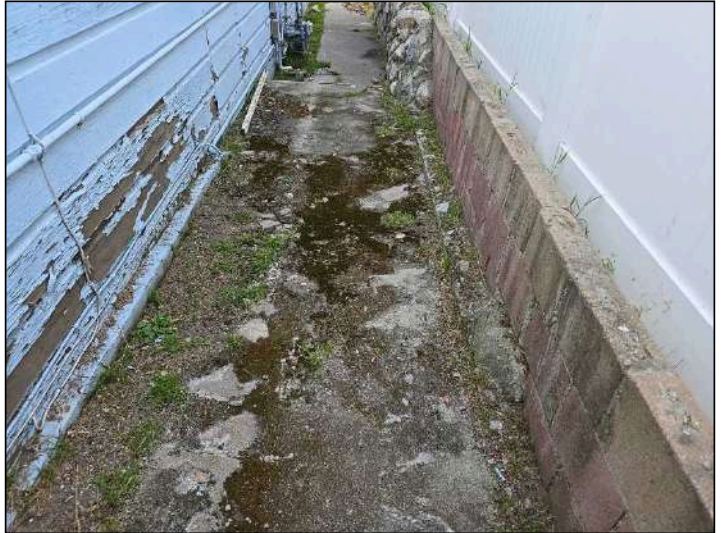
Stains present, evidence of ponding water east side, recommend further evaluation

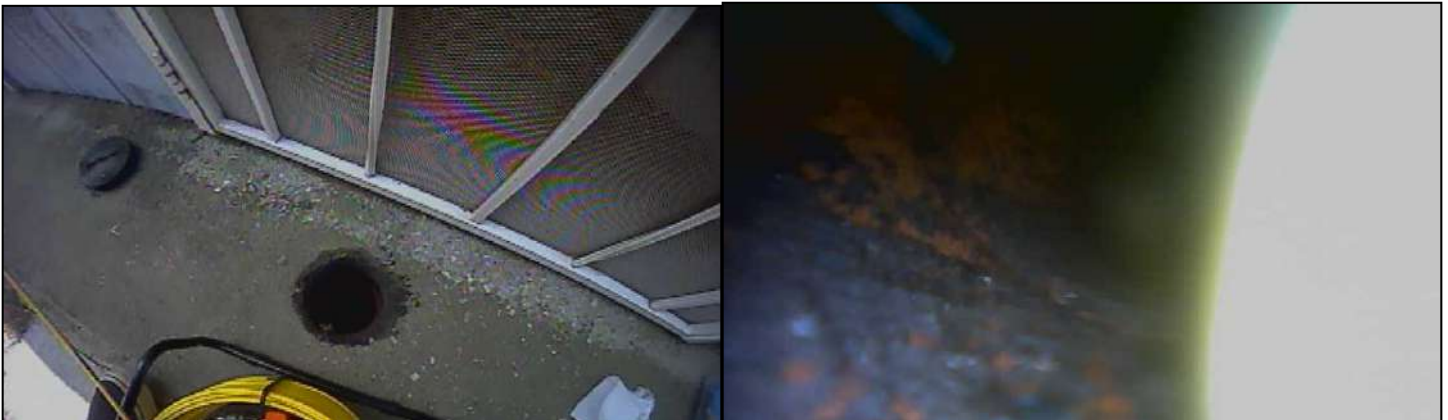
- Sewer line was found to be in a damaged condition and we recommend further evaluation and repairs by a licensed plumber
- Root intrusion found in sewer line at approximate distance of: 10 - 15 feet. (Final distance reached in sewer line)

- The sewer camera was unable to reach the main city connection due to issues within the sewer line(Root Clog), further evaluation is recommended by a licensed plumber

Cleanout entered.

Condition of sewer line at 2.5 feet.

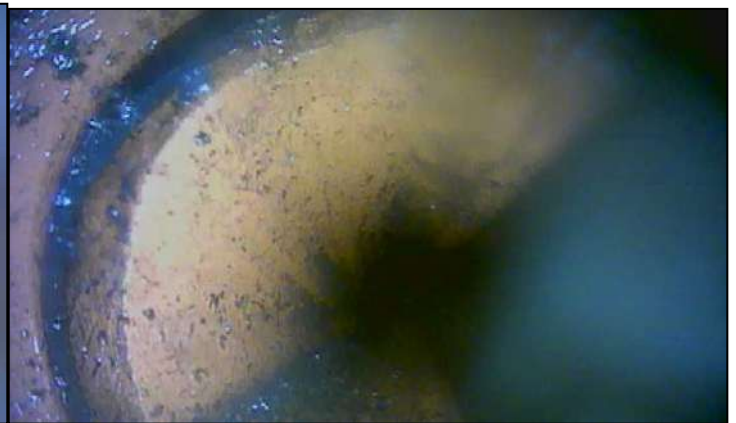
Standing water present in sewer line at 5 feet.
(Camera is submerged)

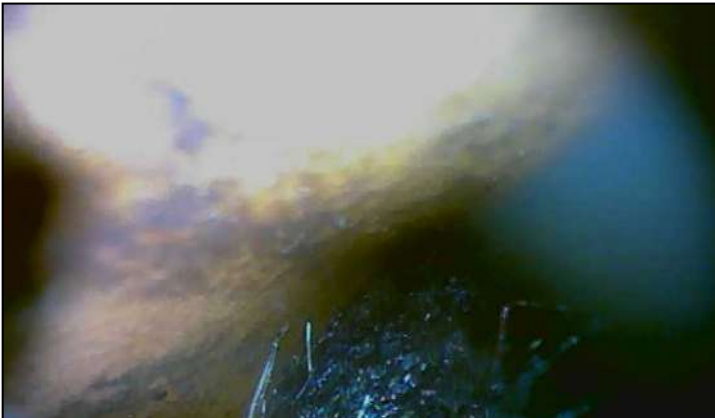
Standing water present in sewer line at 7.5 feet.

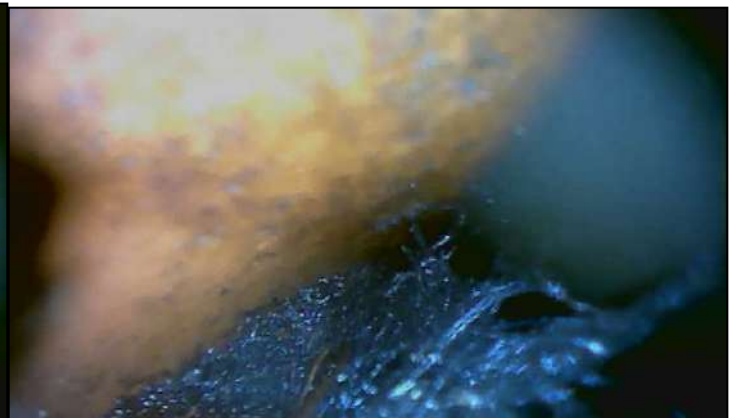
Root intrusion present in sewer line at 10 feet.
