SUMMIT INSPECTIONS

Property Location: 6501 MATILIJA AVENUE
VALLEY GLEN, CA

Structure Type: Single Family Home

Inspection Date: March 14, 2024

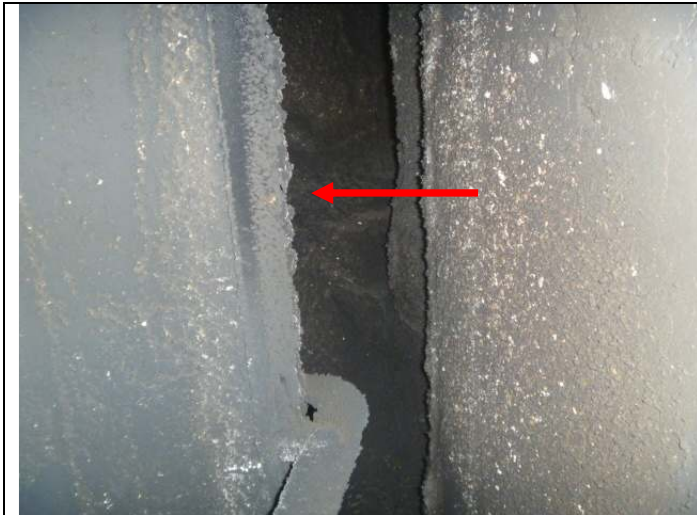
Fireplace damper in the open position.

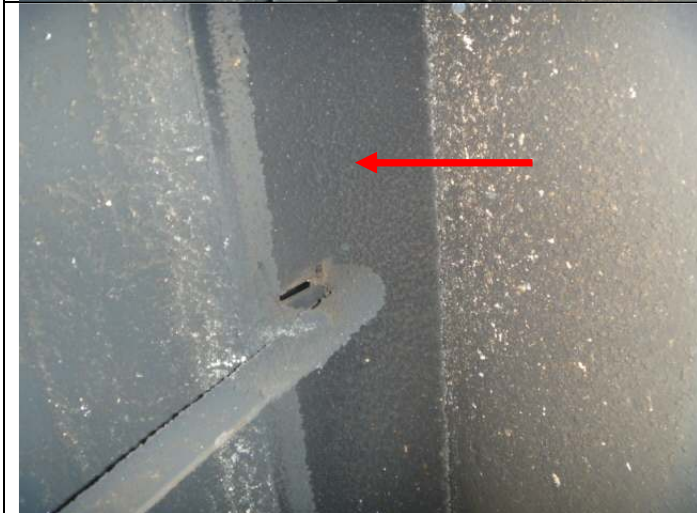
Fireplace damper in the closed position.

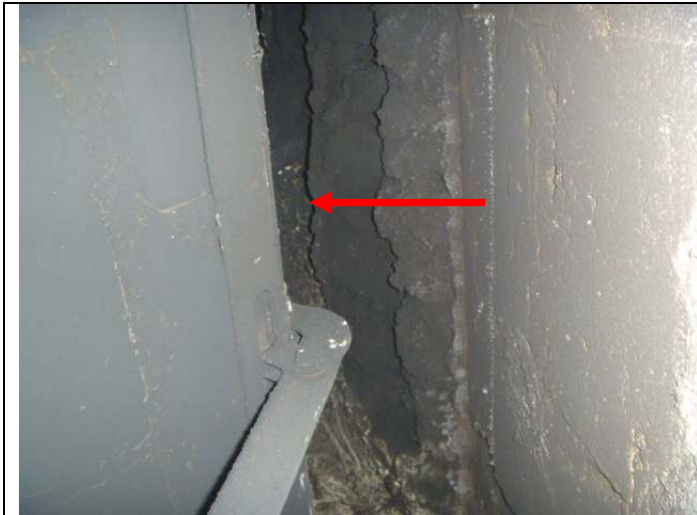
Fireplace damper in the open position.

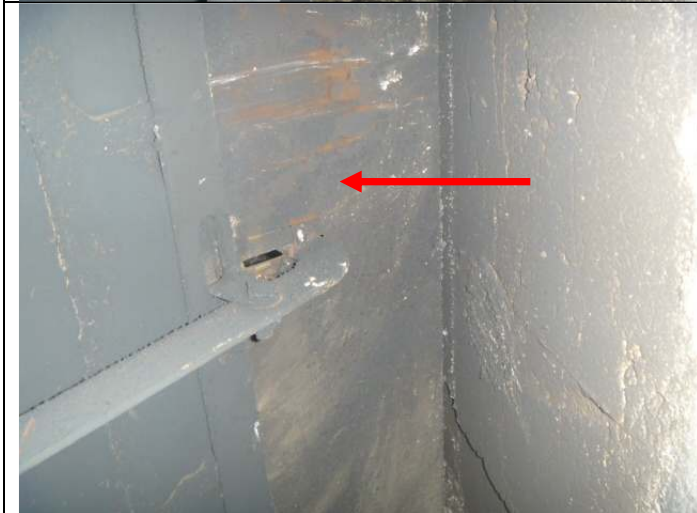
Fireplace damper in the closed position.

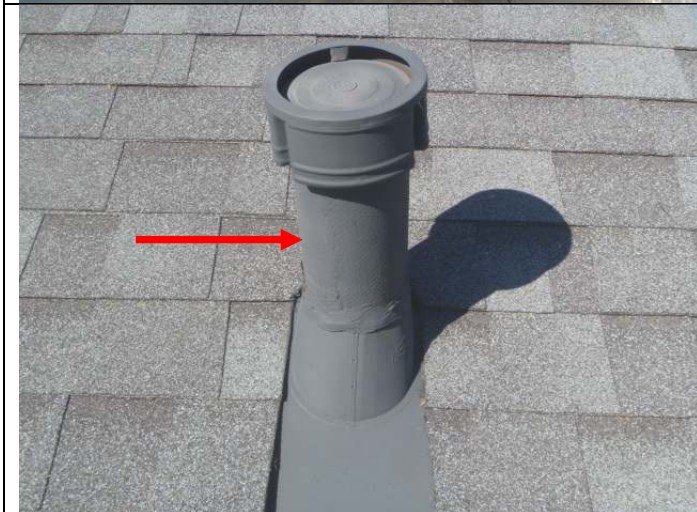
Transite vent pipe (for the original water heater and not in use).

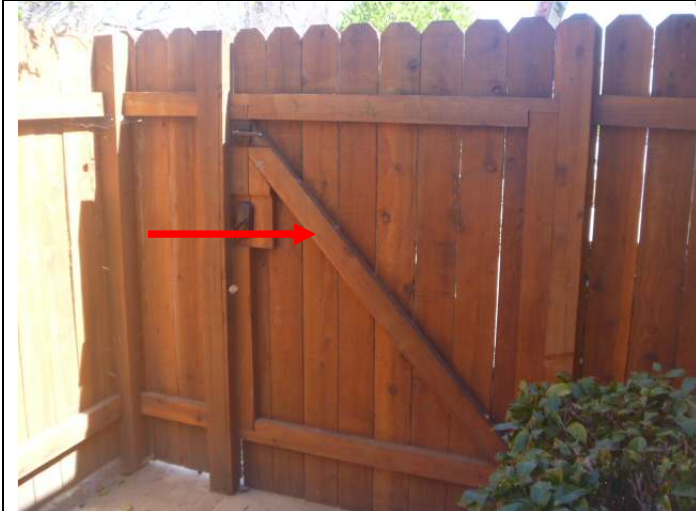
North side gate with pool area access. Note: The gate is not properly self-closing.

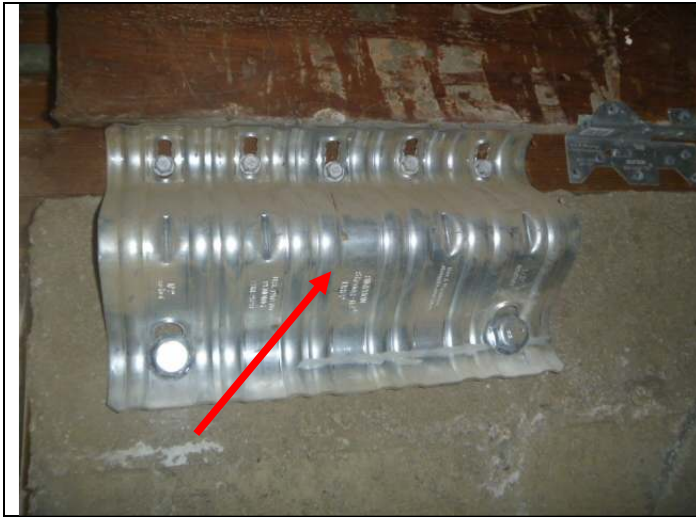
Retrofit foundation anchor plate.

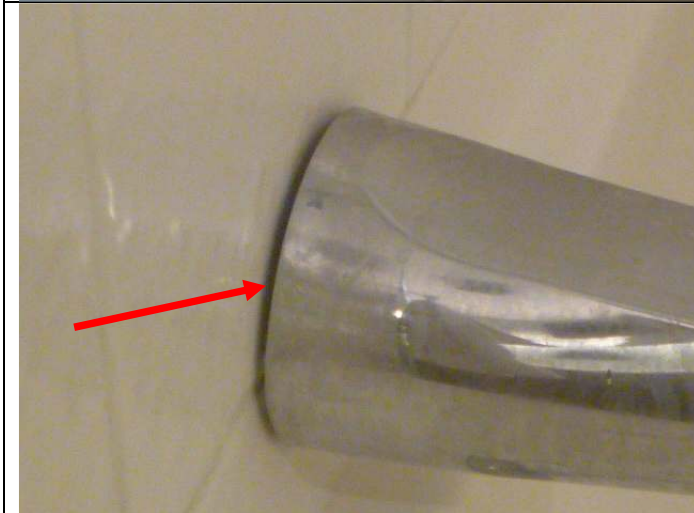
- A SINKS:** Functional.
- B/ C FIXTURES:** North: The shower/tub fixture (pull type) is somewhat stiff. The tub spout is loose and there is a gap at the wall. The tub stopper is inoperative. South: The sink hot water faucet is somewhat stiff (minor). Note: The shower head is a handheld type.

Gap at the north bathroom tub spout.

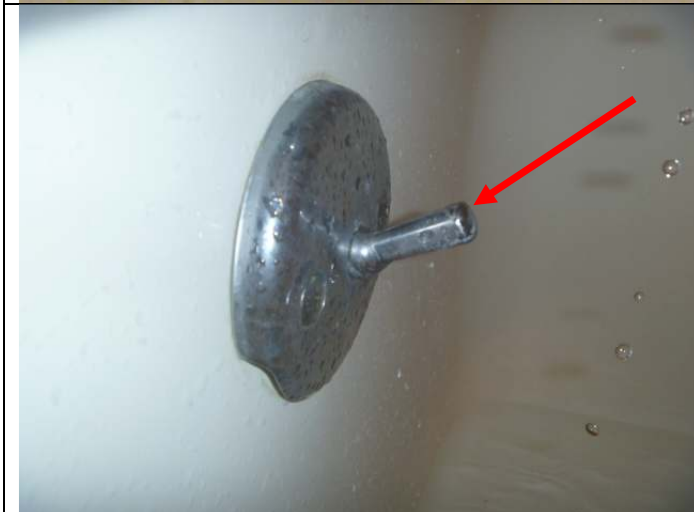
North bathroom tub stopper control. Note: The stopper is inoperative.

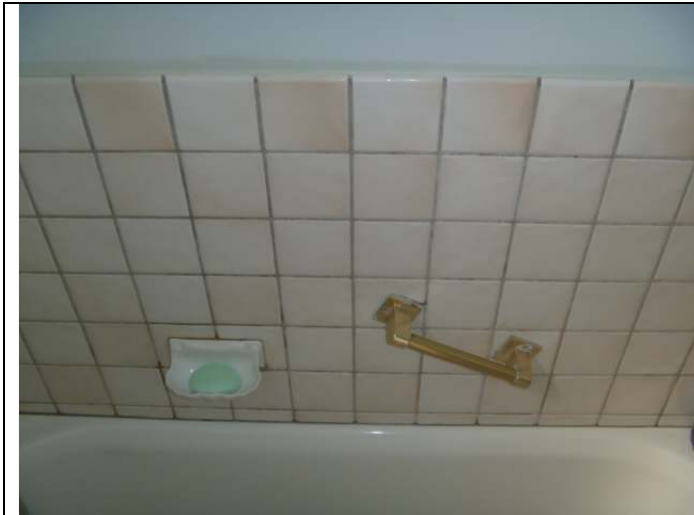
South bathroom tub tiles. Note: The tiles backing type was not determined.

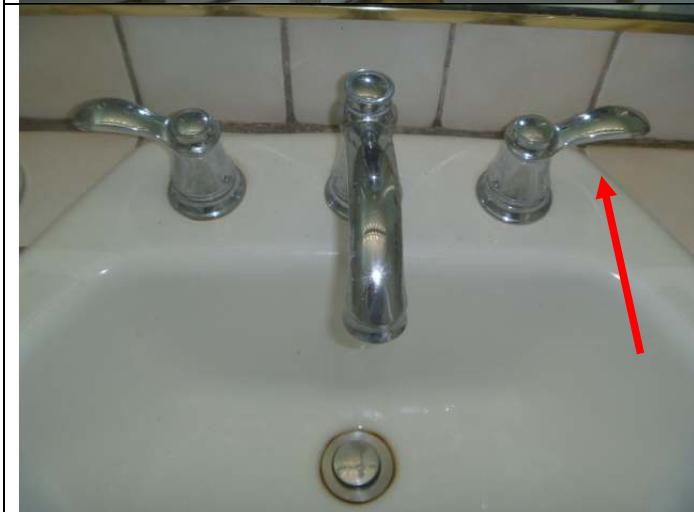
South bathroom sink. Note: The cold water faucet is somewhat stiff (minor).

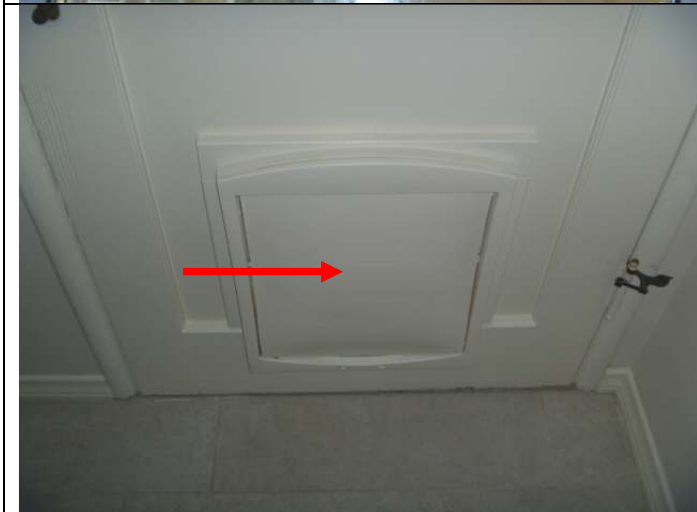
Pet door in the service porch exterior door.

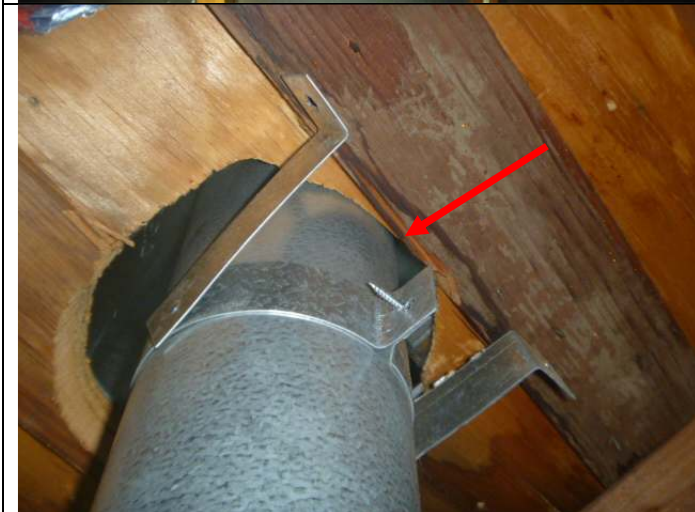
- A FRAMING:** The framing appeared to be structurally intact.
- A ROOF INTERIOR:** No indication of active roof leakage is visible. See EXTERIOR section regarding the roof.
- A VENTILATION:** Note: There is a ventilation fan at the north gable vent.
- B DUCTS AND VENT PIPES:** The central heater vent pipe does not have the proper (1" minimum) clearance at the roof sheathing.

Central heater vent pipe without the proper (1" minimum) clearance at the roof sheathing.

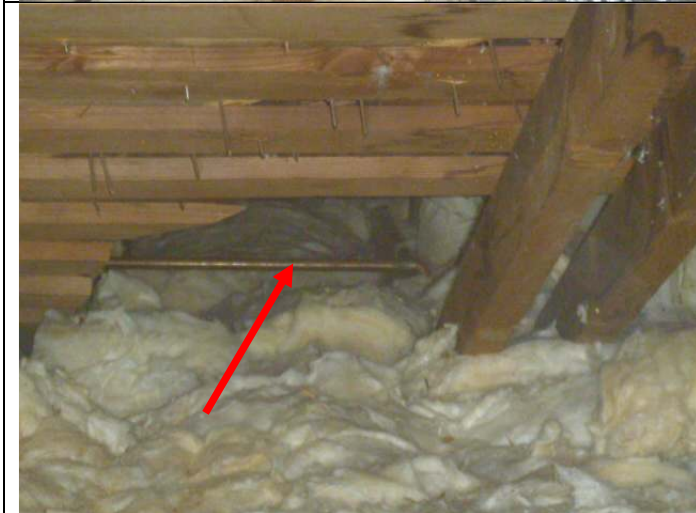
Limited access to the far right front attic area.

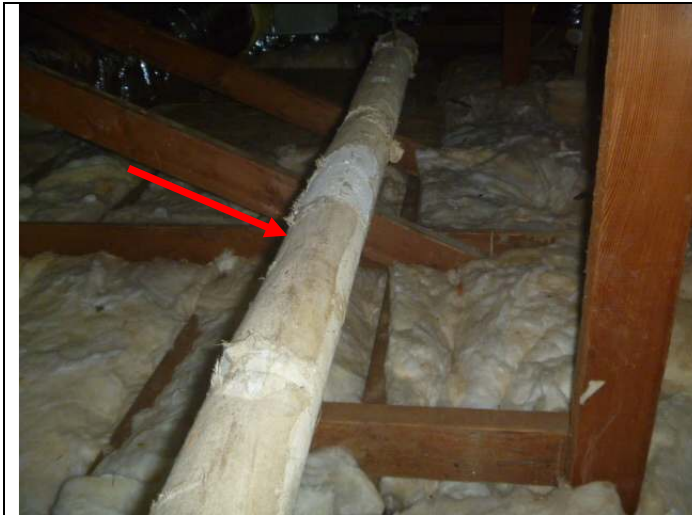
- A INSULATION:** Functional (batts type).
- **ADDITIONAL COMMENTS:** There is a considerable amount of asbestos insulated piping (not in use). Recommend consulting an asbestos specialist for further review and abatement. There is an open electrical box in the north end of the attic. Note: The left front and left rear sections of the attic have especially limited access.

Asbestos pipe insulation in the attic.

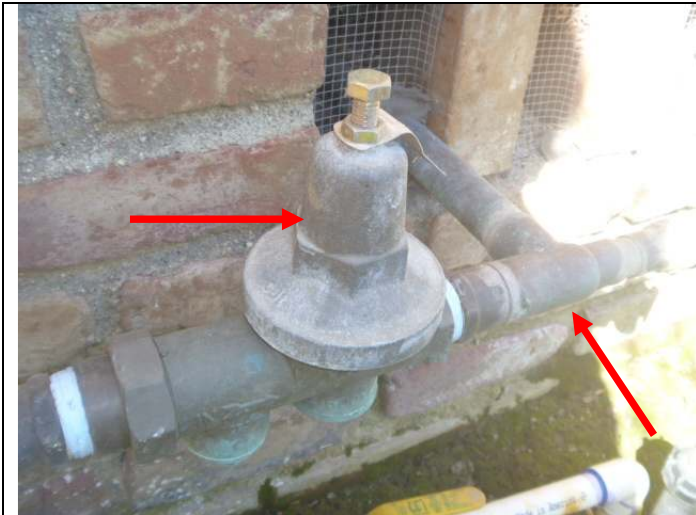
- B/ C FIXTURES:** The plumbing fixtures appeared to be in functional condition with the exceptions noted. See BATHROOMS section.
- A WATER PIPES:** Copper. The water piping is a replacement copper type and overall appeared to be functional.

Copper water piping and the water pressure regulator.

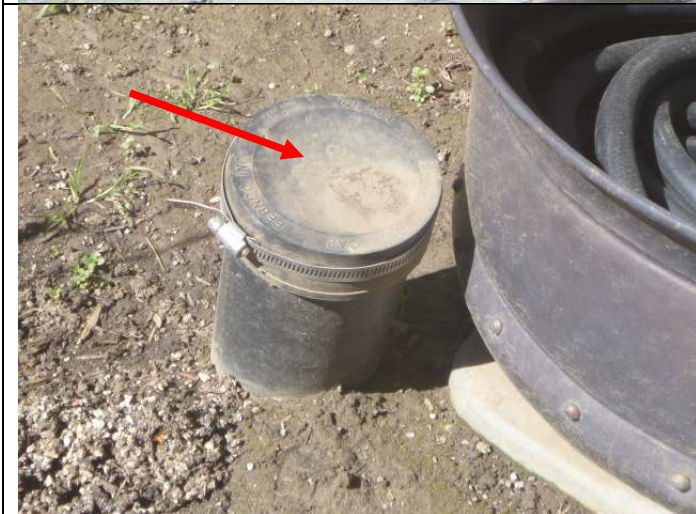
Main drain cleanout at the front exterior.

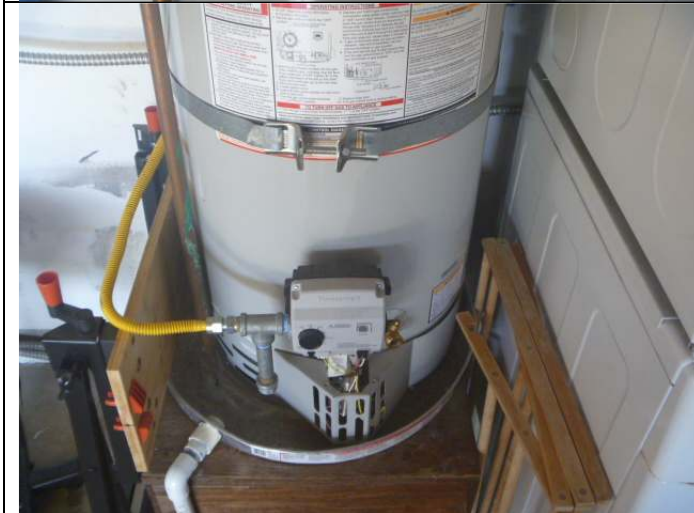
Water heater lower section.

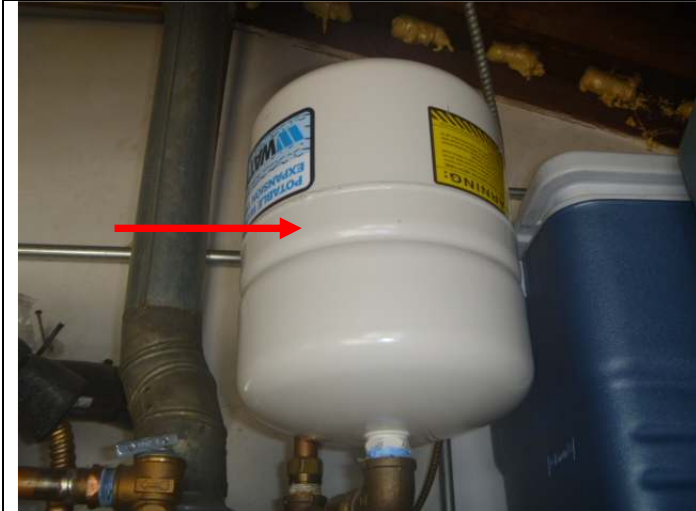
Thermal expansion tank above the water heater.

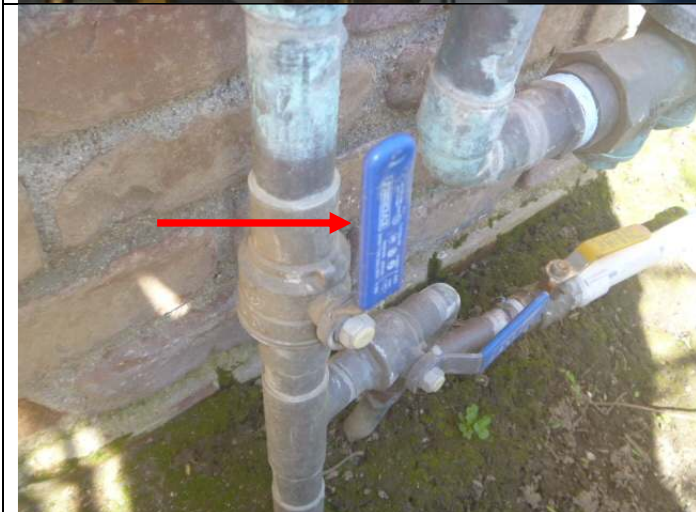
Main water valve.

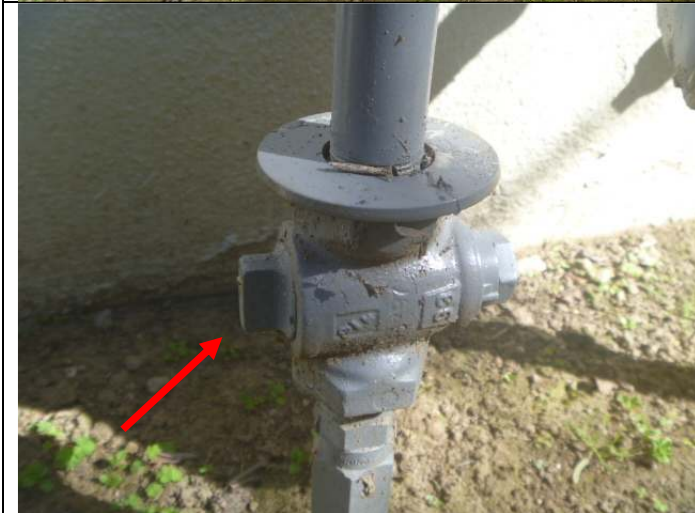
Gas shut off valve.

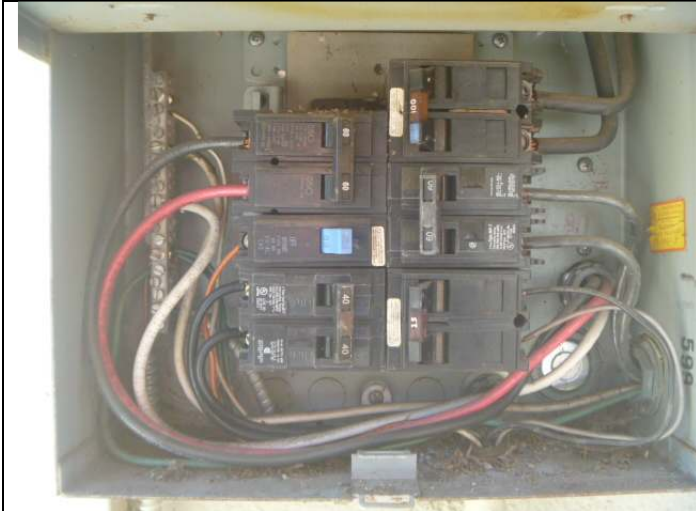
- B SERVICE PANELS:** Main: The main service panel at the north exterior of the garage consists of one 100 amp double pole (main), two 60 amp double pole (air conditioners), one 40 amp double pole (air conditioner), one 15 amp double pole and one 15 amp breakers. The panel is older and the capacity is limited. Subpanel 1: The upper subpanel on the garage rear wall consists of two unidentified double pole and four 15 amp breakers. The panel is old (original) and the breaker set is obsolete. Subpanel 2: The lower subpanel on the garage rear wall consists of one 40 amp double pole and seven 20 amp breakers. The panel overall appeared to be functional but is older. One black wire (as for a hot wire) and one green wire (as for a grounding wire) are connected to the neutral bus bar – irregular installation. Note: The 40 amp breaker is not in use.

Main service panel.

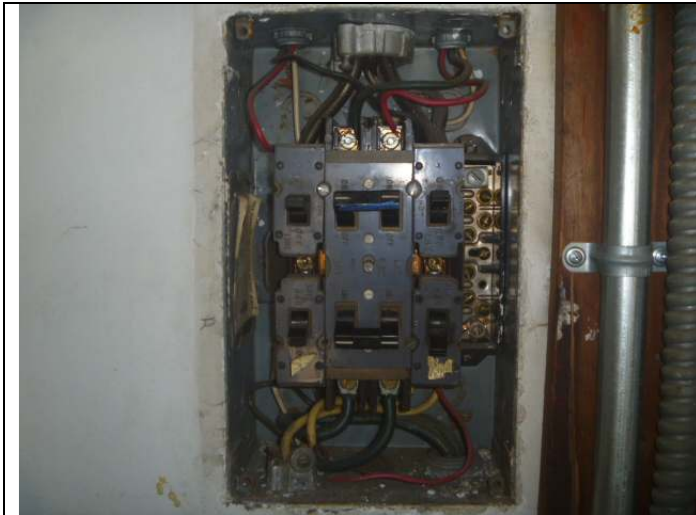
Upper subpanel in the garage.

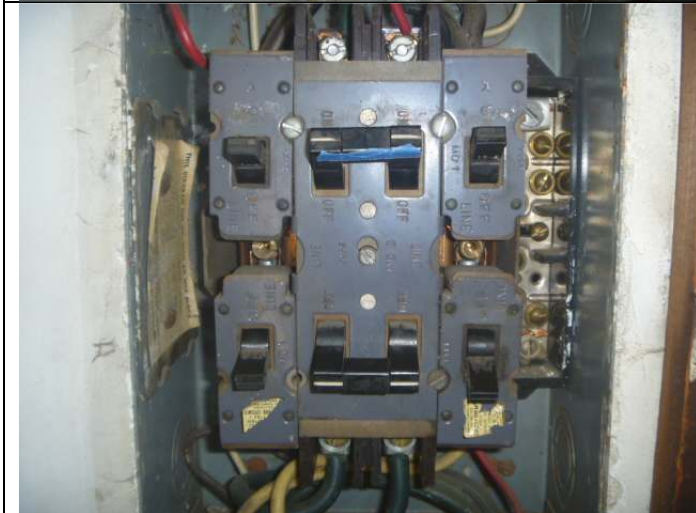
A closer view of the breakers.
Note: The obsolete circuit breaker set.

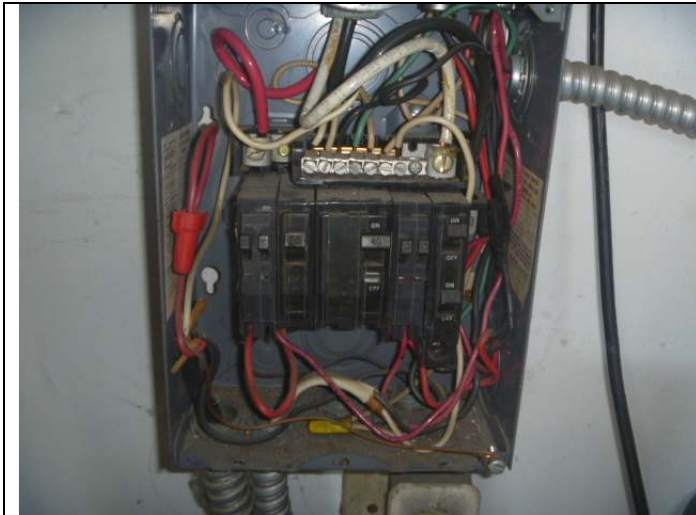
Lower subpanel on the garage rear wall.

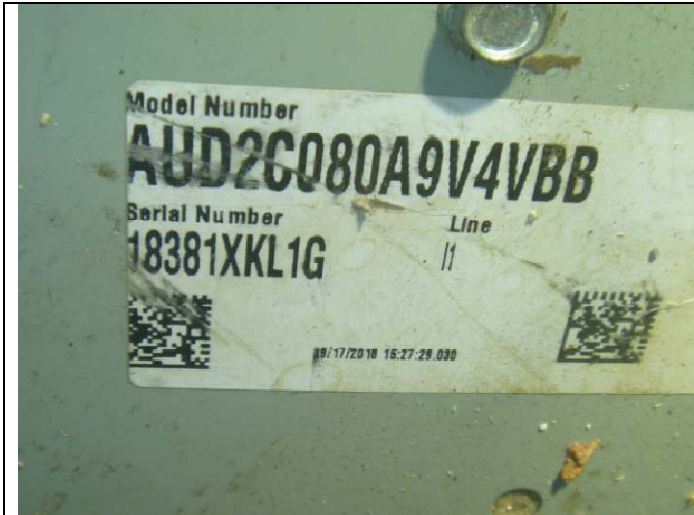
Heater/fan unit model and serial numbers (indicating a 2018 build date).

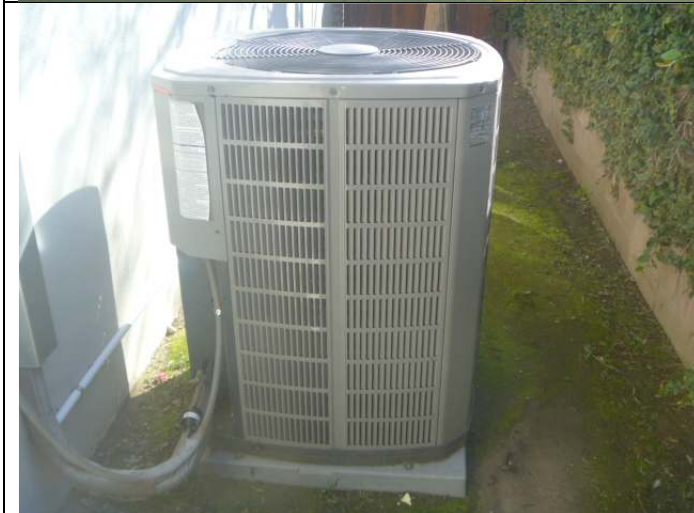
Air conditioner condensing unit.

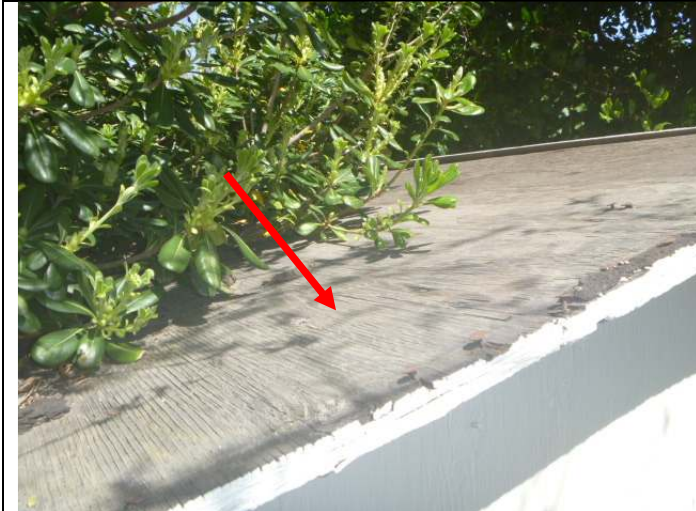
Pool enclosure roof without a roof covering.
