SUMMIT INSPECTIONS

Property Location: 9976 TUJUNGA CANYON BOULEVARD
TUJUNGA, CA

Structure Type: Single Family Home

Inspection Date: March 7, 2024

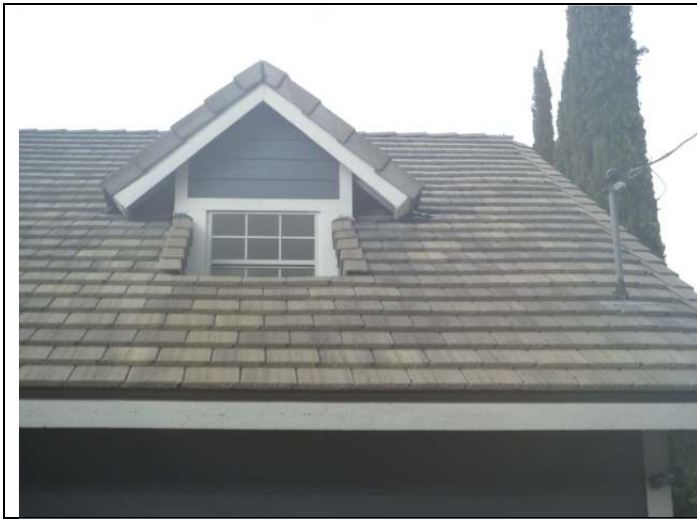
Tile roofing (upper front).

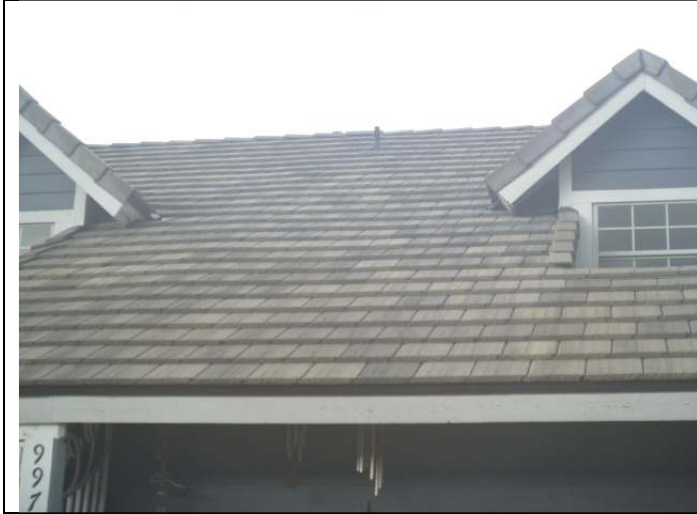
Tile roofing (upper front)

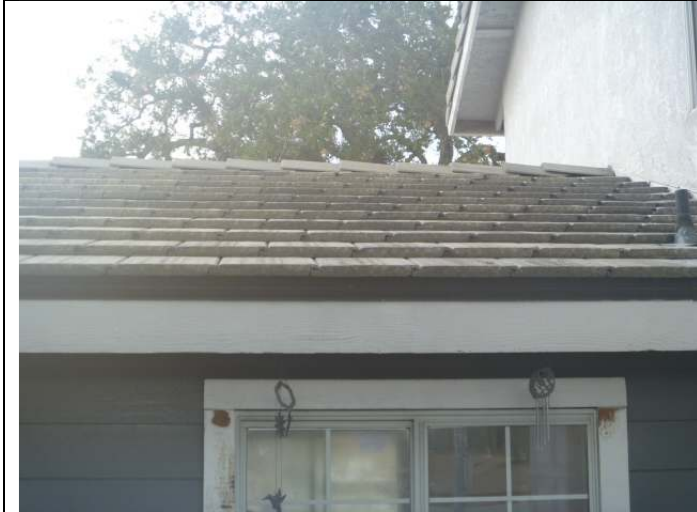
Tile roofing (lower left front).

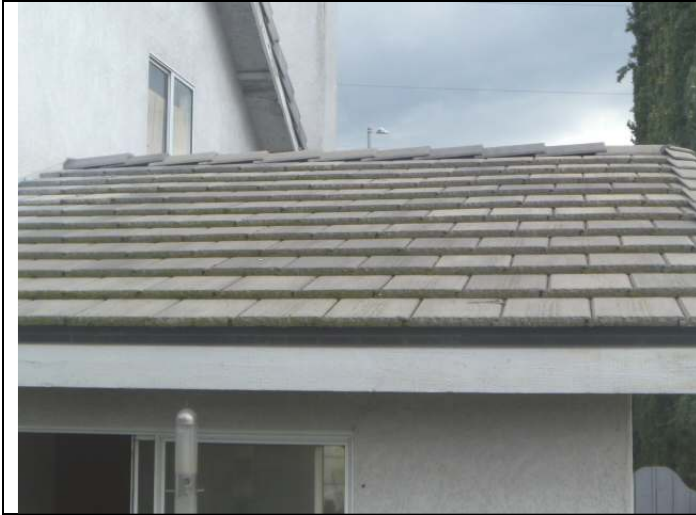
Tile roofing (lower left rear).

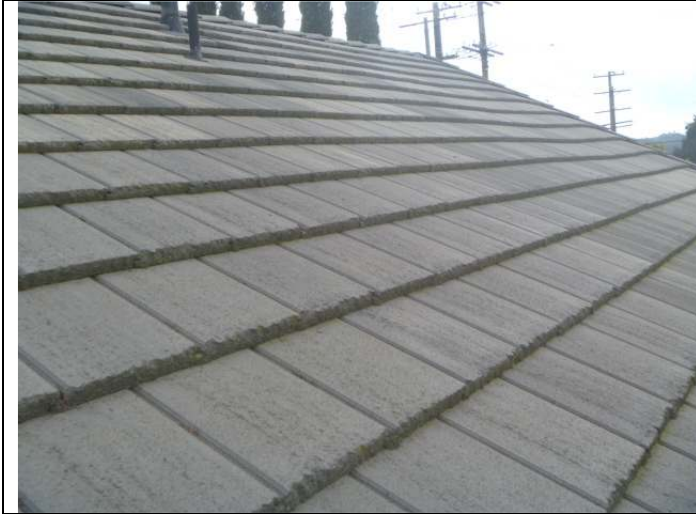
Tile roofing (upper rear).

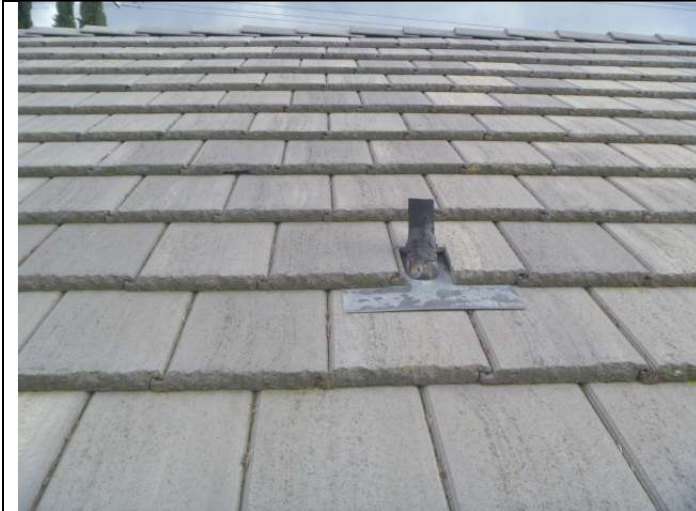
Tile roofing (upper rear).

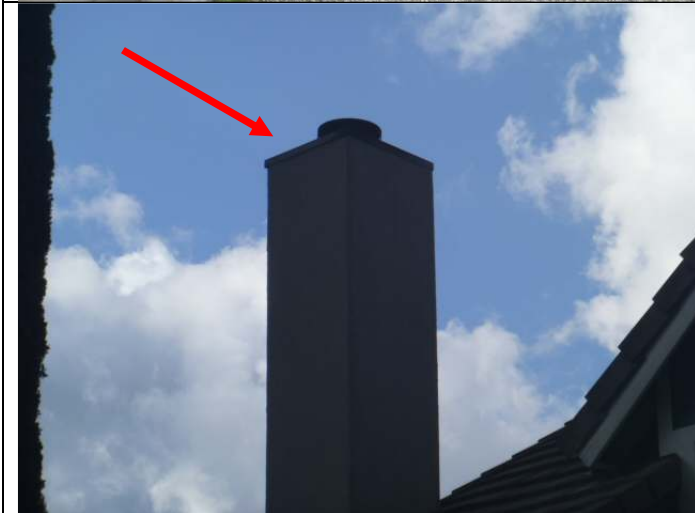
Chimney upper exterior.

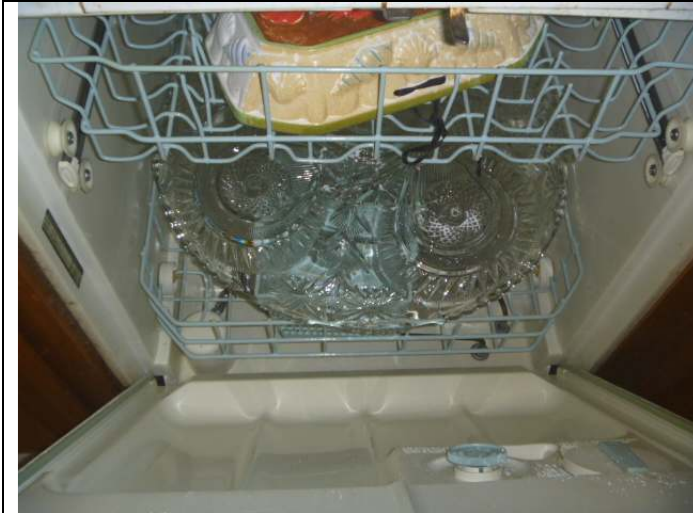
Dishwasher interior. Note: The unit is older.

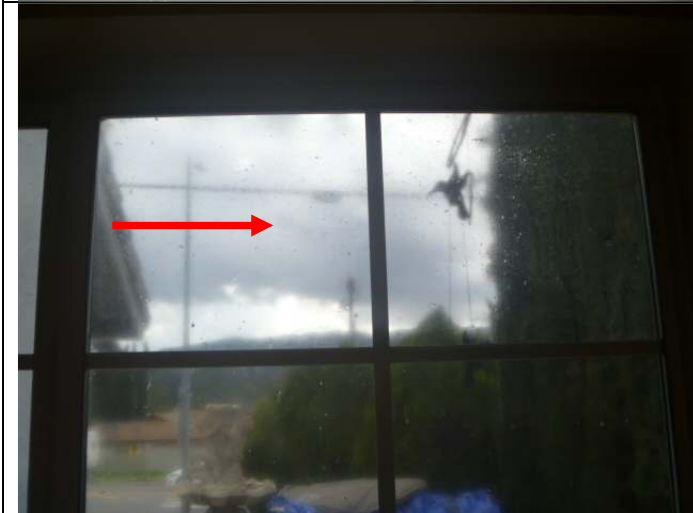
Fogged window pane (dual pane type) at the kitchen sink.

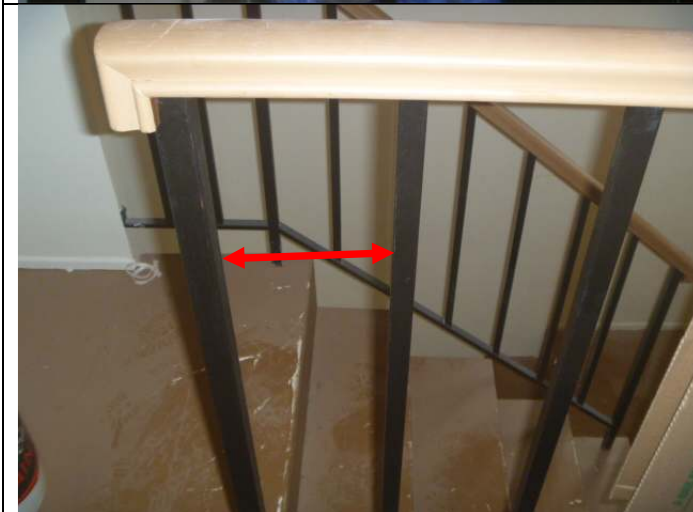
Hallway railing with relatively wide spacing – older style installation.

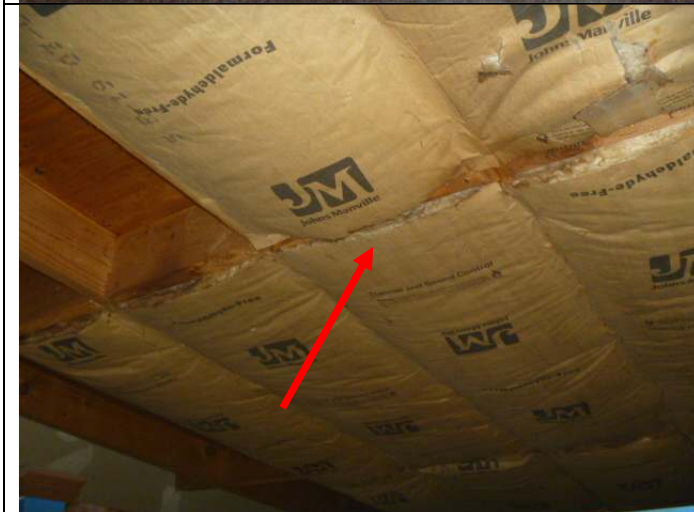
Fiberglass insulation on the unfinished sunroom ceiling.

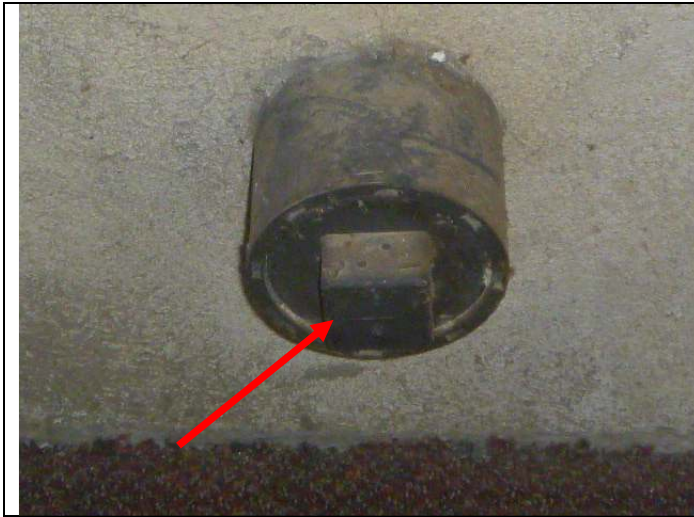
Main drain cleanout the sunroom lower left front wall.

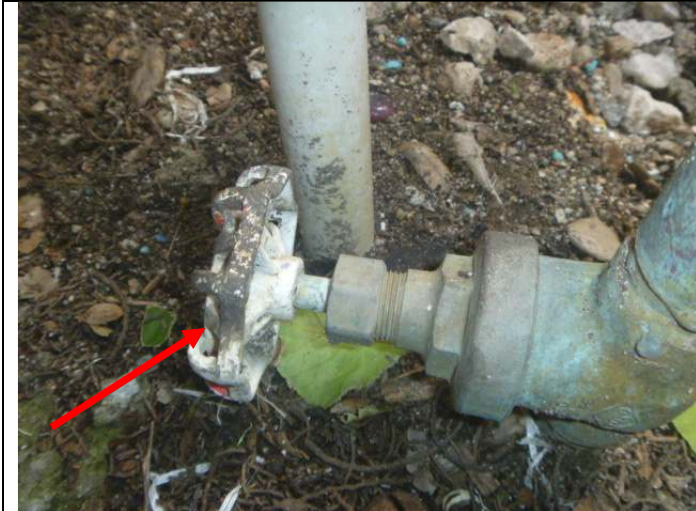
Older gate type main water valve.

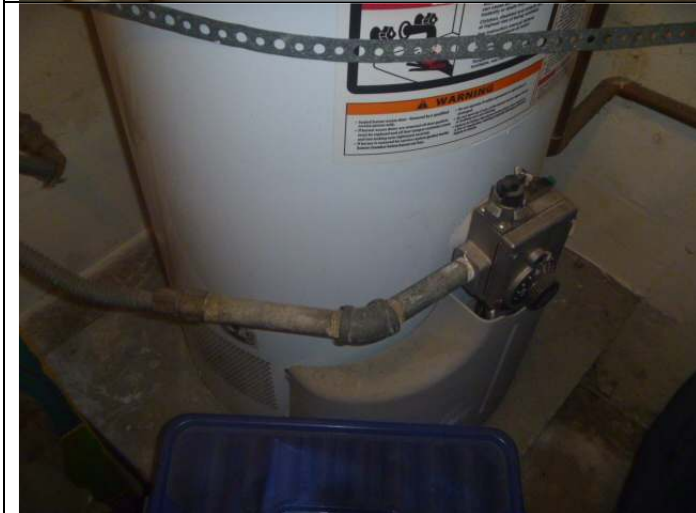
Water heater section.

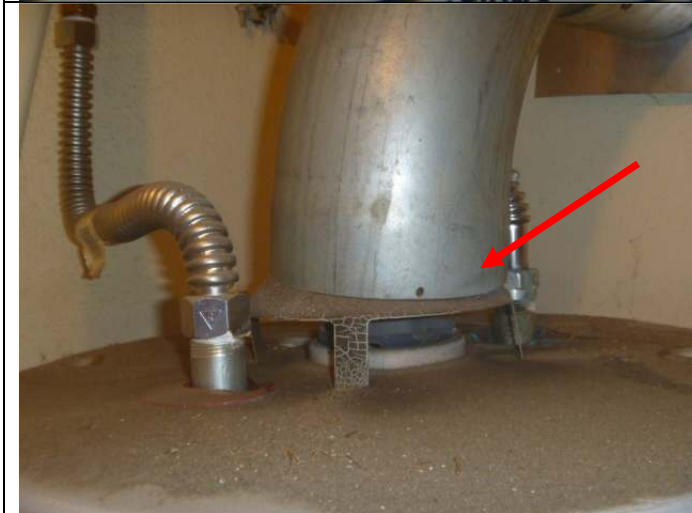
Vent piping (non-powered) immediately above the water heater.

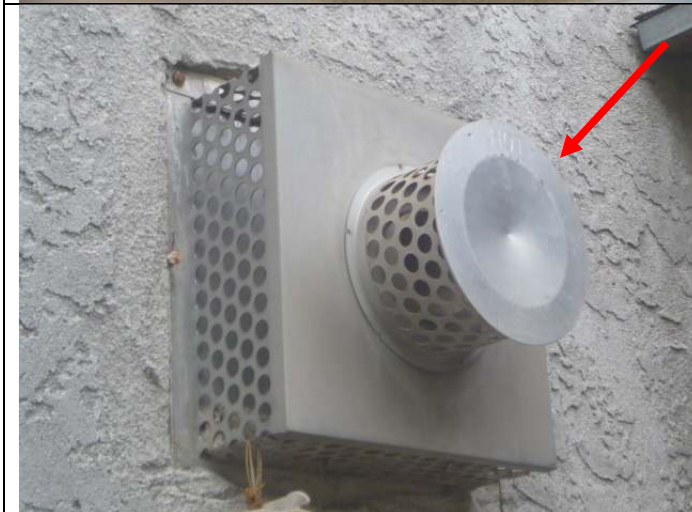
Water heater vent outlet at the side exterior wall.

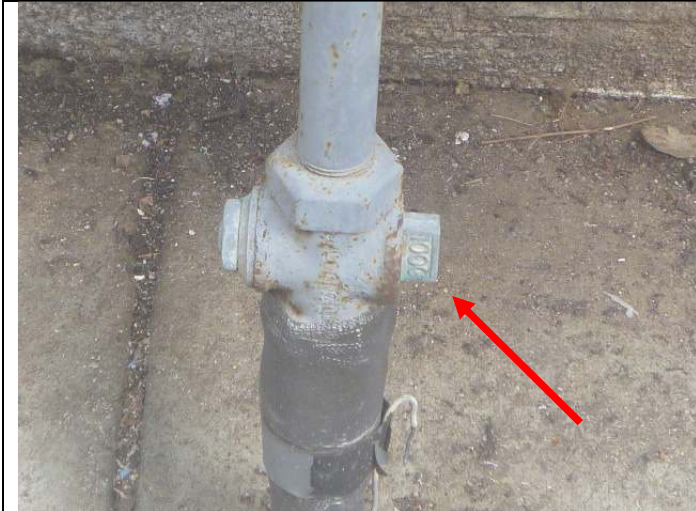
Gas shut off valve.

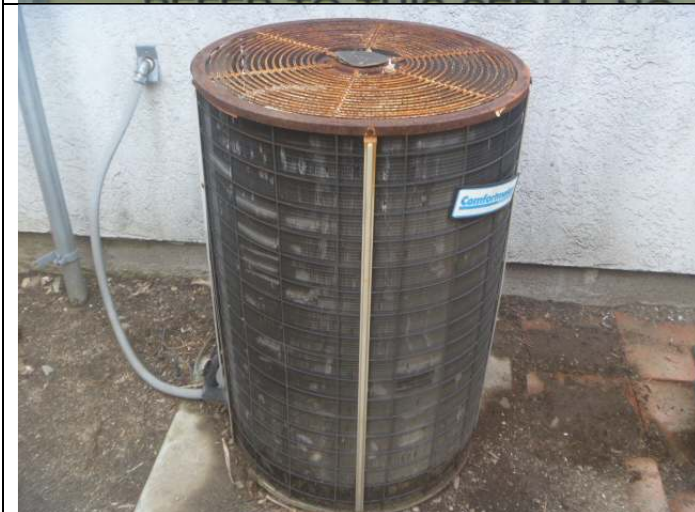
Air conditioner condensing unit.

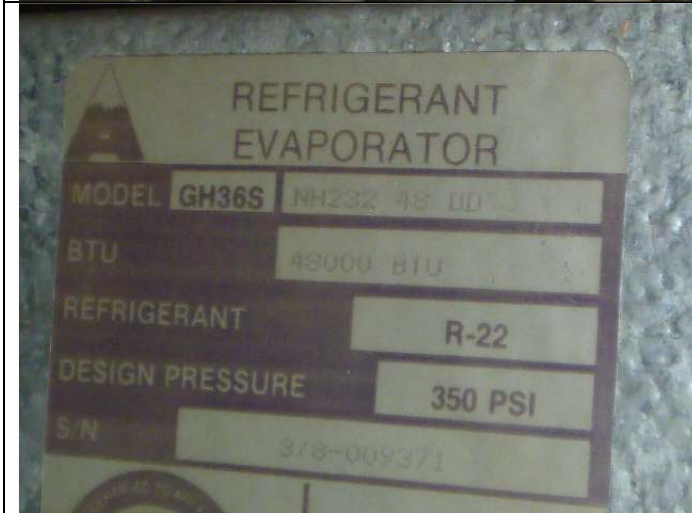
- B **DUCTS:** The ductwork is the original and there is a damaged and missing section of duct insulation toward the west end of the attic.
- A **CAPACITIES:** Heater: 80,000 BTU. Air Conditioner: Not Determined (illegible). Note: The air conditioner coil unit capacity is 4 tons.

Air conditioner coil model number, capacity, refrigerant type (R-22) and serial number.
