## 2176 Calle Nardo Thousand Oaks

### Pre-Market Inspections

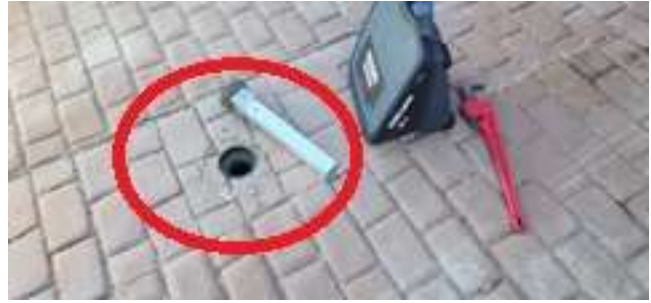
Cleanout in driveway

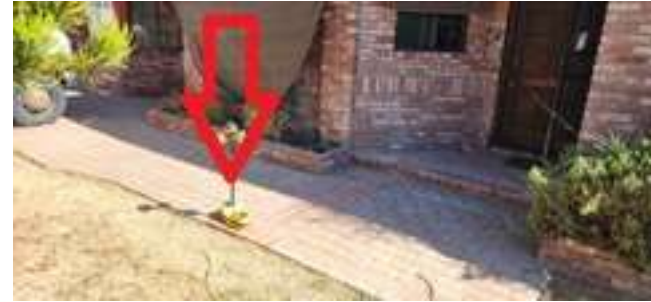
Line transitions from plastic to clay about 3 ½ feet deep

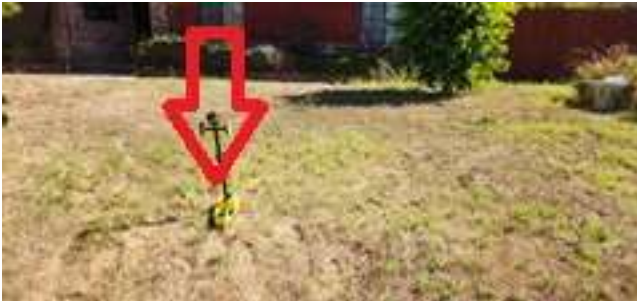
Line drops deeper and turns toward street

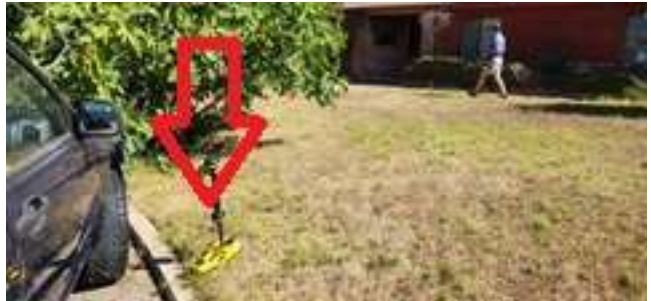
Needs attention - Portions of this system are made of a fiber-cement pipe. The pipe under the street is fiber-cement. This pipe is beginning to show signs of wear. This is a fairly uncommon material and it is recommended to keep an eye on it with review inspection to determine how it performs over time.

Sewer line exits property about 7 feet deep

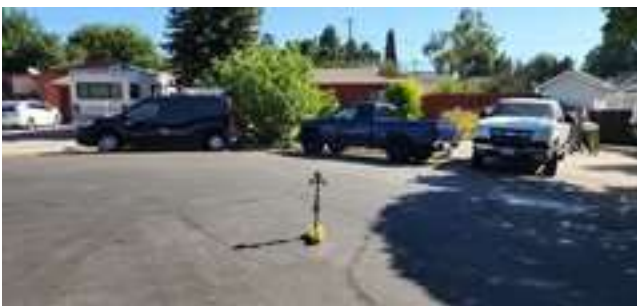
Connection to city sewer line about 10 feet deep

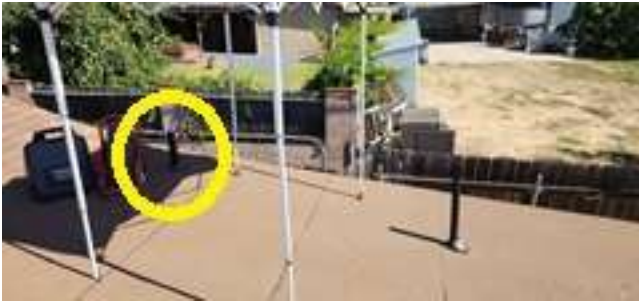
2 inch roof vent used for inspection from ADU

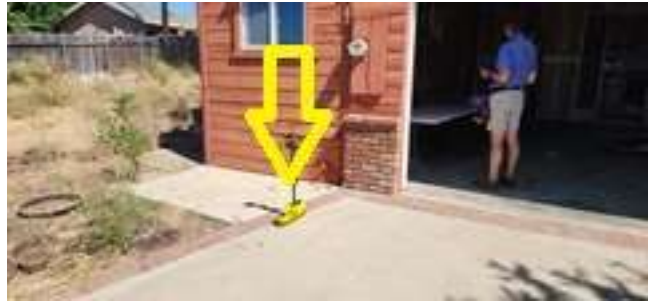
Sections of the ADU line were not seen today due to lack of a proper cleanout for the ADU. Once the recommendation for cleanout installation is done, a review inspection should reveal the condition of the remainder of the ADU line.

Furthest point reached from ADU roof vent. Good spot for cleanout installation. About 4 feet deep

RE: the line from ADU to the main line. Access should be established into this system. While the entire section appears to be a plastic line and is in serviceable condition, a portion of the sewer line couldn't be seen with the camera from the vent on the ADU roof. The photo below shows an approximate location to install. Your contractor would decide the exact location.

**Costing:** The access installation recommended for this property might cost around \$2,500.

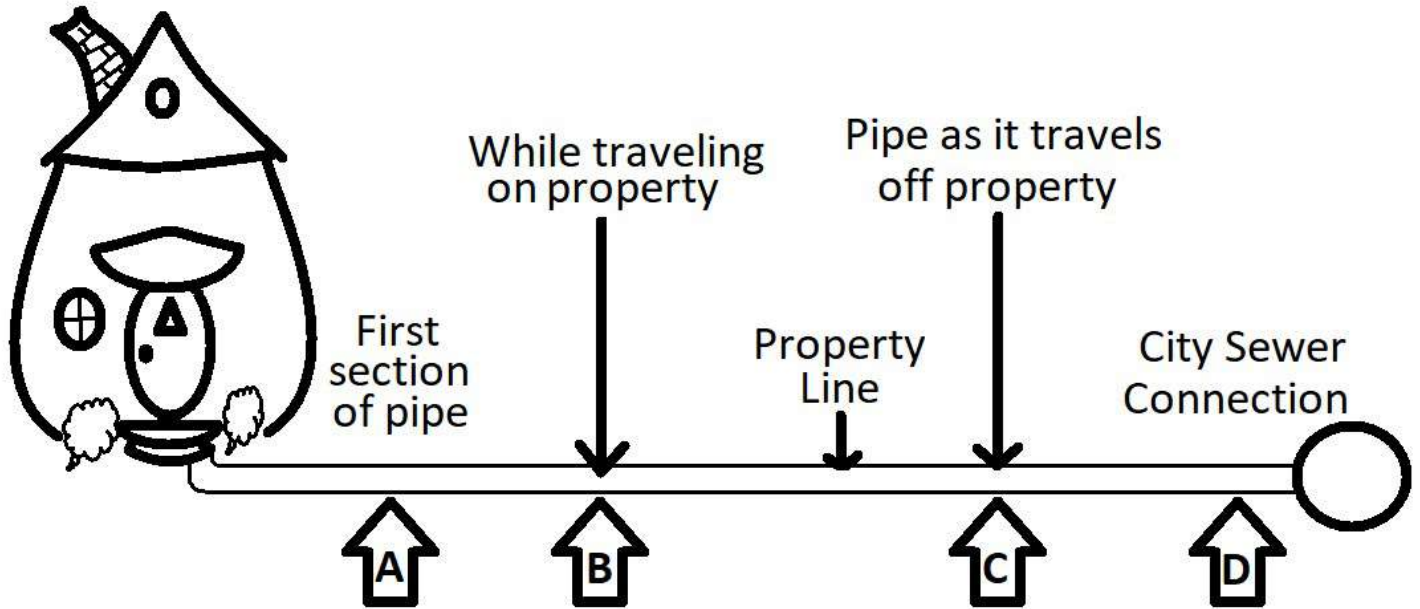
- A: Plastic in both the main line and the line from the ADU
- B: plastic to clay Fiber-cement at property line.
- C: Fiber-cement
- D: Fiber-cement

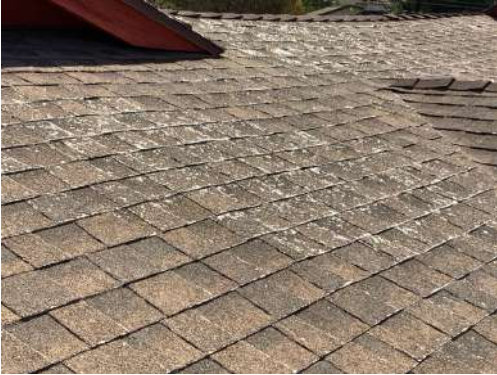
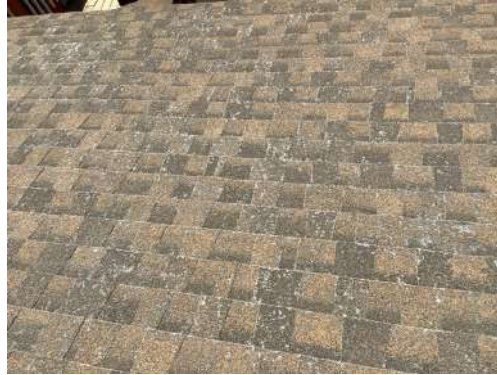
The surface granulation are deteriorated (exposing fibers) and there are surface cracks developing. These are signs of aging. Regular/annual maintenance is recommended.

The condition(s) and/or configuration noted demands attention for the long term viability of the roofing surface. For necessary repair and/or preventive maintenance, we recommend the advice and services of a licensed roofing contractor before the close of escrow.

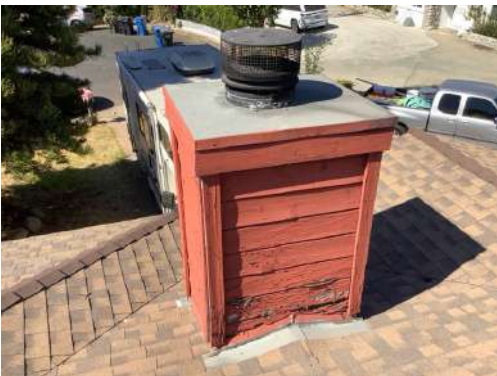
The chimney spark arrestor was not removed for an examination of the interior of the chimney.

The chimney chase cover at the prefabricated chimneys shaft is too tight at the frame (less then 1 inch clearance). We recommend correcting this installation, per standards.

The inspection of the interior of the chimney is not within our scope. A full evaluation by a specialist with proper equipments (video camera, etc.) is available and is recommended.

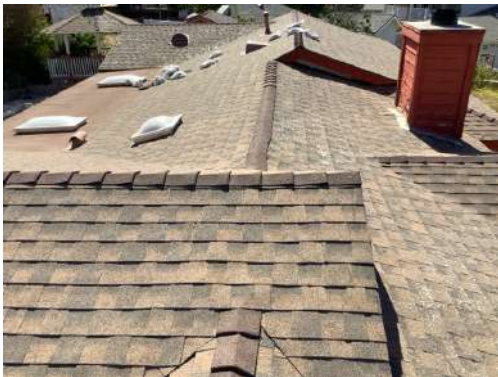
This roof cover is near the end of its expected service life. Although it appears to be presently watertight, the need for replacement should be expected.

For further evaluation of noted conditions and/or regular/annual maintenance of this roof, we recommend you consult a licensed roofing contractor before the close of escrow.

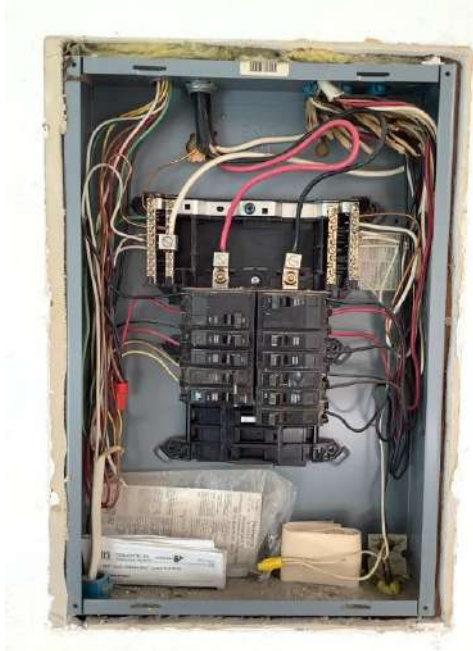
An additional distribution panel, or subpanel, is located in the rear sunroom.

**DNGR** The neutrals and the grounds are bonded together in the subpanel. This is not a permitted configuration because of a possible failure of the grounding system. We recommend the neutrals and the grounds be separated.

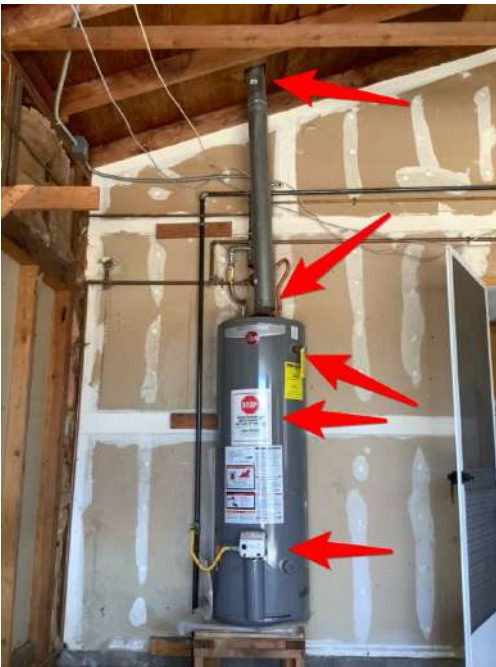
The water heater's energy source was shut off and was not operational. We cannot offer opinions about its performance or general state of repair. We recommend inspection when the energy source has been restored.

For attention to the condition(s) noted above, we recommend the advice and services of a licensed plumbing contractor.

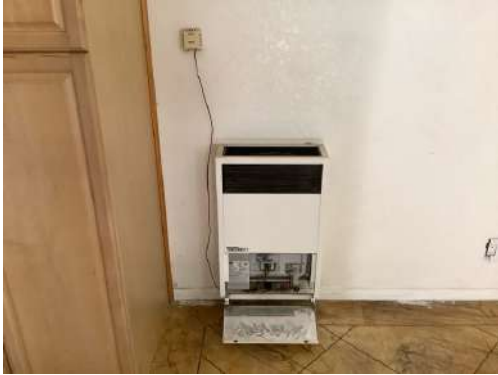
The heating unit's energy source was shut off and the system was not operational. We cannot offer opinions about system performance or general state of repair. We recommend inspection when service has been restored.

There is no visible service record of this equipment. Because of the age of this unit and noted items, we recommend this system be service and verified for safe use by a licensed heating contractor before the close of escrow.

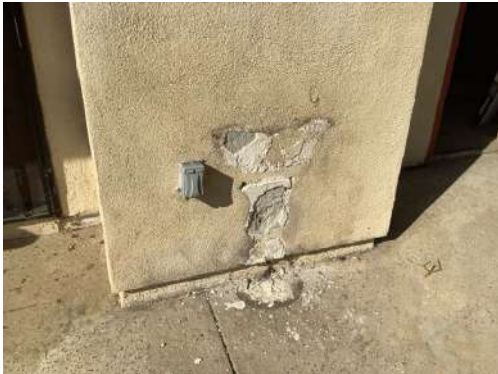
Sections of the stucco at rear wall are damaged. We recommend they be repaired.

For attention to the condition(s) noted above, and/or cost estimates, if necessary, we recommend the advice and services of a licensed plastering contractor.

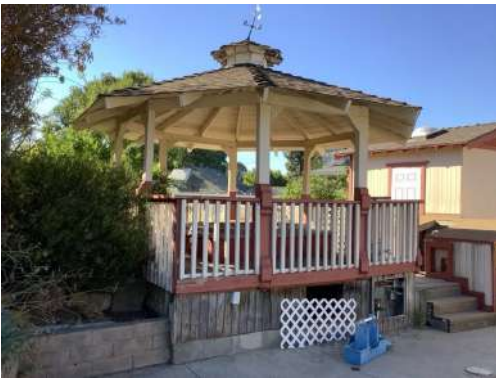
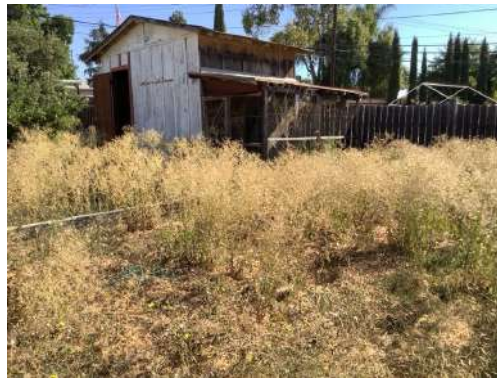
The storage sheds/spa deck-gazebo/chicken coop structures in backyard were not inspected and are not included in this report.

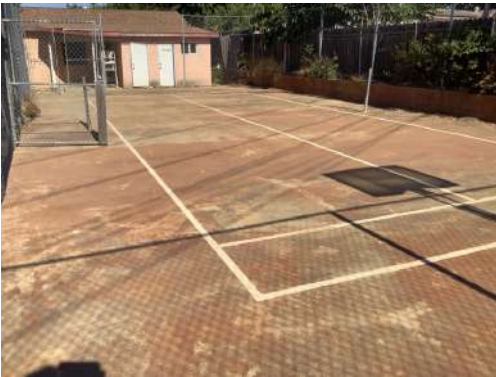
The sport court/basketball hoop equipment in backyard was not inspected and is not included in this report.

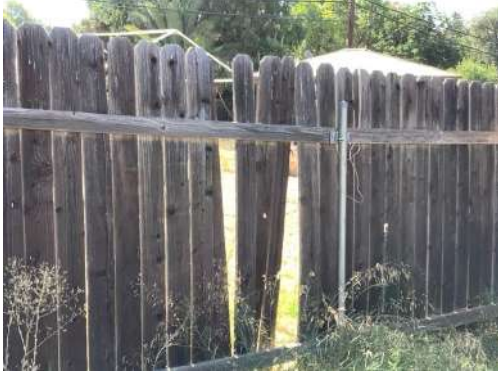
There is damage (cracks, loose blocks) noted in block fencing. We recommend to check the entire perimeter fencing and the damaged fencing sections be repaired and/or replaced as necessary.

For attention to the condition(s) noted above, and/or cost estimates, if necessary, we recommend the advice and services of a licensed fencing contractor.

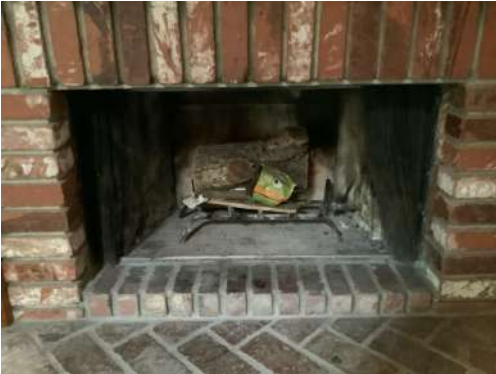
The gas log lighter is controlled by a valve near the hearth. We suggest keeping the key for the log lighter out of the reach of children. The gas supply line in firebox was capped off at the time of this inspection and the valve was not tested.

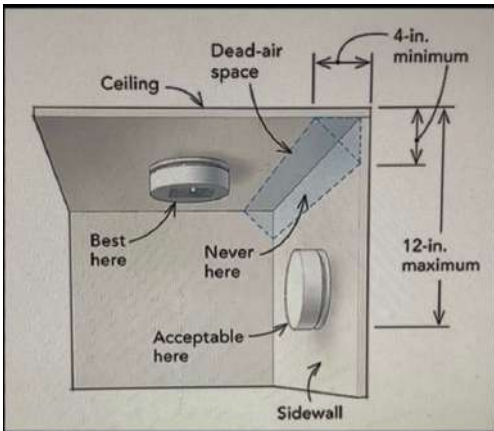
Present standards require smoke alarms in all bedrooms. Complying with state laws is recommended for increased safety, before occupancy. (within 12 inches of the highest point of the ceilings)

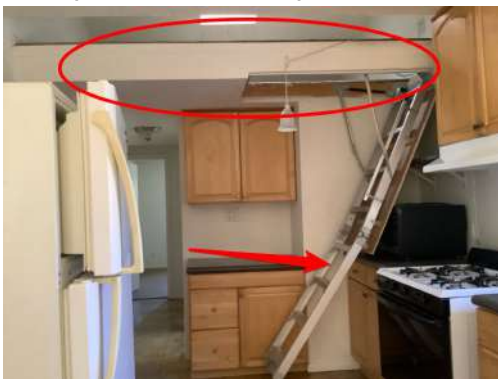
The loft area and pull down ladder was added and/or improved after original construction. We can not verify it's proper structural design and installation (use of required screws/nails, etc.). We recommend the owner or building department be consulted to determine if permits were secured and "signed off" for all improvements completed.

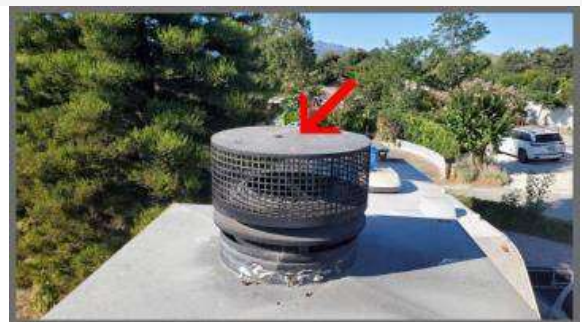
### CHASE COVER:

**FIRE SAFETY RISK.** The spacers at the top of the chase (providing for air circulation) between the chase cover and the framing are not present. Generally, the chase cover is supposed to be raised off the wood framing and is supposed to be larger than the outer surfaces of the chase to allow for the escape of heat and circulation.

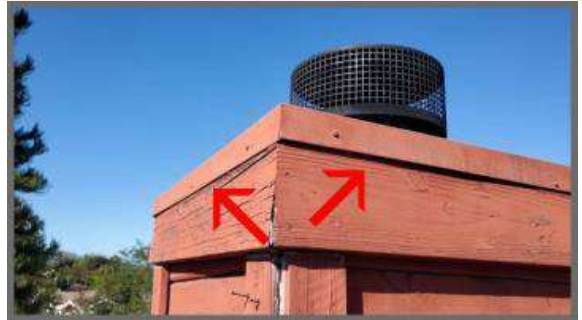
### CHASE STRUCTURE:

**NEEDS ATTENTION.** There is damage to the wood surfaces of the chase.

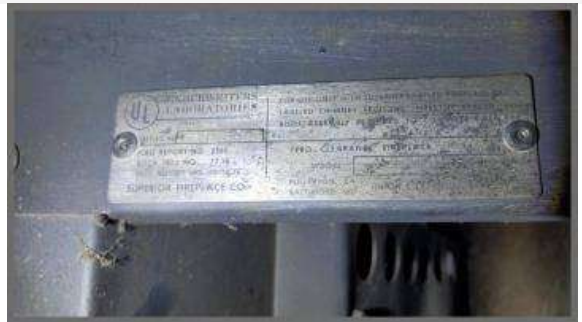
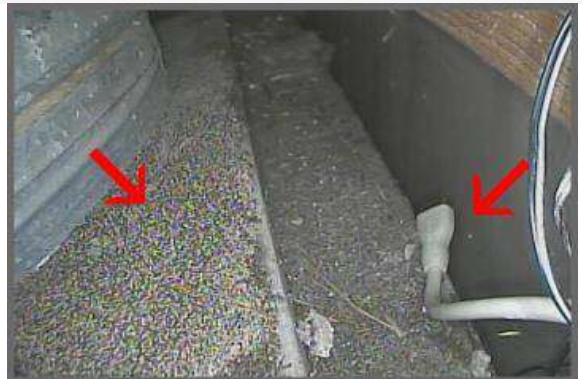
## PREFABRICATED UNIT:

**FIRE SAFETY RISK.** There is debris on top of the firebox. This is a violation of the fireplace manufacturers requirements.

**ADDITIONALLY.** There are cables in contact with the top of the firebox.

**NOTE.** The side metal panels are warped. This is not a significant issue in my opinion.

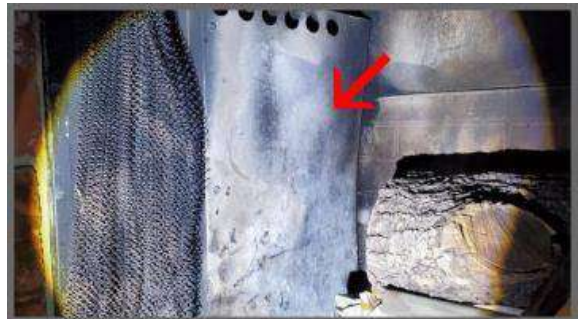
## GAS LINE:

**FIRE SAFETY RISK.** The gas line into the fireplace does not have a proper fireproof seal where it enters the firebox, this is typically a matter of filling the gap with a fireproof sealant.

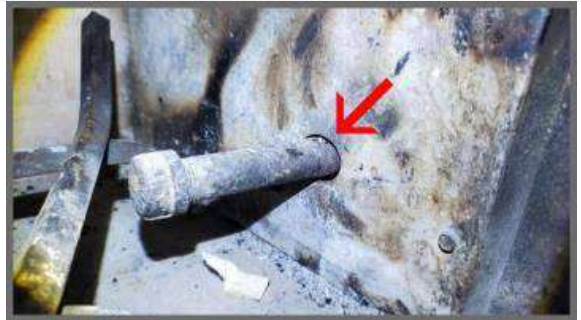
## GAS VALVE:

**NEEDS ATTENTION.** The gas is turned on with a handle and not a key. This could be used by a child to turn the gas on. A key is preferable as it can be placed in a position where it cannot be easily reached by a child.

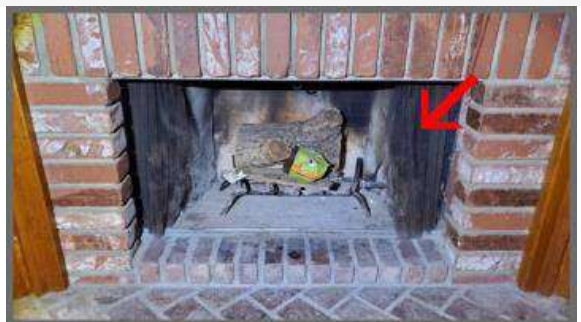
## SURROUND:

**FIRE SAFETY RISK.** There are gaps where the finish materials meet the facing around the firebox opening. Typically, there are not supposed to be any gaps between the finish materials and the firebox edges. Gaps can allow for heat and gases to pass into areas not intended for heat and combusted fuel.

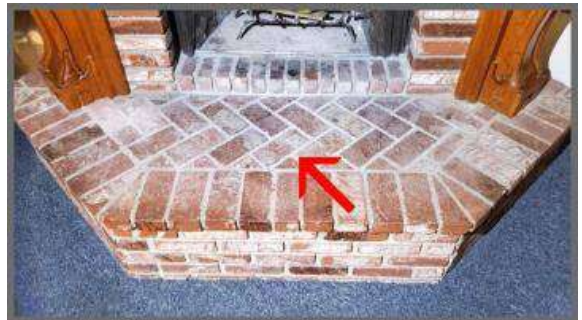
It cannot be determined during a non-intrusive inspection whether or not the required spark strip has been installed below the firebox.

Additionally, there should not be combustible materials along the facing around the firebox, including below the hearth extension. In most cases, it is beyond the inspectors ability to determine whether or not there are combustibles against the firebox metal facing.
