SUMMIT INSPECTIONS

Property Location: 6501 MATILIJA AVENUE
VALLEY GLEN, CA

Structure Type: Single Family Home

Inspection Date: March 14, 2024

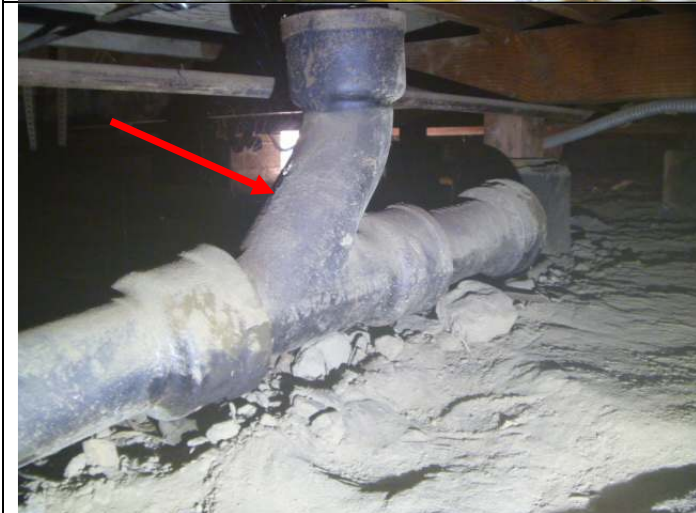
Original cast iron drain piping.

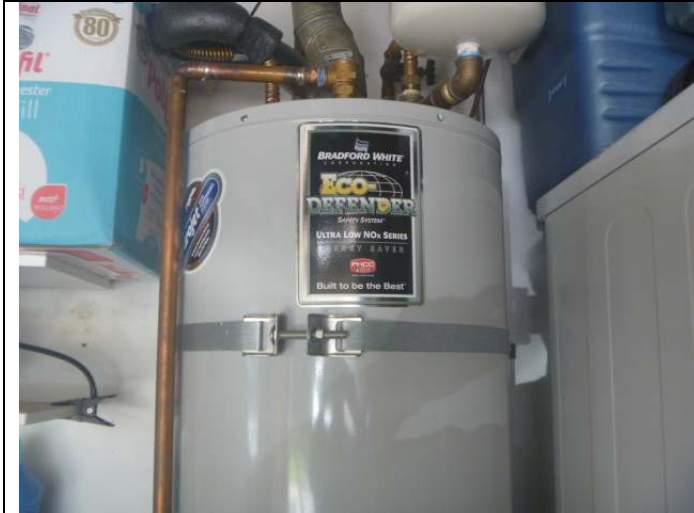
Water heater upper section.

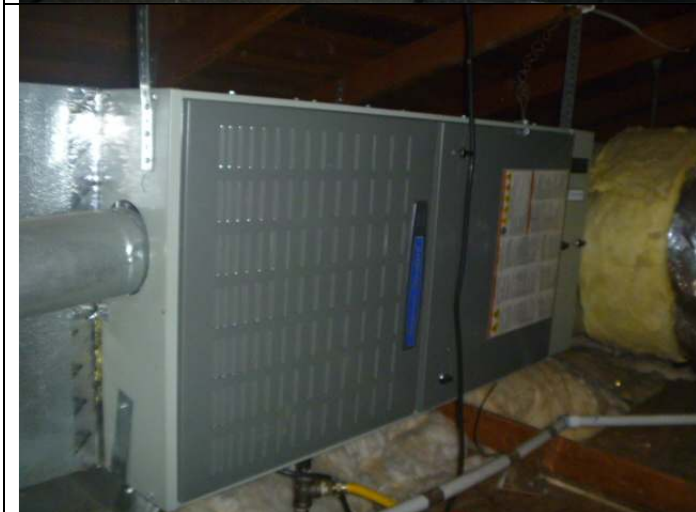
- A TYPE:** Central Forced Air (American Standard brand)
- A CONTROL:** Thermostat
- A DUCTS:** Functional.
- A CAPACITIES:** Heater: 80,000 BTU
Air Conditioner: 4 Tons
- A LOCATION:** Heater/Fan Unit: Attic
AC Condensing Unit: South Exterior
- **ADDITIONAL COMMENTS:** The heating/air conditioning system is approximately five years old ('19) and overall appeared to be functional.

Heater/fan unit.

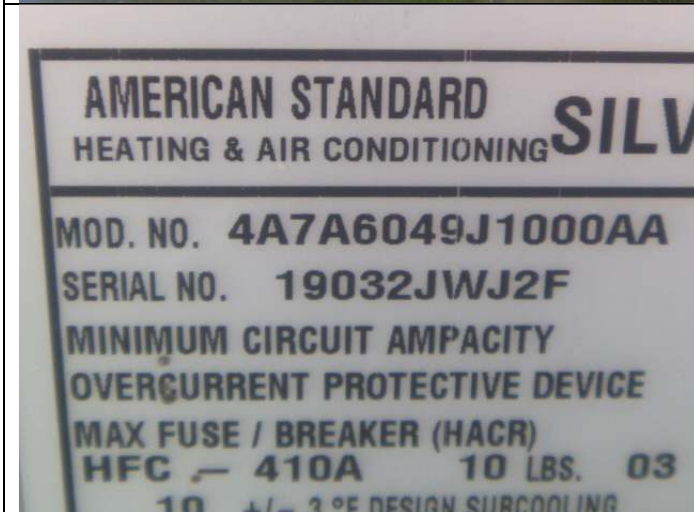
Air conditioner model and serial numbers.

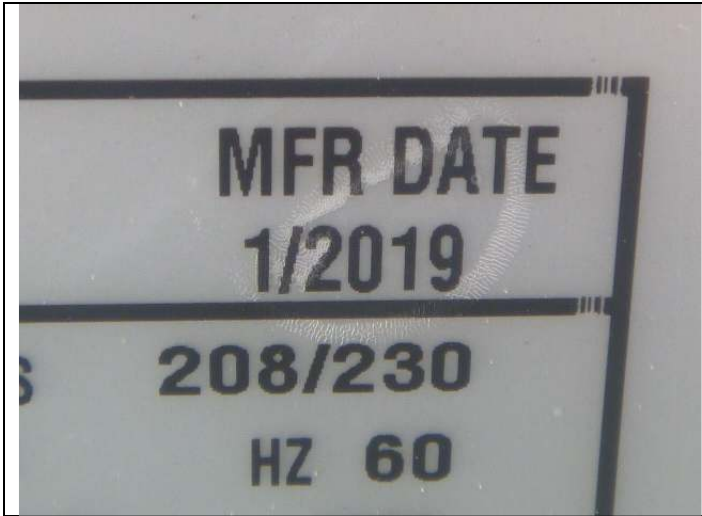
<p>MFR DATE 1/2019 208/230 HZ 60</p>	<p>Air conditioner date (2019).</p>

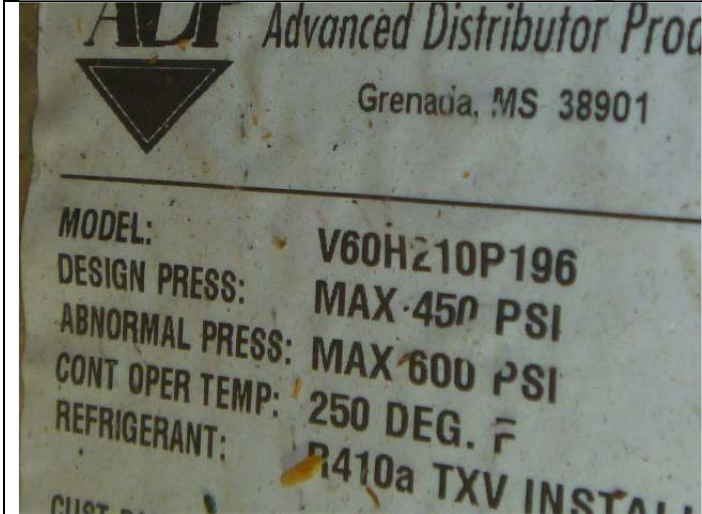
<p>Advanced Distributor Procs Grenada, MS 38901 MODEL: V60H210P196 DESIGN PRESS: MAX 450 PSI ABNORMAL PRESS: MAX 600 PSI CONT OPER TEMP: 250 DEG. F REFRIGERANT: R410a TXV INSTALL</p>	<p>Air conditioner coil model number.</p>

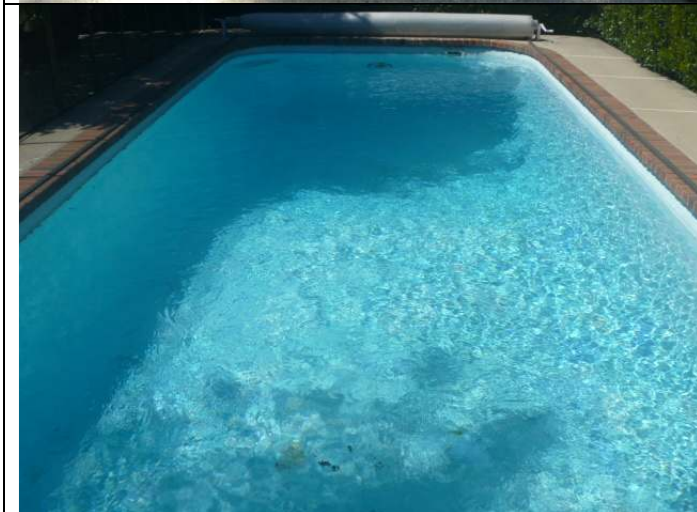
- B DECK:** There is some damaged vinyl along the deck expansion joints. There is an uneven joint at the left rear of the pool.
- B POOL:** The pool (fiberglass type) appeared to be old and there is some general deterioration and chipping.
- C EQUIPMENT:** The pool light appeared to be inoperative and the light is likely without ground fault circuit interrupter (GFCI) protection. The insulating cover below the pump timer switch is missing. The latch for the timer box exterior cover is missing. The condition of the old gas piping (for a previous heater) is beyond the scope of the inspection. Note: The topside of the equipment area roof is damaged and without roofing material.
- **ADDITIONAL COMMENTS:** The inspection is limited. Recommend consulting a pool specialist for further review.

Pool.

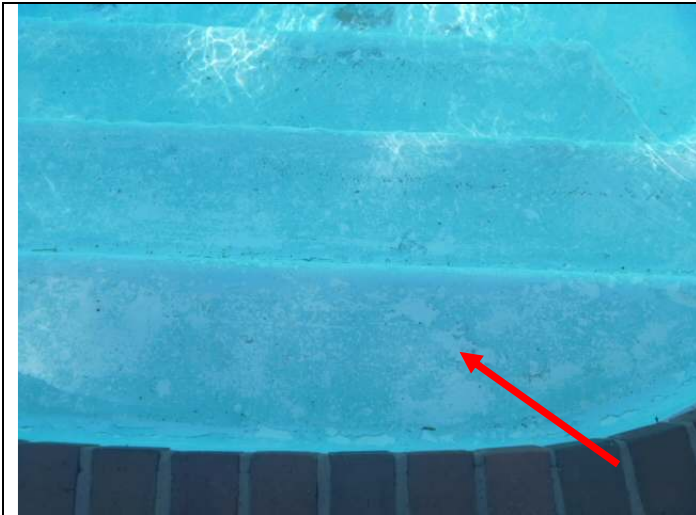
Pool steps close-up.

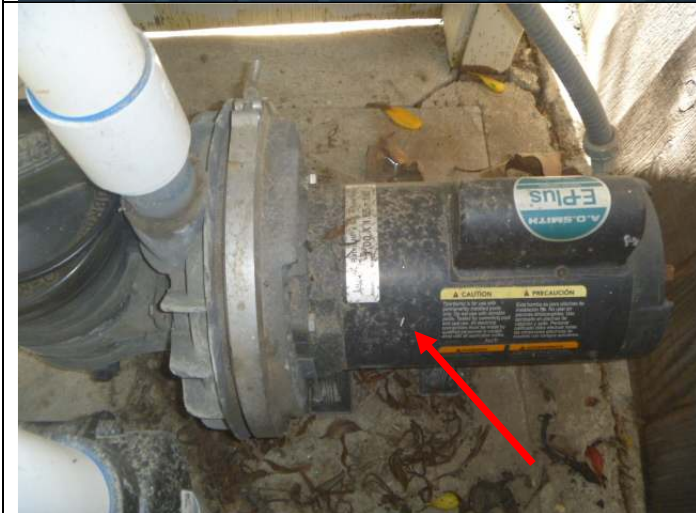
Pool pump.

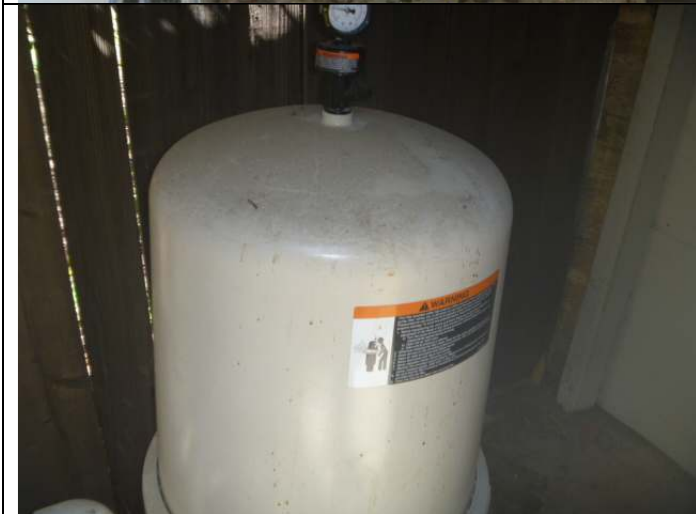
Pool filter.
