SUMMIT INSPECTIONS

Property Location: 9976 TUJUNGA CANYON BOULEVARD
TUJUNGA, CA

Structure Type: Single Family Home

Inspection Date: March 7, 2024

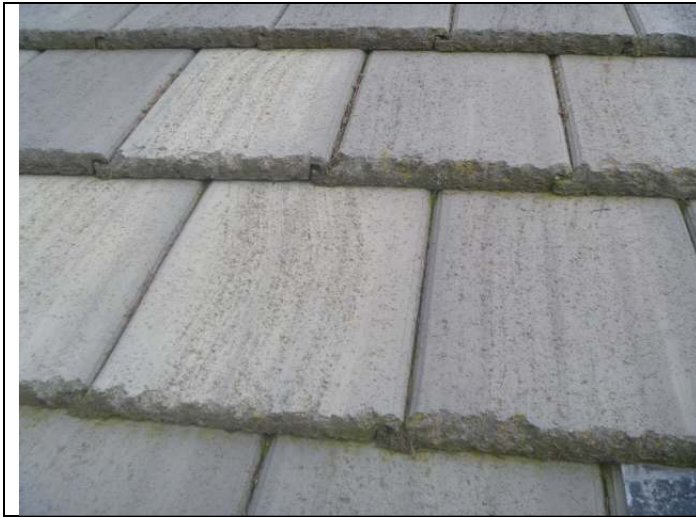
Tile close-up.

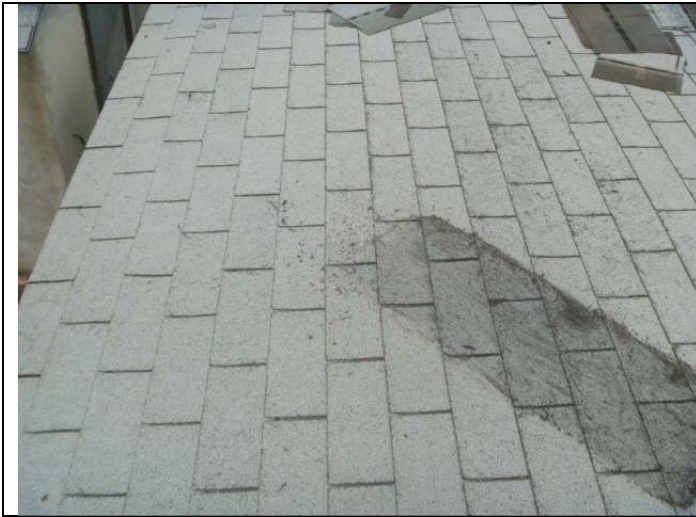
Sunroom roof.

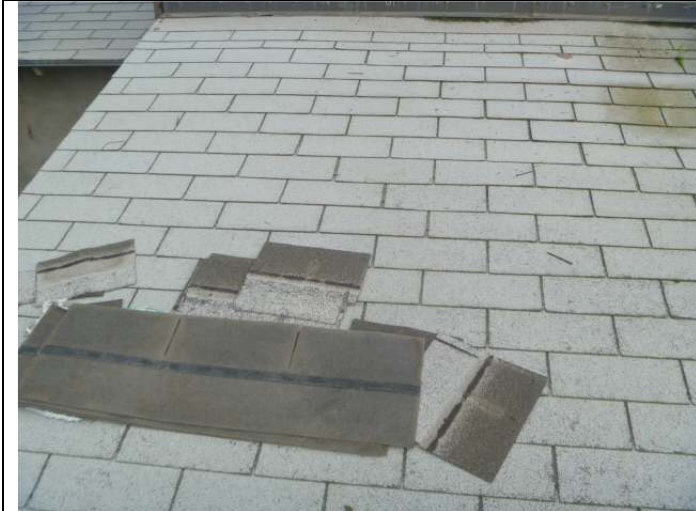
Sunroom roof.

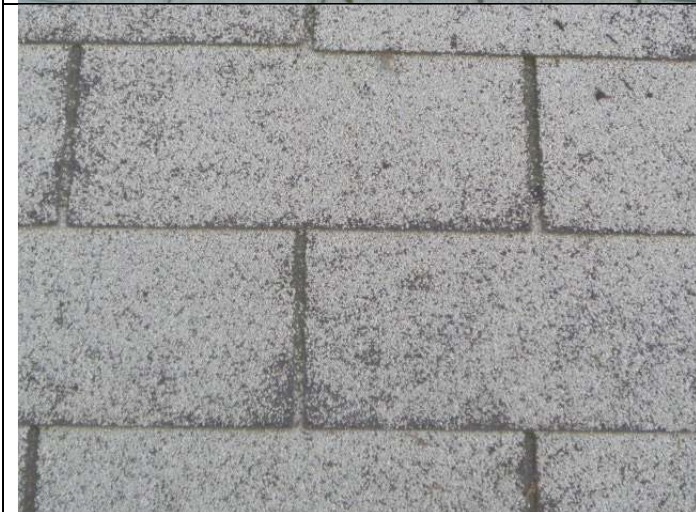
Shingle close-up.

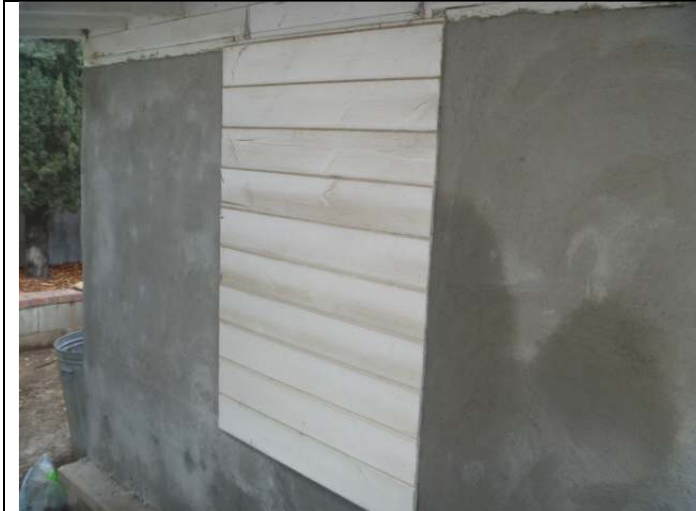
- B WALLS AND CEILINGS:** Sunroom: The sunroom is not finished. There is evidence of moisture entry, in the form of efflorescence, along the lower rear wall – possibly old. See EXTERIOR section for exterior drainage related comments. There is exposed fiberglass insulation at the ceiling. Note: The room access was especially limited due to personal items.

Sunroom unfinished rear exterior wall.

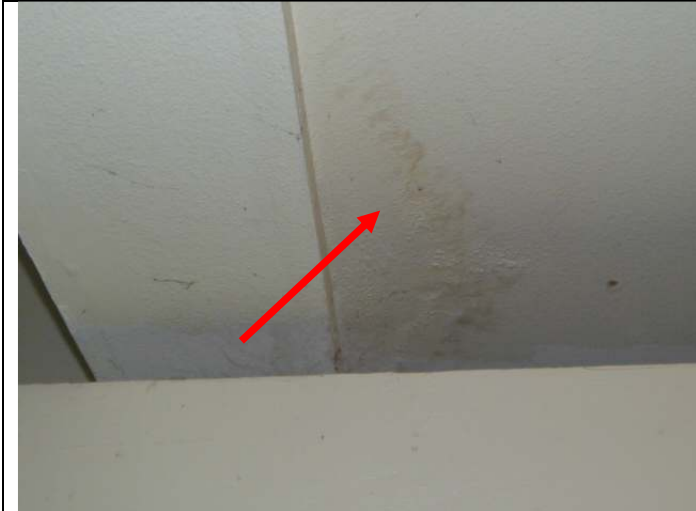
Discoloration in the garage ceiling.

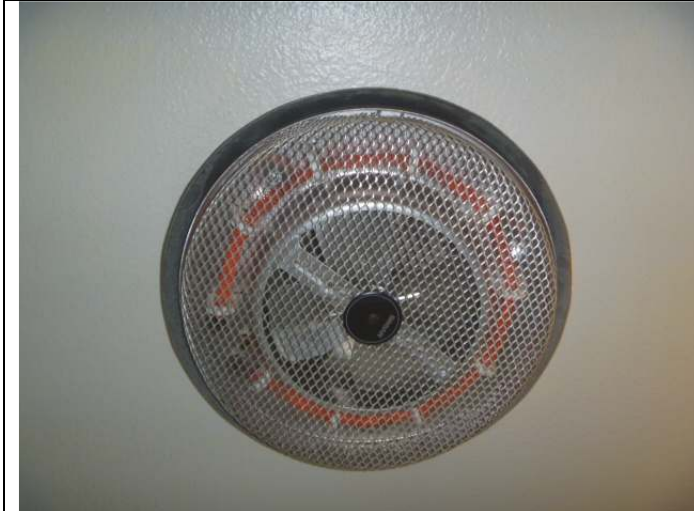
Upstairs 3/4 (primary) bathroom heater. Note: The unit fan is noisy.

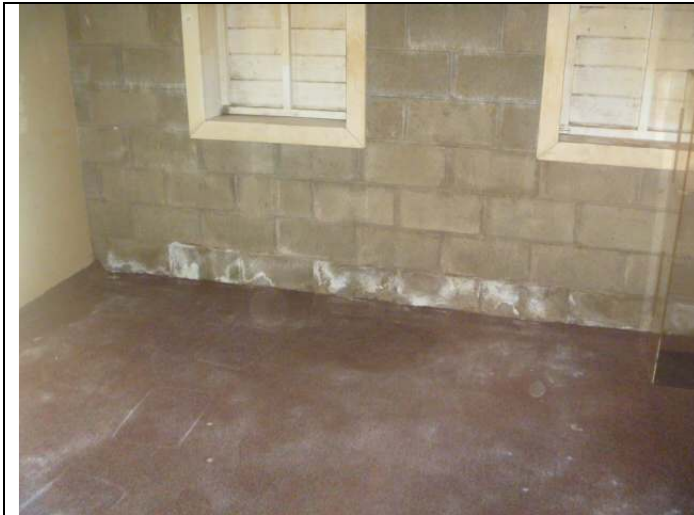
Unfinished sunroom.

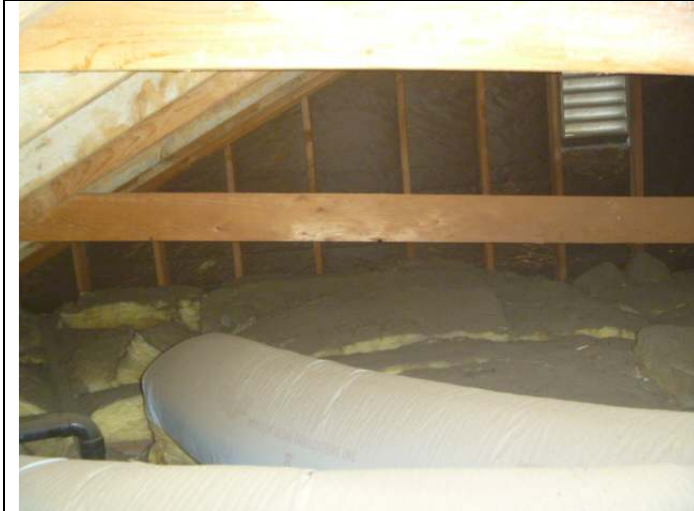
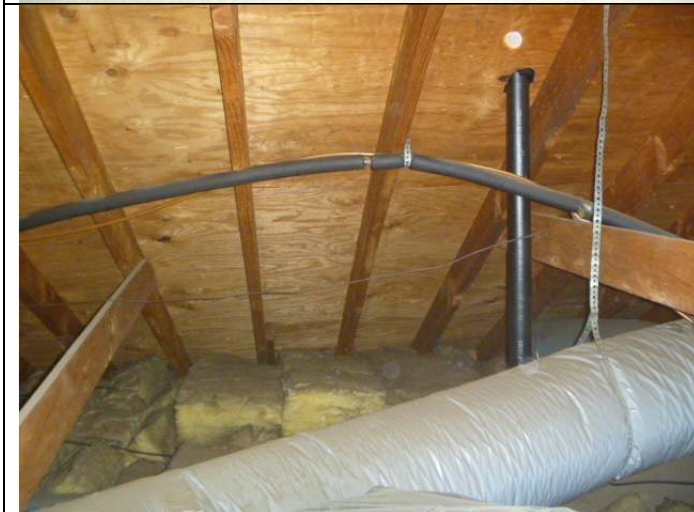
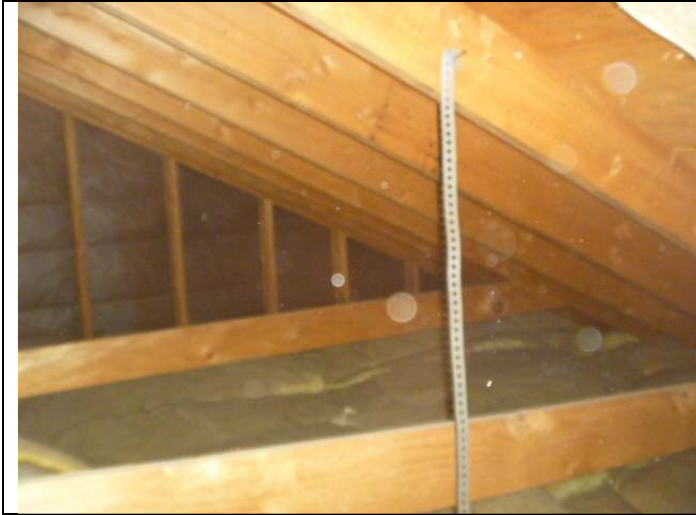
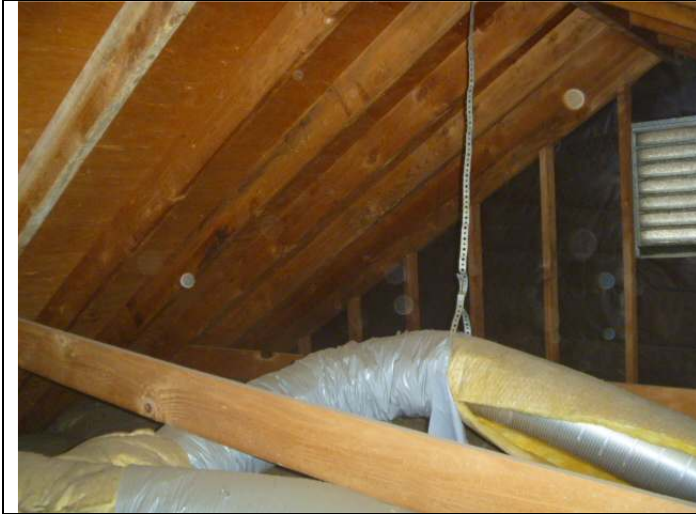
Attic.

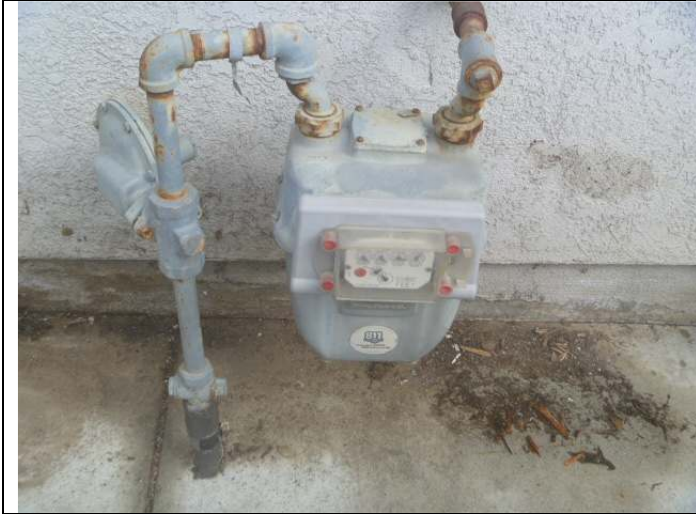
Gas meter.

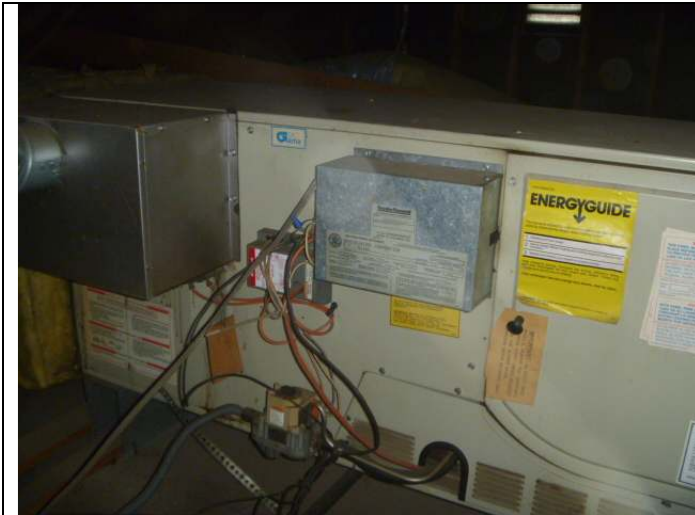
Heater/fan unit.
