9355 Skyview Terrace Tujunga, CA 91042

Reports & Pre-Market Inspections

This report provides an account of the results of a building inspection done at the above property. The purpose of the inspection is to report the general conditions of the structure and the electrical, plumbing and mechanical systems.

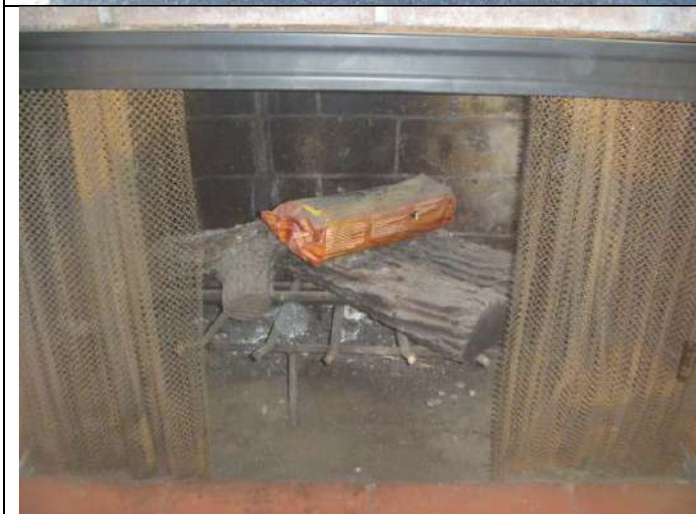
Fireplace.

<p>Fireplace gas valve. Note: The valve is relatively stiff.</p>
 	<p>Fireplace damper in the open position.</p>
 	<p>Fireplace damper in the closed position.</p>

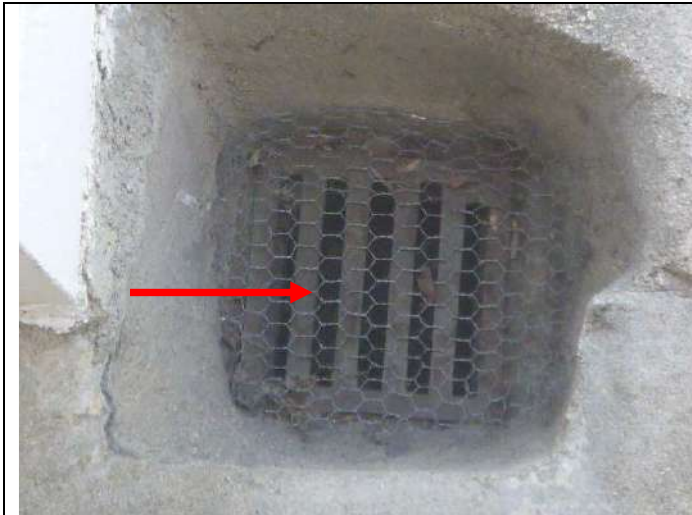
An exterior surface drain (at the center front).

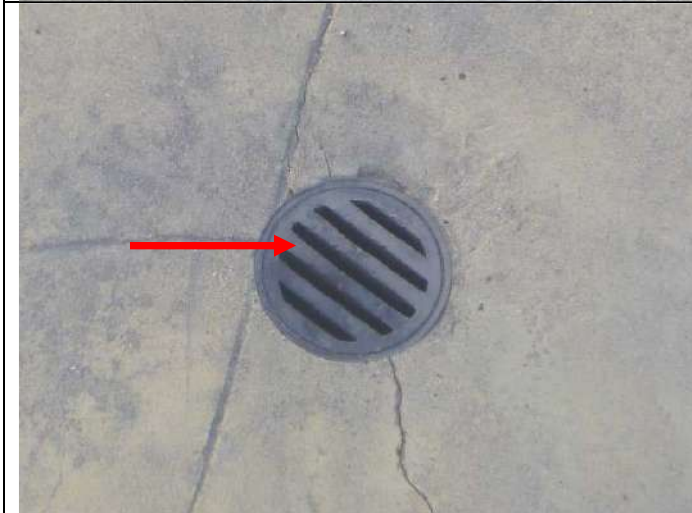
An exterior surface drain (at the right rear).

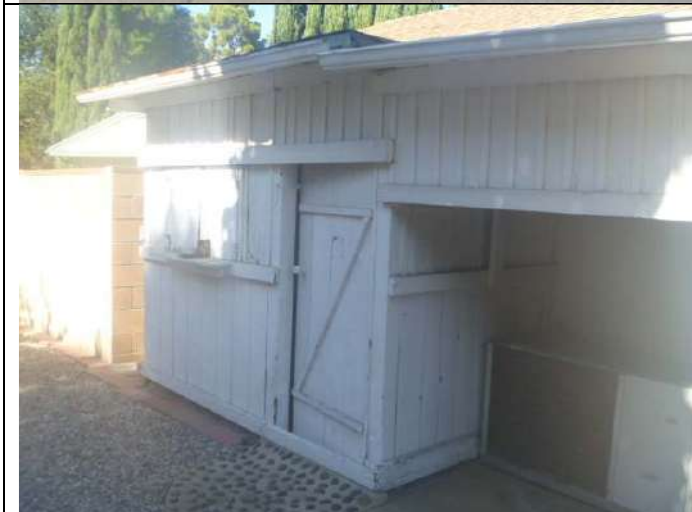
West side storage structure.

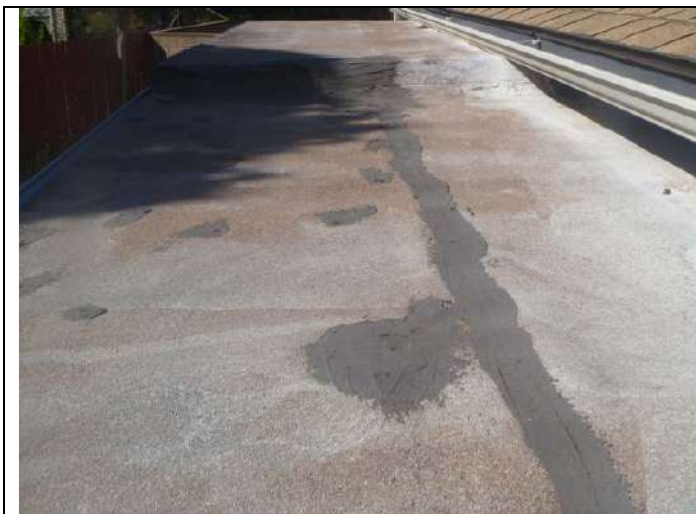
Storage structure roof.

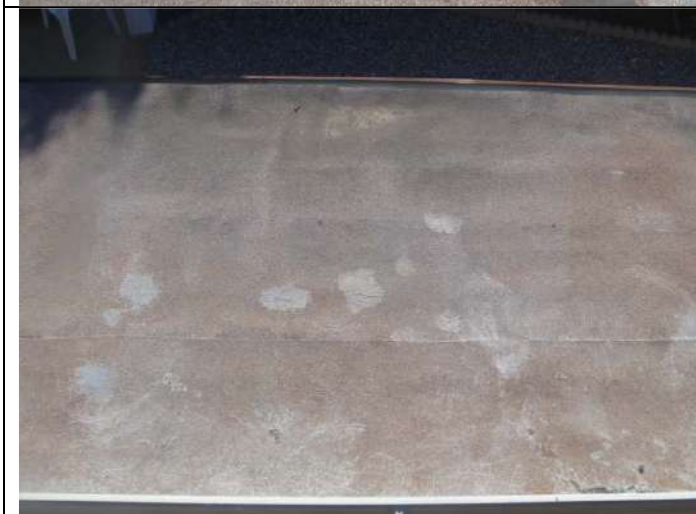
Storage structure roof.

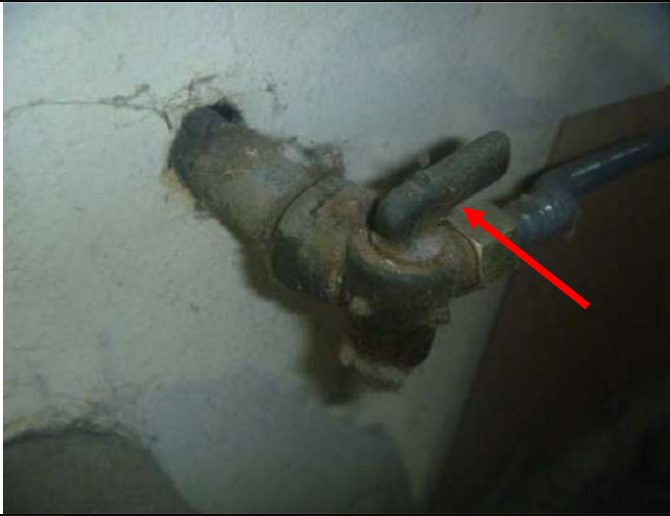
<p>Dryer older gas valve.</p>

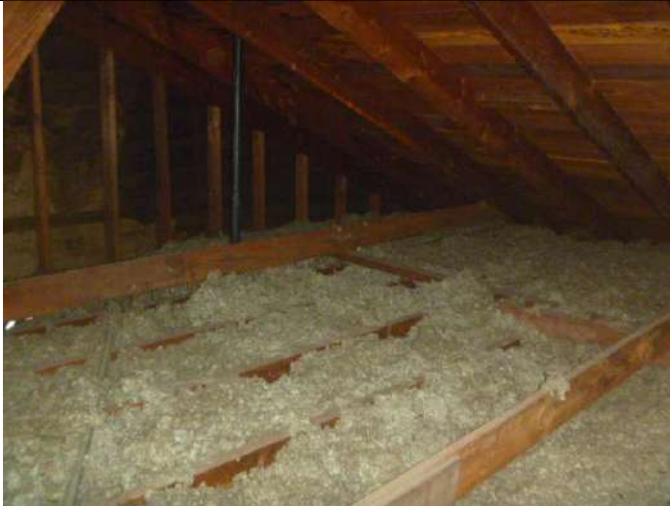
<p>Attic.</p>

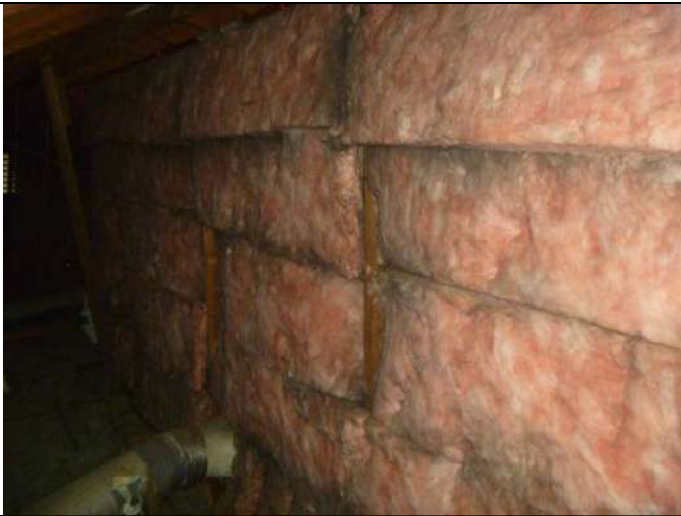
<p>Batts type attic insulation along the walls.</p>

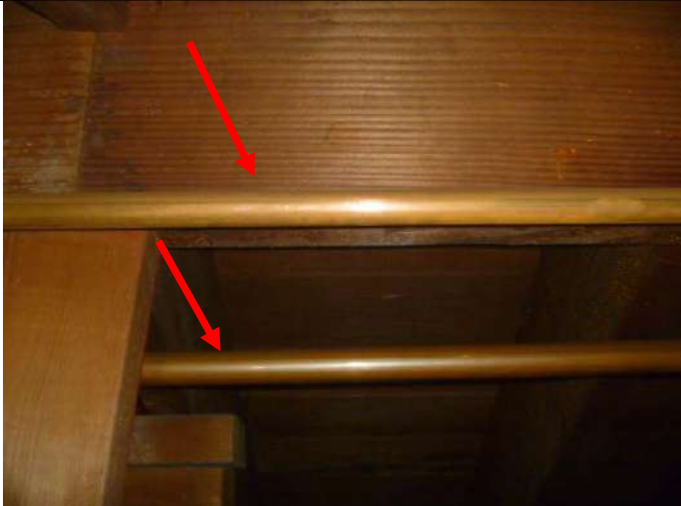
<p>Replacement copper water piping in the attic.</p>

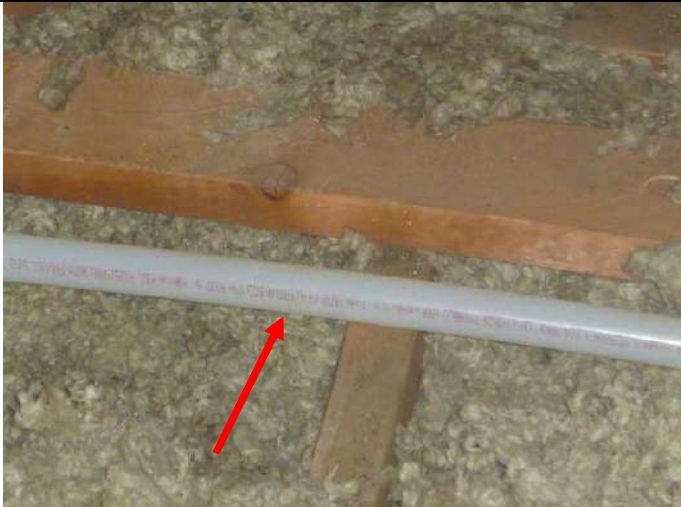
A photograph showing a white PEX (cross-linked polyethylene) water pipe running horizontally in an attic. The pipe is surrounded by yellow insulation and wooden joists. A red arrow points to the pipe.	<p>PEX (cross-linked polyethylene) water piping in the attic. Note: This is for exterior water piping.</p>

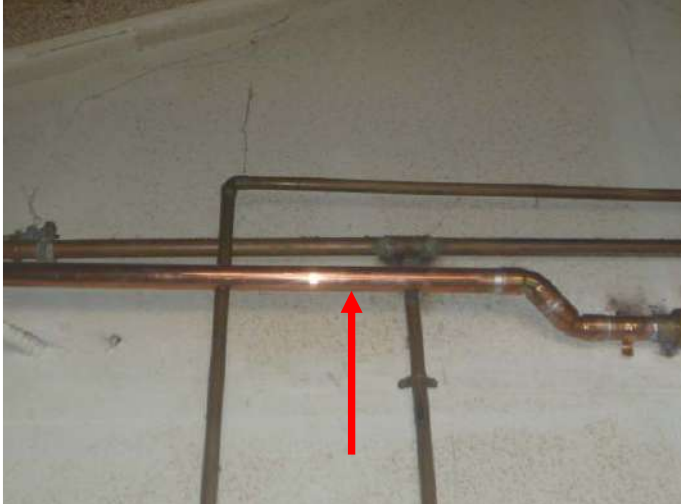
A photograph showing newer copper water piping in a garage. The pipes are running horizontally and vertically against a light-colored wall. A red arrow points to one of the horizontal pipes.	<p>Newer water piping in the garage. Note: This is for exterior water piping.</p>

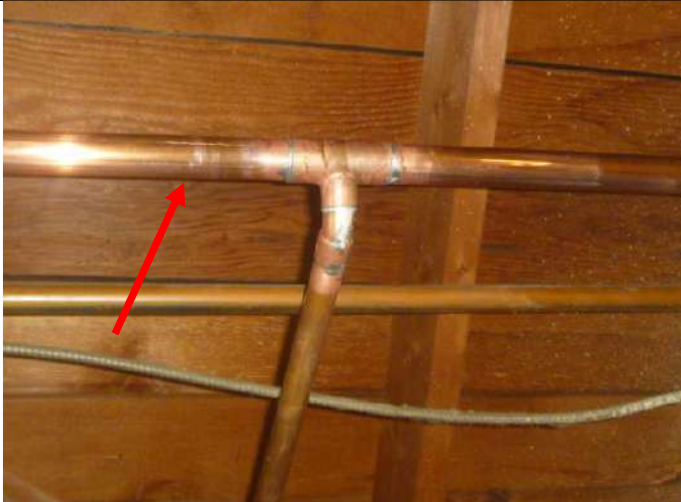
A photograph showing newer copper water piping in a garage, focusing on a T-junction. The pipes are running horizontally and vertically. A red arrow points to the horizontal pipe.	<p>Newer water piping in the garage. Note: This is for exterior water piping.</p>

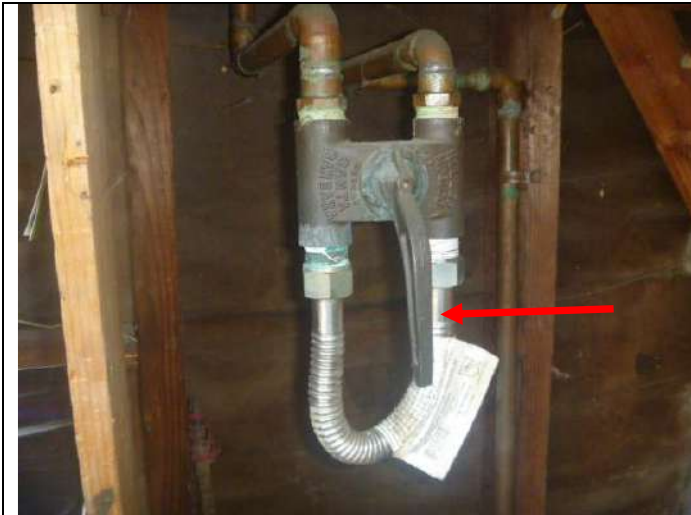
Hookups for a water softener at the left front interior of the garage.

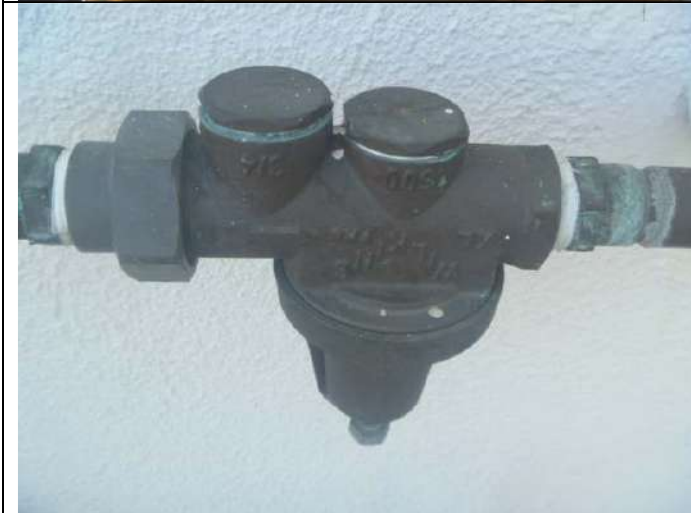
Water pressure regulator.

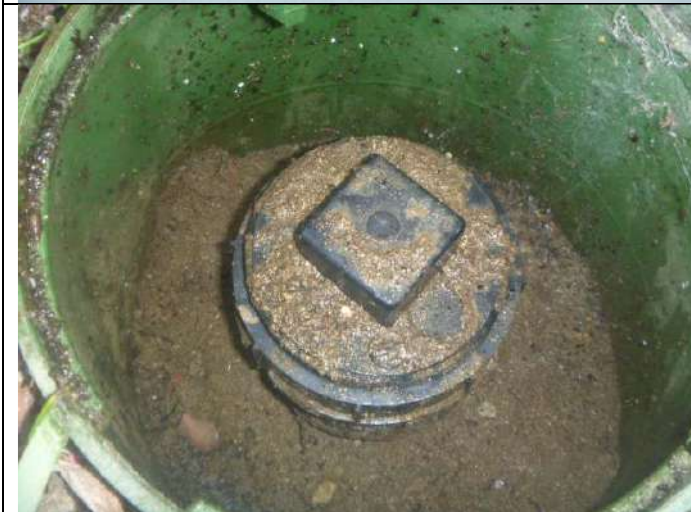
Main drain cleanout at the southeast exterior of the garage.

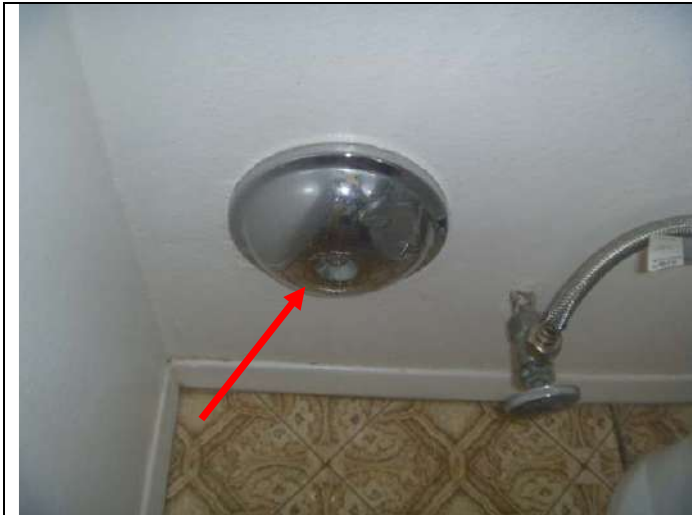
Main drain cleanout at the lower left of the 3/4 (primary) bathroom toilet.

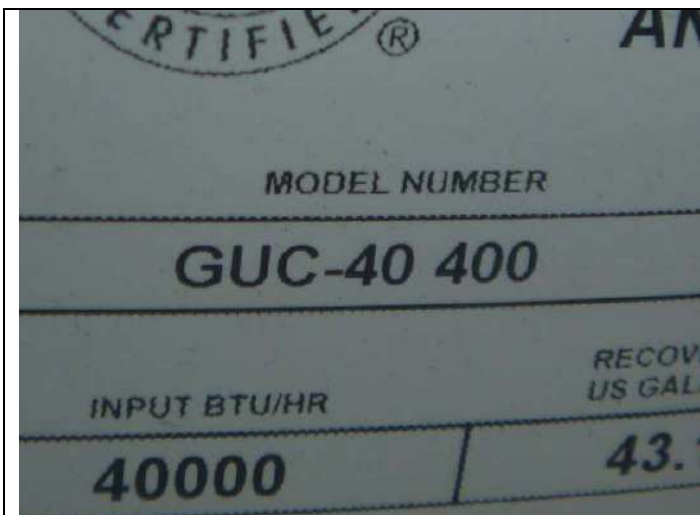
<p>CERTIFIED®</p> <p>MODEL NUMBER</p> <p>GUC-40 400</p> <p>INPUT BTU/HR 40000</p> <p>RECOVERY US GAL 43.</p>	<p>Water heater model number.</p>

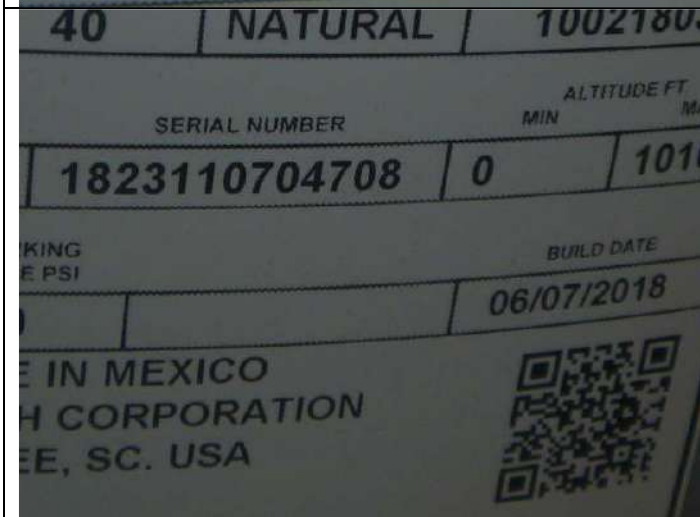
<p>40 NATURAL 1002180</p> <p>SERIAL NUMBER 1823110704708</p> <p>ALTITUDE FT. MIN 0</p> <p>BUILD DATE 06/07/2018</p> <p>IN MEXICO CORPORATION E, SC. USA</p>	<p>Water heater serial number and date.</p>

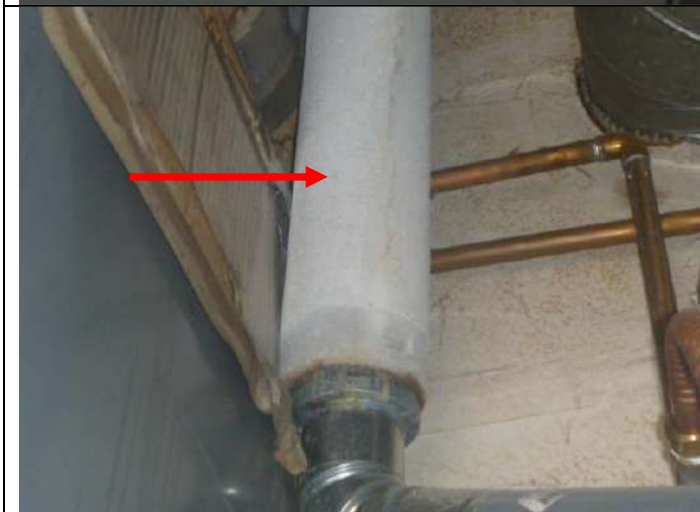
<p>Water heater transite vent pipe.</p>

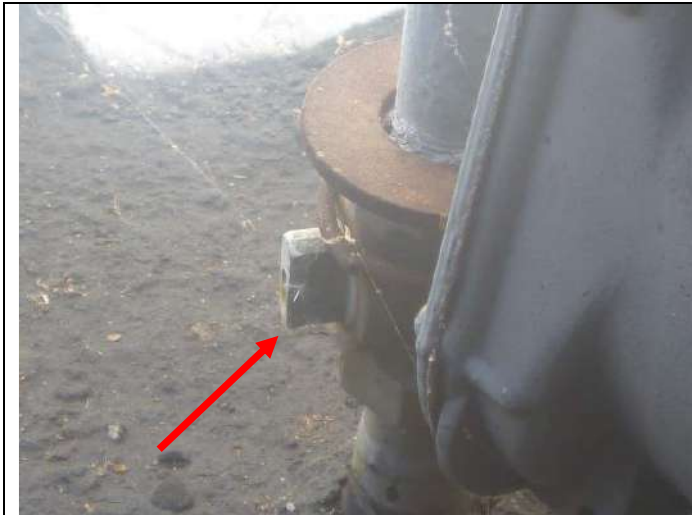
Main gas valve.

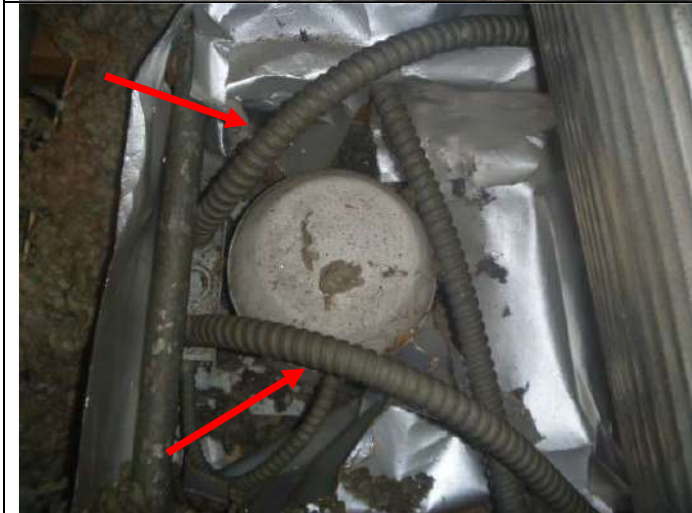
Flexible conduit wiring. Note: The majority of the wiring is this type.

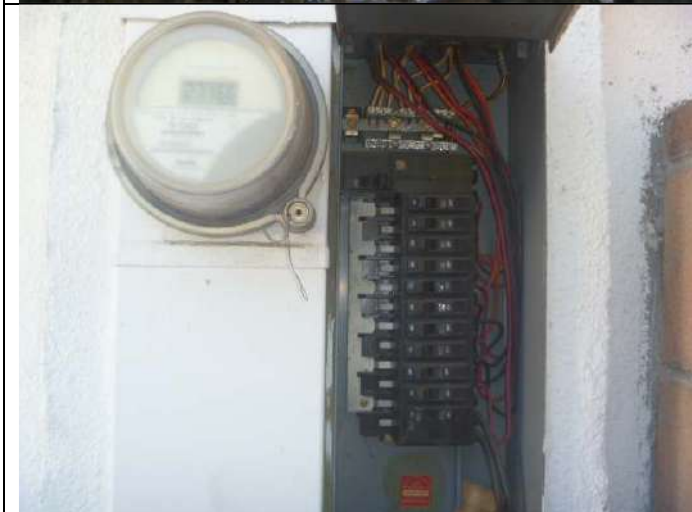
Main service panel (with interior cover removed for inspection).

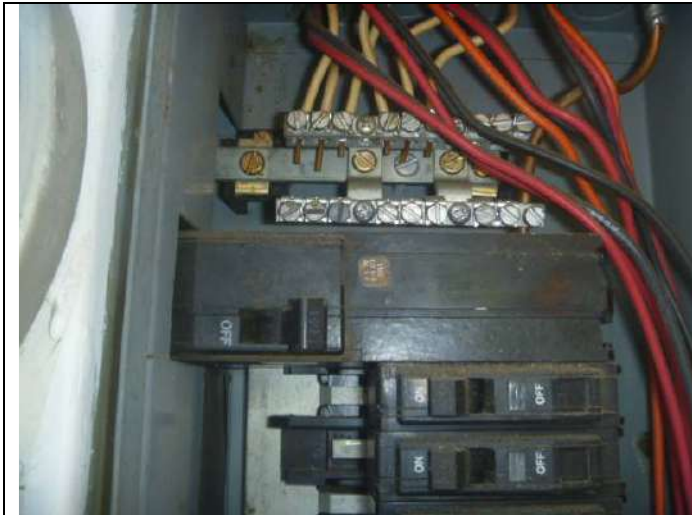
A closer view of the main breaker.

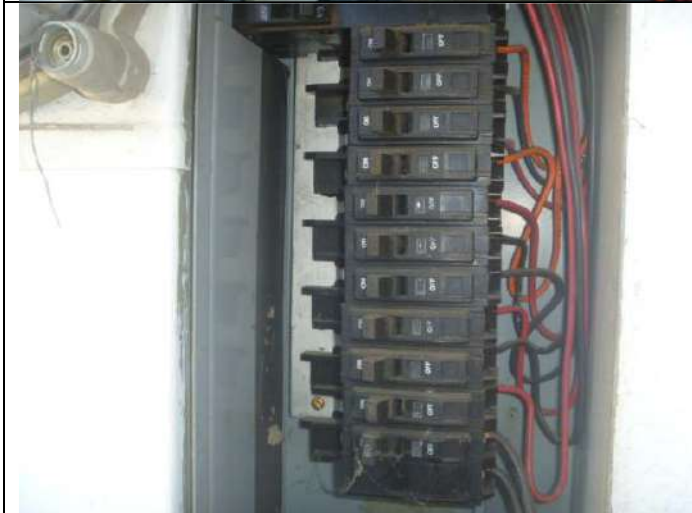
A closer view of the branch circuit breakers.

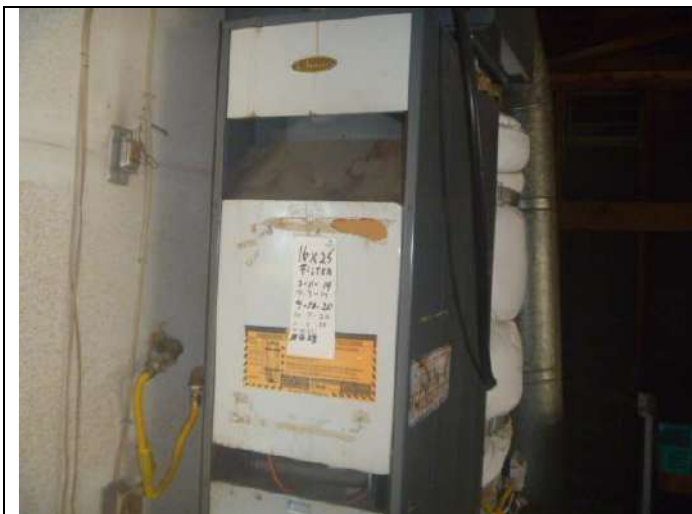
Heater/fan unit.

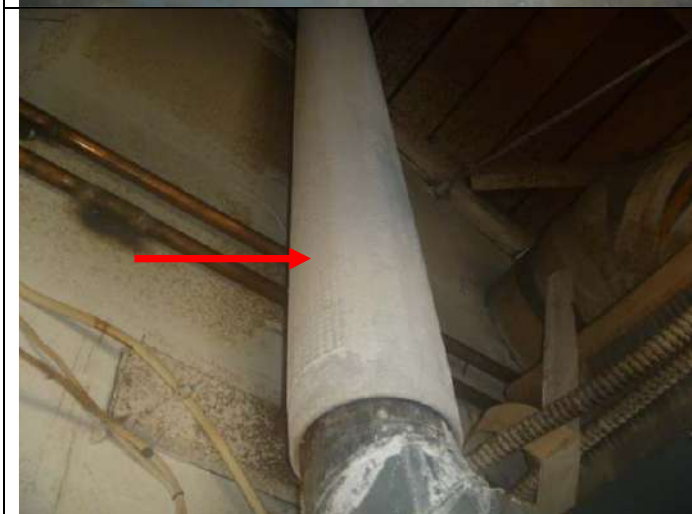
Heater transite vent pipe.

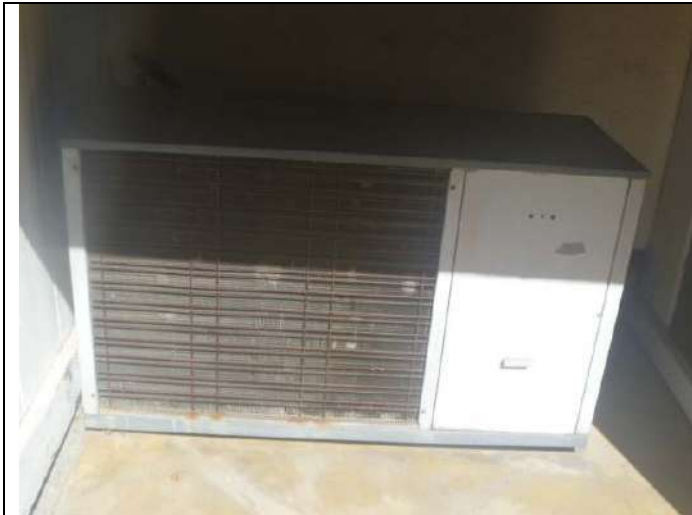
Air conditioner condensing unit.

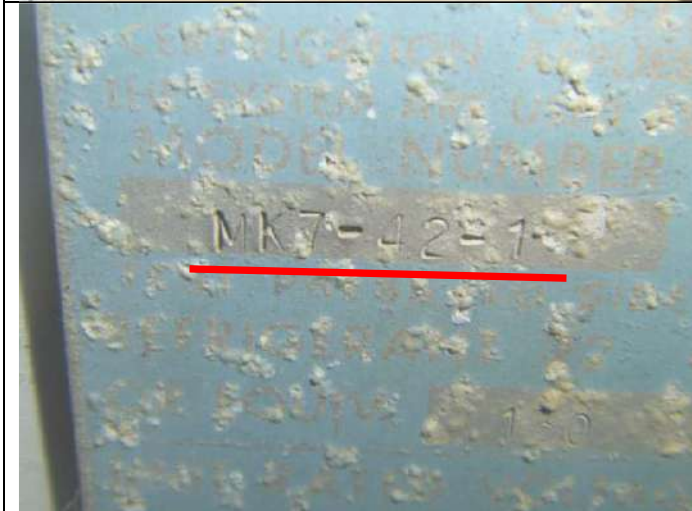
Air conditioner model number.

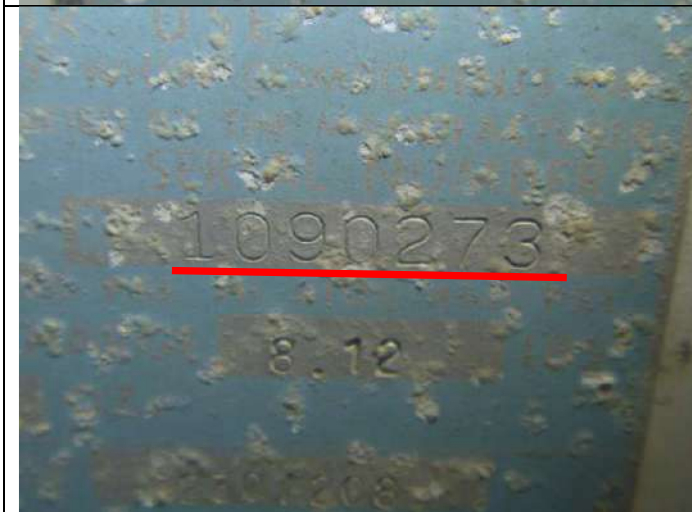
Air conditioner serial number.

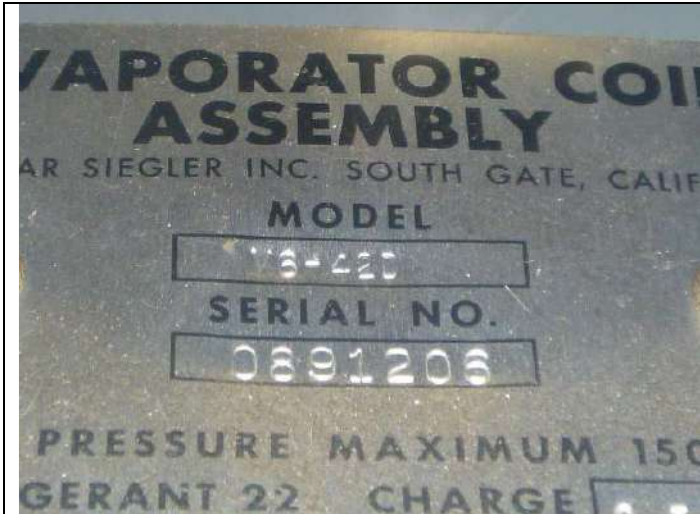
A close-up photograph of a metal label for an evaporator coil assembly. The label is dark with white text. At the top, it reads "EVAPORATOR COIL ASSEMBLY" in large, bold letters. Below this, it says "AR SIEGLER INC. SOUTH GATE, CALIF". Underneath, there is a section for "MODEL" with the number "16-420" in a box. Below that is a section for "SERIAL NO." with the number "0891206" in a box. At the bottom, it says "PRESSURE MAXIMUM 150" and "GERANT 22 CHARGE".	<p>Air conditioner coil model and serial numbers.</p>

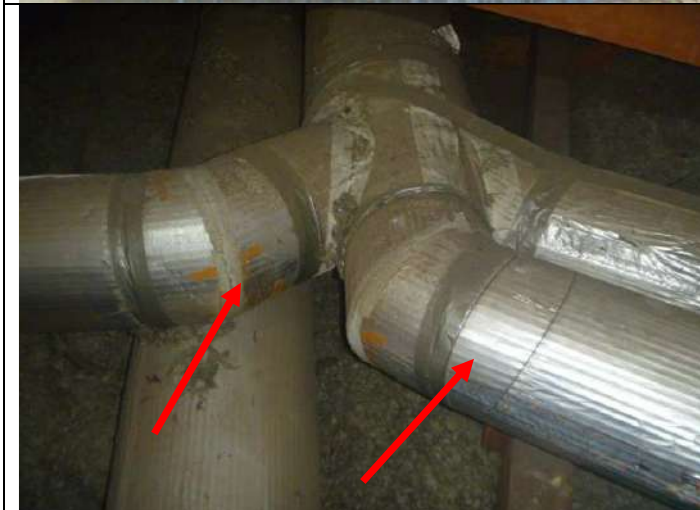
A photograph showing a junction of ductwork wrapped in a thick, light-colored, fibrous material, likely asbestos insulation. The ductwork is located in an attic space, with wooden joists visible in the background. Two red arrows point to the insulation.	<p>Asbestos insulated ductwork in the attic.</p>

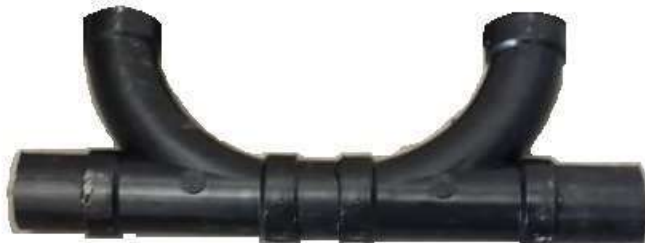
Bullhorn cleanouts are the ideal design for access.

Access should be installed. The most efficient method would be to install two points of entry which face toward each other. This is sometimes referred to as "bull horns cleanout" as it slightly resembles this. See the image below for an example of this configuration.

The existing access allowed for me to reach the city sewer connection but it is not ideal for full maintenance of the line. This new cleanout would be very helpful and might prove sufficient however once it is installed it is recommended to test it out to be sure it provides the access needed.

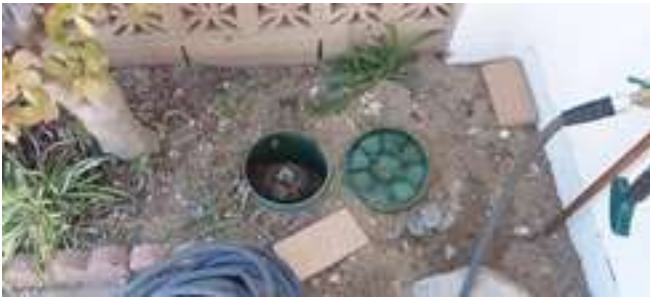
Cleanout used for today's inspection.

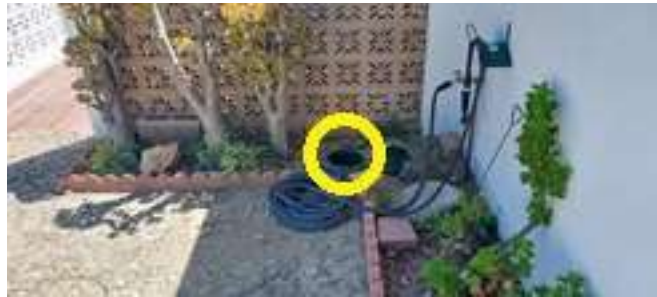
Location of cleanout.

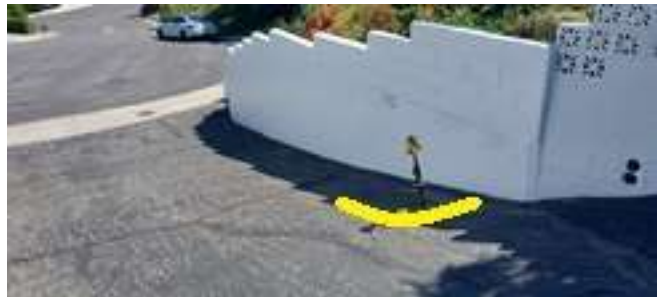
Path of main line. Depth about 4'.

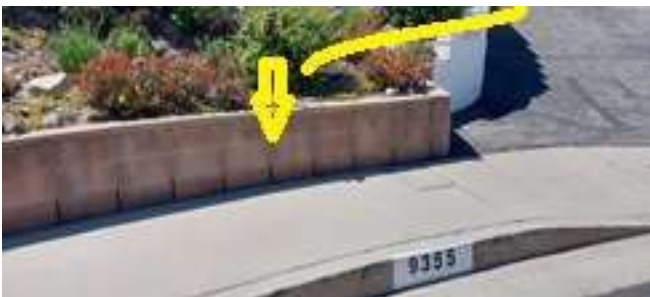
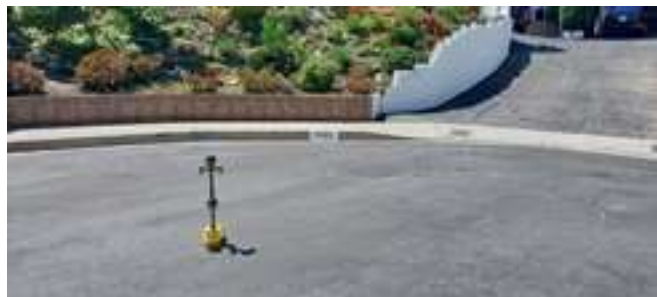
Transition from 4" to 6" diameter pipe. Depth about 9'. Connection to city sewer line. Depth about 7'.

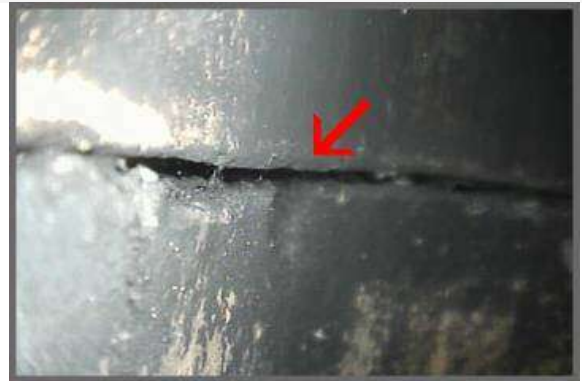
MASONRY FLUE:

FIRE SAFETY RISK. There is deteriorated/missing grouting between the flue tiles. This is considered a fire safety concern and is a violation of masonry flue liner installation standards.

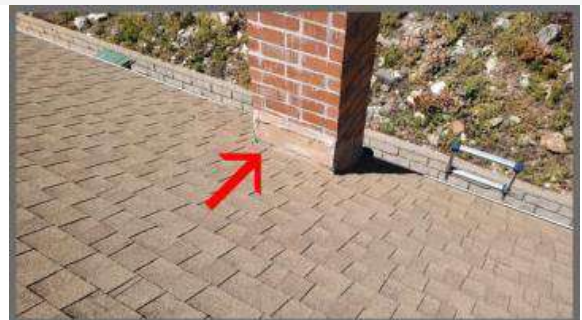
EXTERIOR BASE:

NEEDS ATTENTION. There are some minor cracking along the exterior brick surfaces.

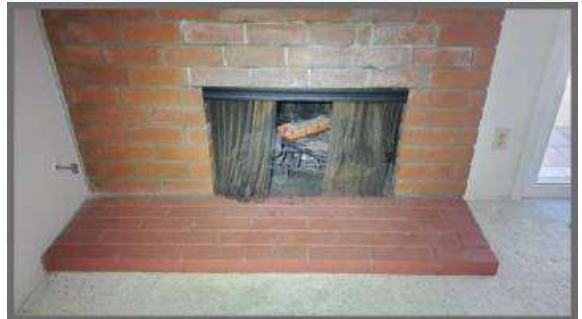
DAMPER:

FIRE SAFETY RISK. The fireplace has an "appliance" system and the damper was not modified to prevent it from closing, usually a simple clamp can be installed to meet this requirement. The damper should typically be "fixed" in the fully open position.

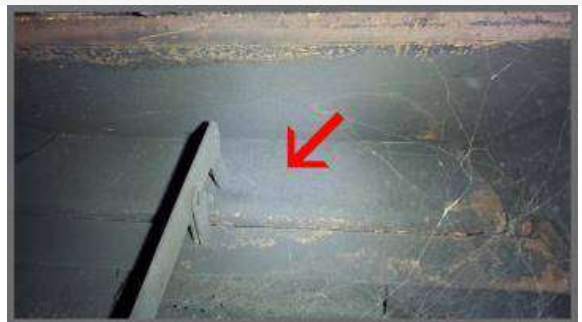
MASONRY FIREPLACE:

FIRE SAFETY RISK. There are gaps where the upper right and left side walls meet the lintel/breast area.

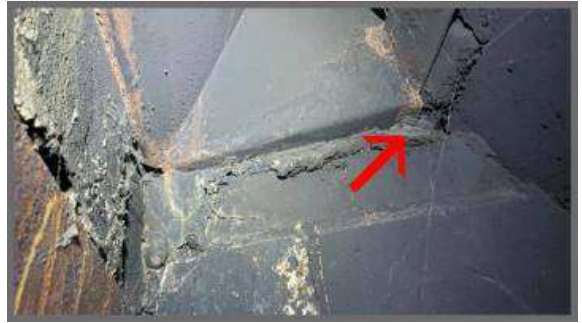
APPLIANCE:

NEEDS ATTENTION. The current gas log set is older and incomplete.

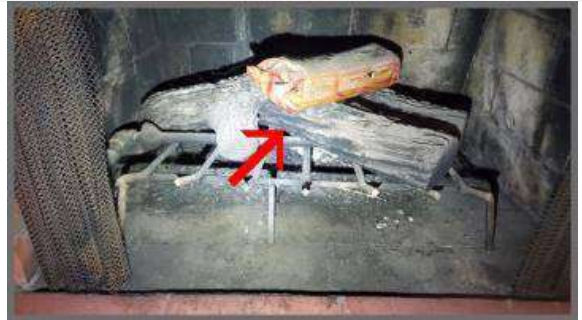
GAS LINE:

FIRE SAFETY RISK. The gas line into the fireplace does not have a proper fireproof seal where it enters the firebox, this is typically a matter of filling the gap with a fireproof sealant.

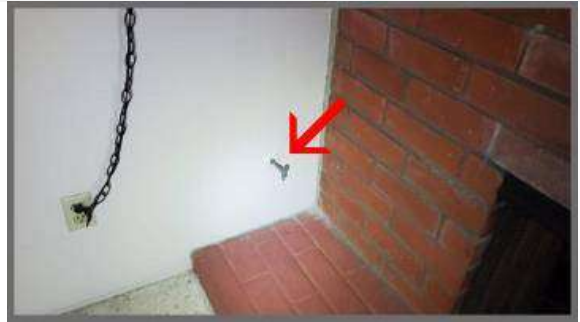
GAS VALVE:

NEEDS ATTENTION. The gas valve operates stiffly and should be evaluated by a qualified plumber.

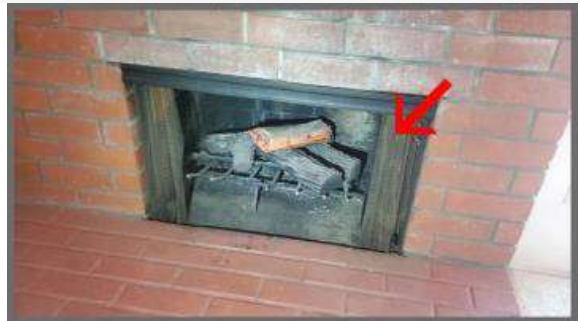
SCREEN:

NEEDS ATTENTION. The pull cords for the screen do not function.
